Martina Bocci, Beatriz Yuste

Recovering the heritage and building traditions of the village of Tacora, Chile

In 2016 the local community entrusted the Fundación Altiplano (FA), a Chilean nonprofit organization, to rehabilitate their houses. They had cooperated with FA in 2012 in the restoration of the Virgen del Carmen Church (late 18th century). The “Programa de Capacitación para la Restauración de Fachadas en Viviendas Patrimoniales de Tacora” (Training Program for the Restoration of Façades of the Heritage Homes in Tacora) was launched in February 2018.

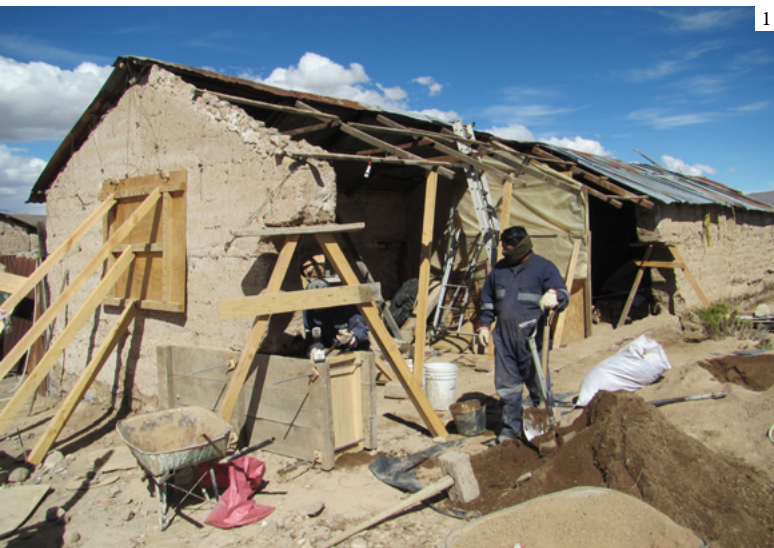
1

1: Process of reconstruction of a rammed-earth wall
2: Wooden reinforcement of a rammed-earth wall

The interventions employed local techniques and solutions, without altering the architectural character of the place. Missing or eroded stone basements were restored; collapsed or detached portions of walls were rebuilt; cracks and fissures were repaired with earthen mortar injections, filled with adobe bricks or with volcanic stones and earthen mortars. In some gables, masonry was replaced by lightweight *quincha*: a local traditional structure made of wood and reeds which is filled with a mixture of earth and straw.

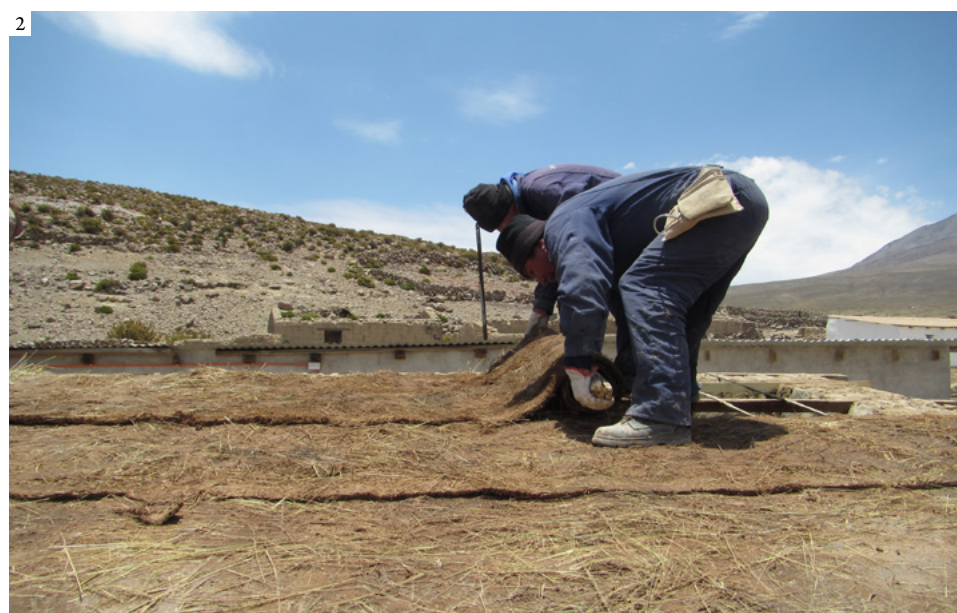
2: A *caruna* being placed on a roof

In the weaving workshop and the shop an oral tradition, which was still remembered by one of the workers, was recovered: *caruna* was laid on cowhide laces, braided to the rafters. *Caruna* is an insulation mat obtained by first placing some straw randomly on a flat surface, then pouring earth and *baba de tuna*, and finally treading on the mix. Once it is almost dry, it is cut and rolled (Bocci 2019).
