Improvement of foundation soil behavior for Gründerzeit buildings in Austria using polyurethane resin injections

# Improvement of foundation soil behavior for Gründerzeit buildings in Austria using polyurethane resin injections

**ABSTRACT:** The second half of the XIX century signed a period of comprehensive industrial and cultural development in Austria known as Gründerzeit. The architecture was deeply influenced during this epoch by the construction of large masonry buildings, called “Gründerzeit Häuser”, which represent today the historical heritage of the most important Austrian cities. Due to the increasing demand for apartments in the centre of these cities, renovations and adaptations of existing buildings has been performed in the last decades. These modifications of the buildings structure represent, besides a business opportunity for the real estate economy, an increase/variation of the load for the foundations. Hence, the renovation and preservation of this architectural heritage often involve the improvement of the foundation soil. This article illustrates how the soil treatment with expanding polyurethane resin represents an efficient solution to achieve this goal. A

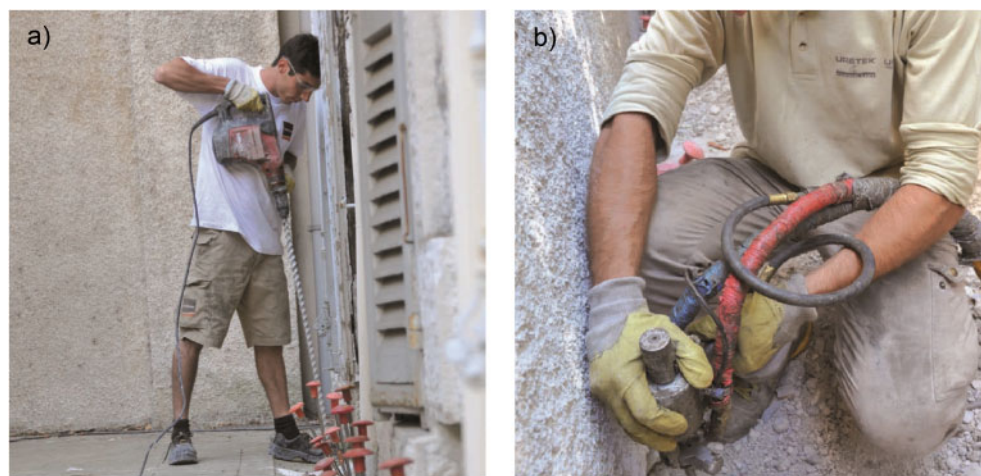
Figure 1. Example of operations: a) Drilling of the borehole; b) Equipment for the injection of the expanding polyurethane resin.

volume increase under unconfined conditions (null mechanical stress) of about thirty times (Buzzi et al. 2008; Dei Svaldi et al. 2005). When the resins are injected underground, the expansion process occurs in confined conditions leading to a compaction of the soil surrounding the injection point until a mechanical equilibrium is achieved between the resin and the soil (Dominijanni & Manassero 2014). The injection can be performed at different depths using either several injection tubes with single-point injection at the bottom end of the tube or a single tube with several lateral injection points (multi-point). In both cases, the injections are performed with small tubes (external diameter of about 10–15 mm) and equipment, reducing the treatment impact on the existing structure as much as possible. Figure 1 shows an example of the drilling operations carried out with a portable drill, and the equipment adopted to perform the injection of the resin in the installed tube from the ground surface.

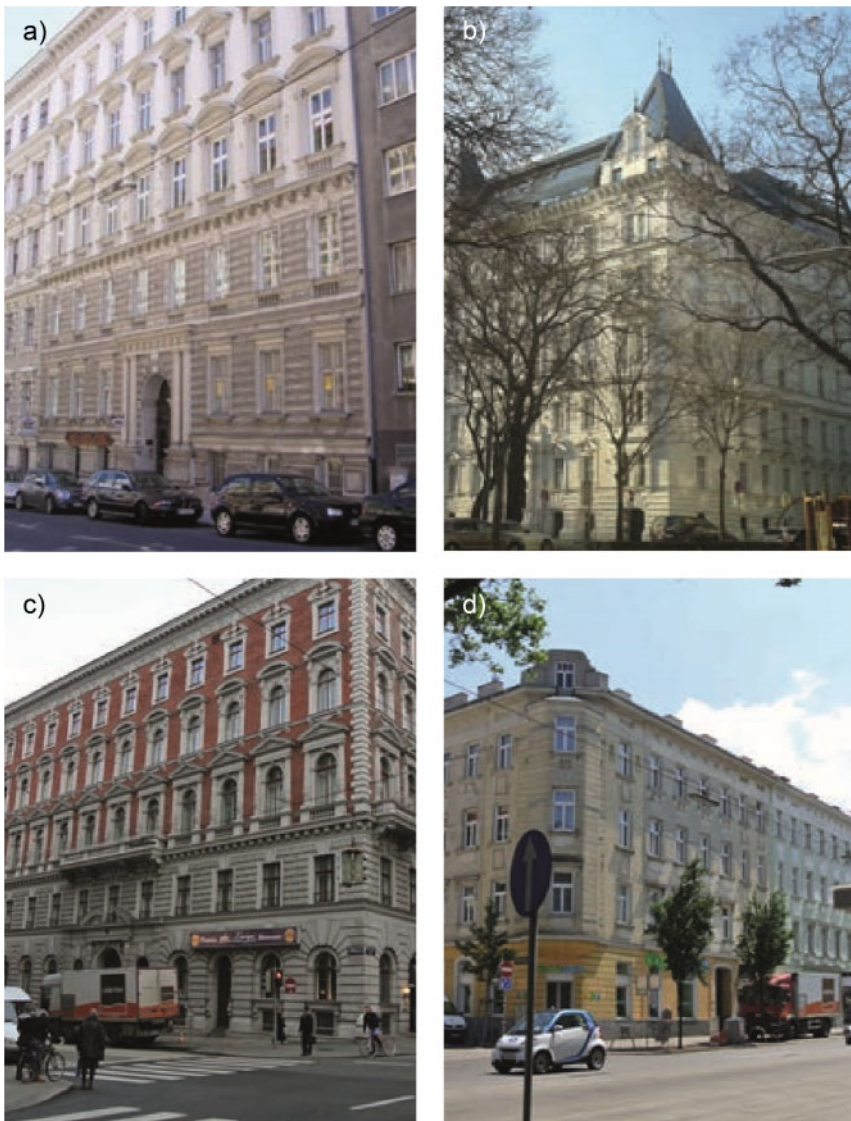
Figure 3. Overview of Gründerzeit buildings in the city of Vienna that undergone foundation soil treatment with expanding polyurethane resins.

An example of four historical buildings in Vienna, constructed during the Gründerzeit period, which have been subjected to soil foundation treatment with polyurethane resins for the construction of attics and/or renovation works, is illustrated in Figure 3. In all of the four cases, the buildings have shallow foundations at a depth in the interval 0.6–2.0 m below the ground surface. In this framework, the injections have been performed underneath the foundation beams. For the building in the image a) (Figure 3), about 260 m linear of strip foundations at a depth interval of 1.3–1.5 m were treated in 20 days of work. For the building in the image b), about 350 m linear of strip foundations at a depth

of 2.0 m were treated in 25 days of work. These two works were performed for the construction of an additional attic floor. For the buildings in the images c) and d) (Figure 3), about 200 m linear and 50 m linear of strip foundations were treated in 18 and 5 days, respectively; in these two last cases, the treatment aimed at the improvement of the foundation soil for settlements mitigation occurred during and after renovation works of the structures. In all the illustrated examples, the foundation soil was mainly composed of a silty sand/gravel. This feature has made the treatment of polyurethane resins extremely attractive. The performed works allowed the stabilization and improvement of the foundation soil, which is usually assessed through settlements monitoring system.

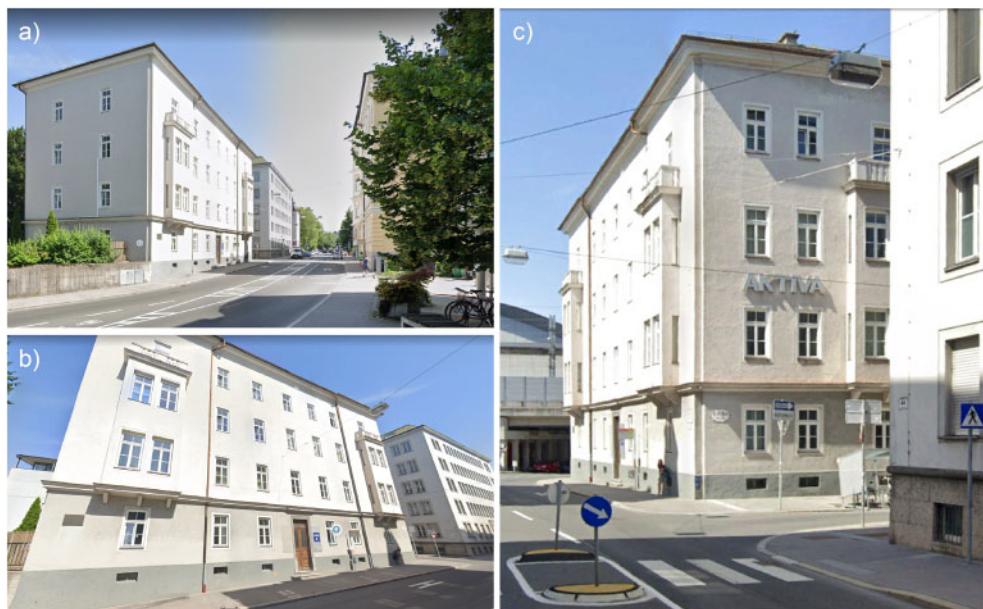
Figure 4. Overview of the building in Salzburg: a) north side of the building; b) west side and main entrance of the building; c) south side of the building.

The structure of the building is composed of four floors above the ground and one underground floor. In Figure 4 are reported some pictures of the building from the main street, named Schwarzs-trasse. The level of the basement is placed at a depth equal to 2 m from the ground surface (418.60 m a.s.l.). The strip foundations of the building have a width equal to 1 m and are located 1 m below the basement level (i.e. 3 m below the ground level). The foundations are composed of rock blocks obtained from the dismantling of the historical boundary wall of the old city.

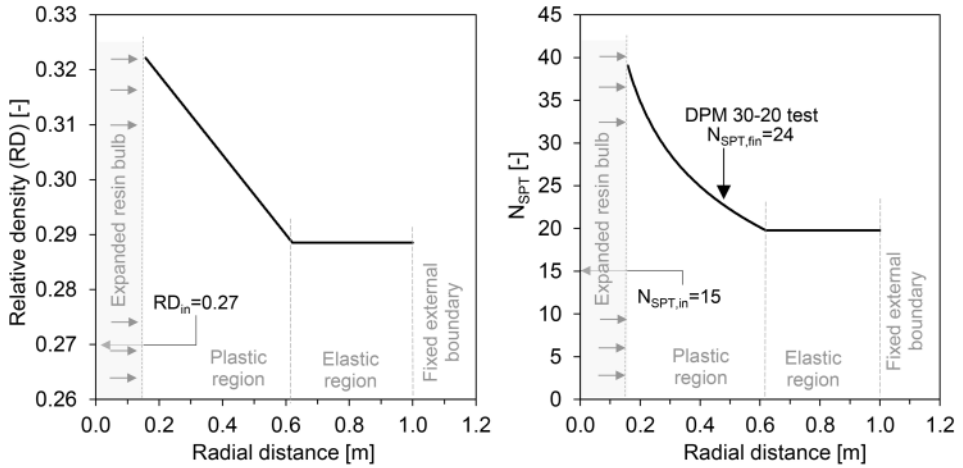
Figure 9. Results of the analysis carried out with cavity expansion theory in a finite medium to evaluate the increase of relative density (a) and blow number NSPT (b).

The results of the analysis are illustrated in Figure 9. The graphs show the evolution with radial distance from the injection point of the calculated relative density and  $N_{SPT}$  value. The relative density achieves a maximum value close to the expanded resin bulb equal to about 32%, and it decreases progressively to a value equal to 29% in the elastic region of the soil. The graph b) illustrates the evolution with the radial distance of the calculated  $N_{SPT}$  value. Also in this case, the maximum value is achieved close to the injection point ( $N_{SPT} = 39$ ), and it decreases gradually to a value equal to  $N_{SPT} = 20$  in the elastic region. At a radial distance equal to 0.5 m from the injection point, the  $N_{SPT}$  value is equal to 23. This value is in good agreement to the average  $N_{SPT}$  value, equal to 24, that has obtained for the same depth interval from the DPM 30-20 test performed in-situ after the treatment. This outcome has been obtained considering an amount of resin injected equal to 20 kg, which is equal to the average amount of resin injected in a single point for the treatment of 1 m of soil.
