Stress corrosion cracking of additively manufactured alloy 625 / Cabrini, M.; Lorenzi, S.; Testa, C.; Carugo, F.; Pastore, T.; Manfredi, D.; Biamino, S.; Marchese, G.; Parizia, S.; Scenini, F.. - In: MATERIALS. - ISSN 1996-1944. - ELETTRONICO. - 14:20(2021). [10.3390/ma14206115]

Stress Corrosion Cracking of Additively Manufactured Alloy 625

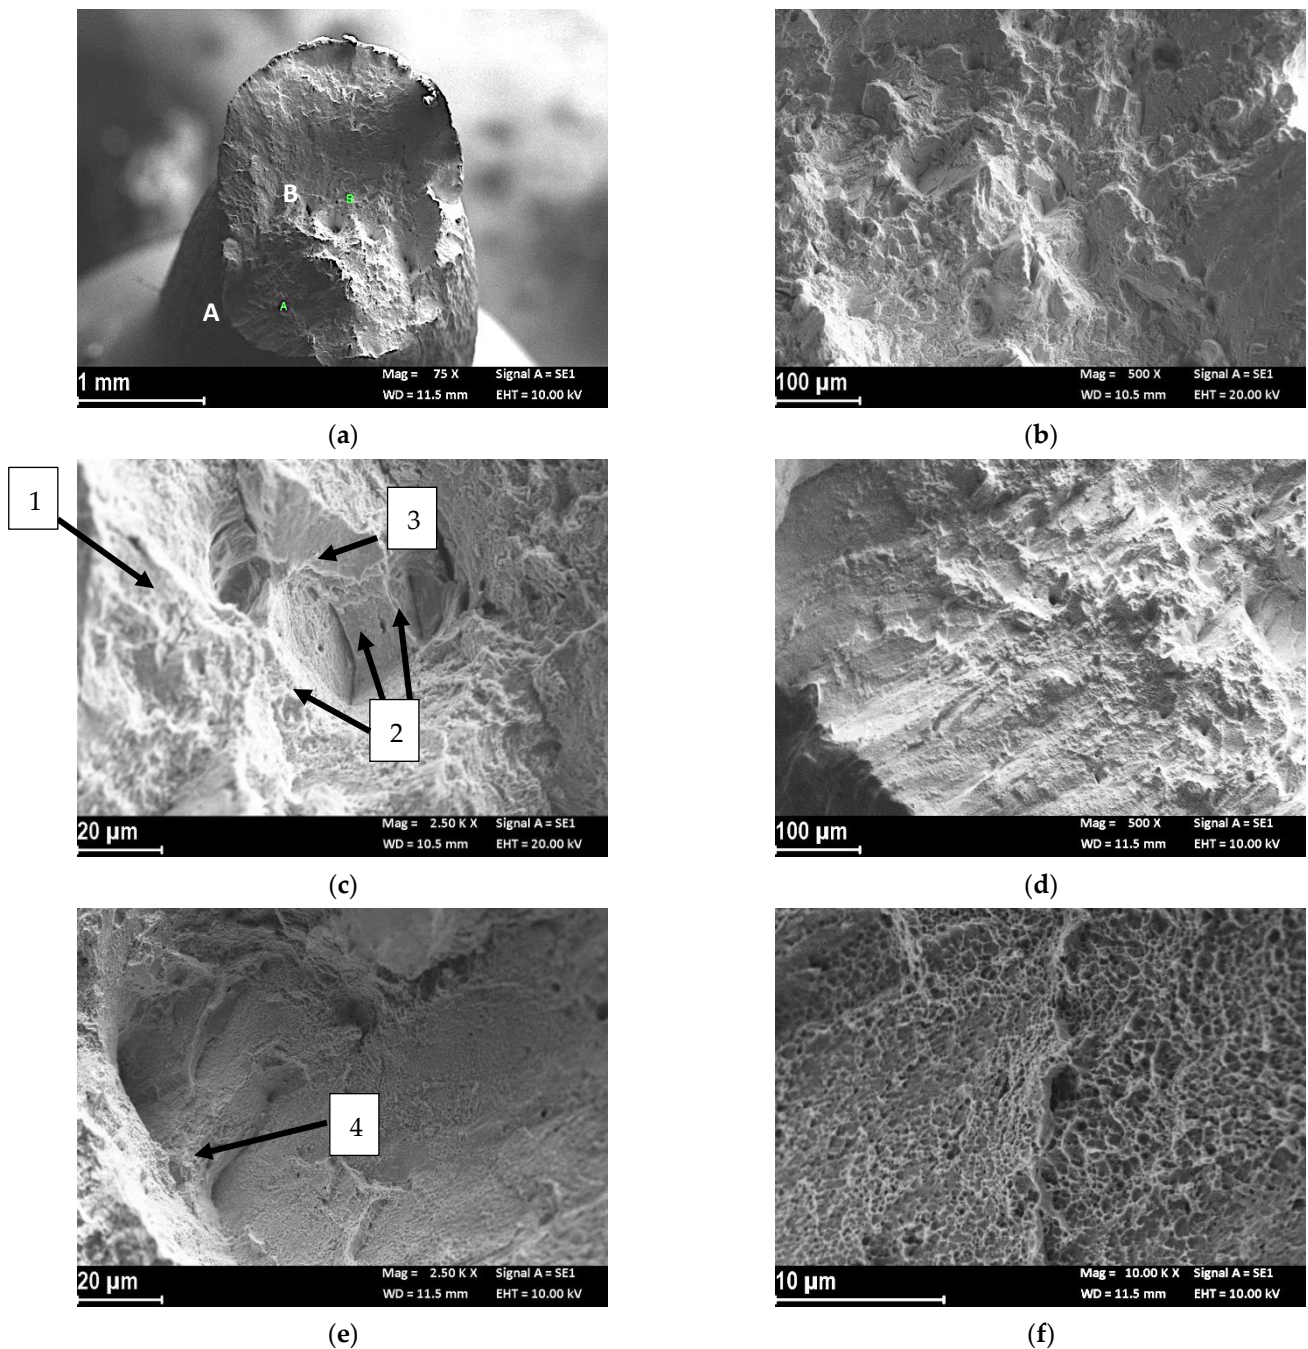
Figure 3. Secondary electron fractographic analysis of the UT-LPBF specimen after the SSRT test in air: (a) macro image; (b) close-up of the center of the specimen (zone B in (a)); (c) close-up at higher magnification of Figure 3b, the arrows indicate: (1) presence of large dimple associated to inclusion, (2) edge of the melt pool, and (3) low toughness zone; (d) close-up of zone A of (a) fracture zone of shearing; (e) close-up of (d) in which is evident the separation of the melt pools, (f) close-up of zone (4) in (e) in which are evident micro dimples in the separation of the melt pools.

Figure 3 shows the fracture morphology of the UT-LPBF specimen tested in air. The specimen did not have a perfectly regular cone/cup fracture surface (Figure 3a). In the center of the specimen, the fracture was characterized by irregular dimples of different sizes (zone B in Figure 3a and close up of Figure 3b,c) sometimes associated with inclusions (zone 1 in Figure 3c), or, more frequently to the border of the melt pools (zone 2 in Figure 3c). Analyzing the center of the specimen at high magnifications, areas of low toughness and points of cleavage almost appeared (zone 3 in Figure 3c). At the border of the specimen (zone A in Figure 3a) the fracture mode was due to shearing (Figure 3d). On the shearing zone there were micro-separations corresponding with either the edge of the melting pool (zone 4 in Figure 3e), or the dimples (Figure 3f). The different cracking behavior in different regions suggested that there were some zones more ductile than others in the specimen, as it was possible to observe by the sharp decrease in the stress vs. strain curves (Figure 2).

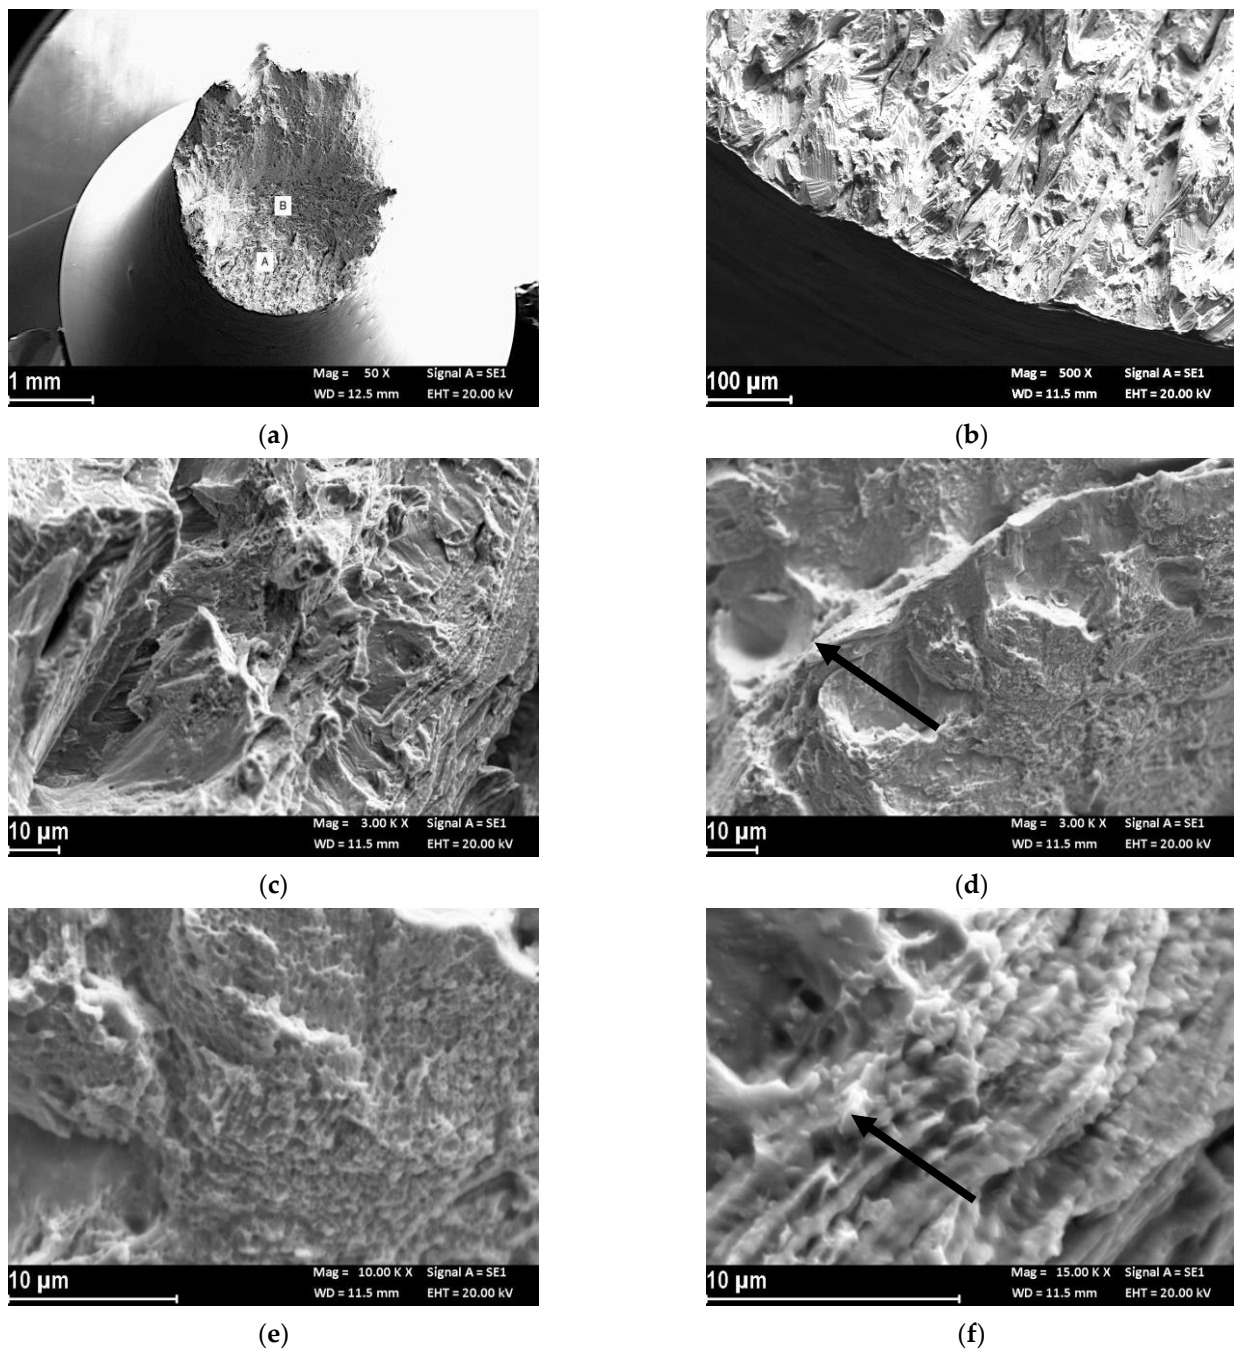
Figure 4. Secondary electron images of the fracture surface of UT-LPBF specimen after the SSRT test at strain rate $3.15 \times 10^{-6} \text{ s}^{-1}$ in SOW and cathodic polarization at -1.1 V vs. Ag/AgCl : (a) macro image; (b) close-up of the trigger zone (zone A in (a)) with brittle morphology; (c) close-up of (b) in which is evident a quasi-cleavage growth, (d) close-up of (b) in which is evident the separation of the melt pool (arrow) and presence of dimples in the upper melt pool; (e) close-up of the center of the specimen (zone B in (a)), presence of dimples and brittle zone; (f) close-up at higher magnification of (e) in which are evident the presence of intermetallic precipitates.

Figure 4a reports the macro image of the UT-LPBF specimen after the test in SOW and cathodic polarization of -1.1 V vs. Ag/AgCl. The specimen still showed plastic deformation, as can be seen from the reduction of area percentage shown in Table 3, but the fracture surface had a flat trigger area (zone A of Figure 4a), which extended to the center of the specimen (zone B of Figure 4a) and the final break was due to sliding by shearing. The trigger zone had a quasi-cleavage aspect (Figure 4b), which is typical of hydrogen embrittlement phenomena. The higher magnification details (Figure 4c) show the alternation of flat areas and small dimples. Microfractures were evident at the separations of the fusion wells, which changed the fracture propagation (Figure 4d). The fracture surface at the center of the specimen (zone B of Figure 4a) was mixed, with brittle area interspersed with small dimples (Figure 4e). The high-magnification image shows the presence of small intermetallic precipitates on the flat facets (Figure 4f).

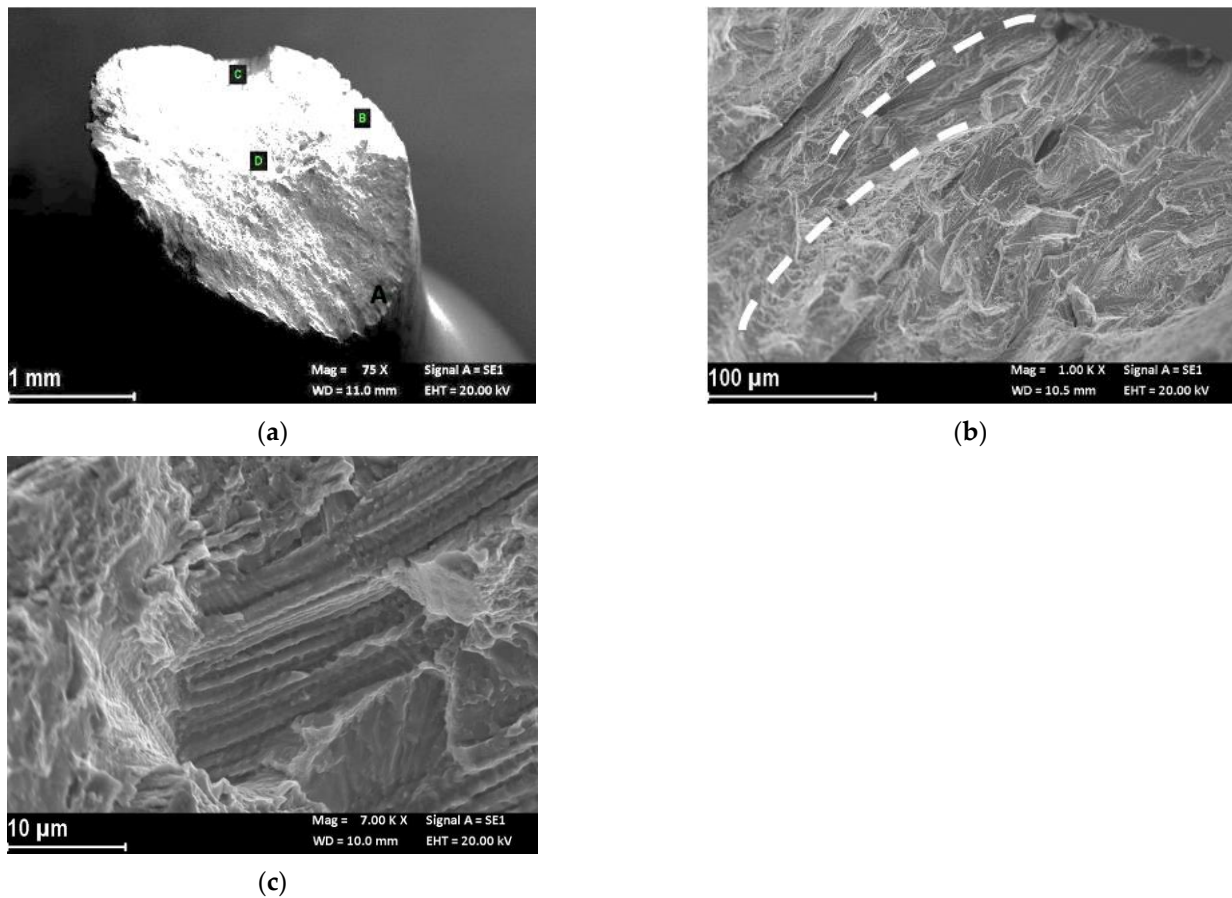
Figure 5. Fractographic analysis of the UT-LPBF specimen after the SSRT test at strain rate $3.15 \times 10^{-5} \text{ s}^{-1}$ in SOW and cathodic polarization at -1.1 V vs. Ag/AgCl after 16 h of hydrogen pre-charging: (a) macro image; (b) close-up of zone A, and (c) a similar morphology is observed in zone C; close-up of zone B; zone D in (a) is fully ductile.

Figure 5a shows the macro image of the fracture surface of the UT-LPBF specimen pre-charged with hydrogen for 16 h and then strained at $3.15 \times 10^{-5} \text{ s}^{-1}$. The fracture surface had some small trigger areas with a morphology typical of hydrogen embrittlement (zone A, B and C of Figure 5a; the close-up of zone A is shown in Figure 5b, the close-up of zone B is shown in Figure 5c), while the central area had a mixed fracture consisting of numerous dimples, small brittle facets and rare areas of quasi-cleavage. The final breakage of the specimen occurred by sharing. The value of the normalized reduction of area was very similar to that obtained in the previous case. At high magnification for areas A (Figure 5b), B (Figure 5c) and C of the specimen, a morphology similar to that observed in Figure 4 could be noted, with many brittle facets arranged perpendicularly to the direction of propagation of the fracture (along the dendritic growth) that occasionally jumped on a different plane, and a separation of the border of the melting pool (dotted line in Figure 5b).

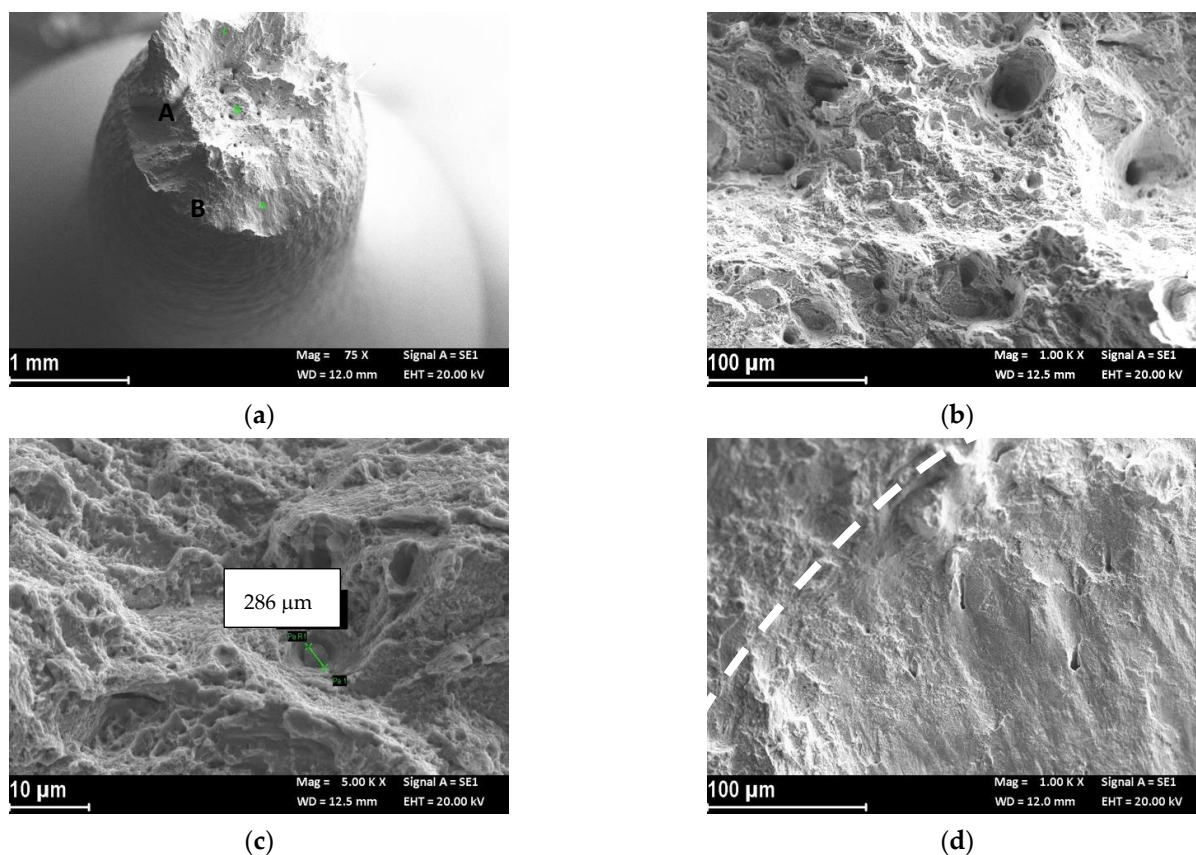
Figure 6. Fractographic analysis of the HT-LPBF specimen after the SSRT test in air: (a) macro image; (b) close up of the center of the specimen (zone A in (a)) with presence of dimples; (c) close-up of a large precipitate in (b); (d) close-up of the border of the specimen (zone B in (a)) in which is evident the change of fracture growth in the corresponding edge of the melt pool.

Figure 6a shows the fracture surface of the heat-treated specimens tested in air. The fracture surface had a typical cup and cone shape with a morphology in the center characterized by dimples of very variable dimensions (Figure 6b). Larger dimples were sometimes associated with large-sized precipitates (Figure 6c). The final fracture, also in this case, occurred by sliding by shearing (Figure 6d), with separations between the melt pools (dotted line in Figure 6d).

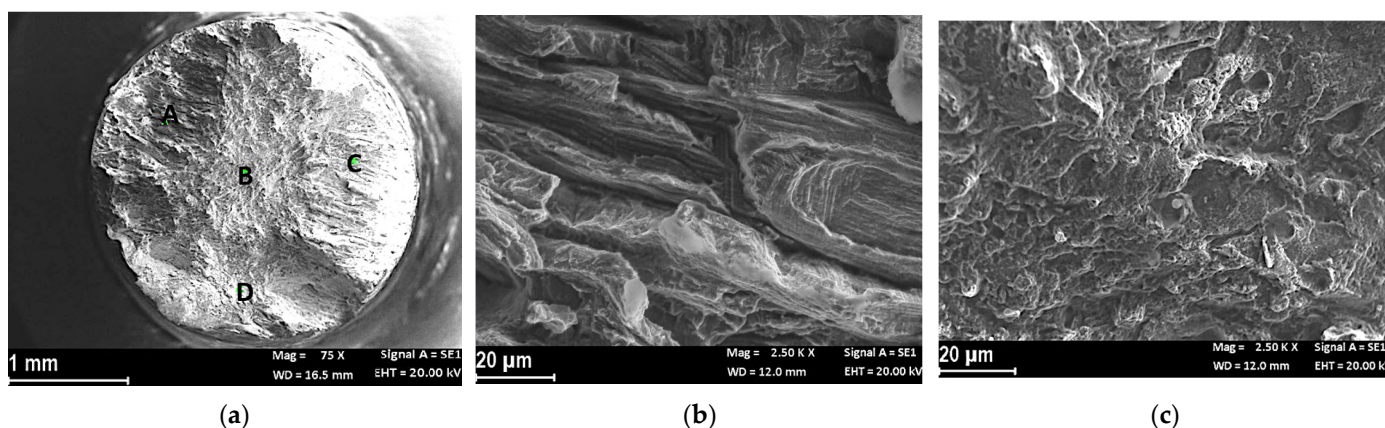
Figure 7. Fractographic analysis of the HT-LPBF specimen after the SSRT test at strain rate $3.15 \times 10^{-6} \text{ s}^{-1}$ in SOW and cathodic polarization at -1.1 V vs. Ag/AgCl: (a) macro image; (b) close-up of the trigger of the fracture (zone A of (a))—zone C has the same morphology of zone A; (c) close-up of the center of the specimen (zone B of (a))—a similar morphology is present in zone D of (a)).

The fracture surface of the heat-treated specimen at the end of the SSRT test with strain rate $3.15 \times 10^{-6} \text{ s}^{-1}$ cathodically polarized at -1.1 V vs. Ag/AgCl in SOW was totally flat (Figure 7a); there were two large trigger zones by hydrogen embrittlement (denoted with A in the Figure 7a) with a morphology similar to the UT specimens (Figure 7b), with flat facets arranged in a radial direction, separated by longitudinal microfractures and flat areas of cleavage. Even the center of the specimen appeared with a quasi-cleavage morphology (areas B and C—close-up in Figure 7c), with a sporadic presence of small dimples.
