Stress corrosion cracking of additively manufactured alloy 625 / Cabrini, M., Lorenzi, S., Testa, C., Carugo, F., Pastore, T., Manfredi, D., Biamino, S., Marchese, G., Parizia, S., Scenini, F.. - In: MATERIALS. - ISSN 1996-1944. - ELETTRONICO. - 14:20(2021). [10.3390/ma14206115]

# Stress Corrosion Cracking of Additively Manufactured Alloy 625

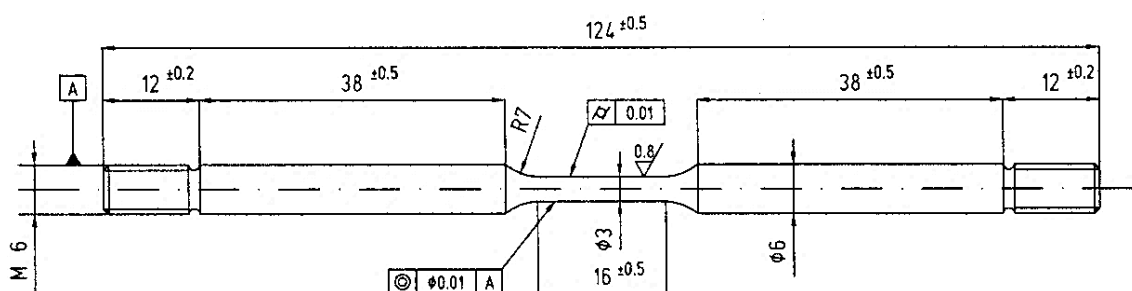
Figure 1. Geometry of the SSRT specimens (all values are in mm).

SSRT tests were also conducted using round dogbone samples whose geometry is schematically reported in Figure 1, by means of a homemade SSRT testing machine with four independent loading stations. The load was applied through an electric motor and reduction gears that could impose displacement rates between  $5 \times 10^{-7}$  and  $5 \times 10^{-3}$  mm/s. The calibration of the cells was performed independently. Acquisition system (spider 8 HBM Italy, Milano, Italy) recorded the load and a function of time. A strain rate of either  $3.15 \times 10^{-6} \text{ s}^{-1}$  or  $3.15 \times 10^{-5} \text{ s}^{-1}$  was chosen.

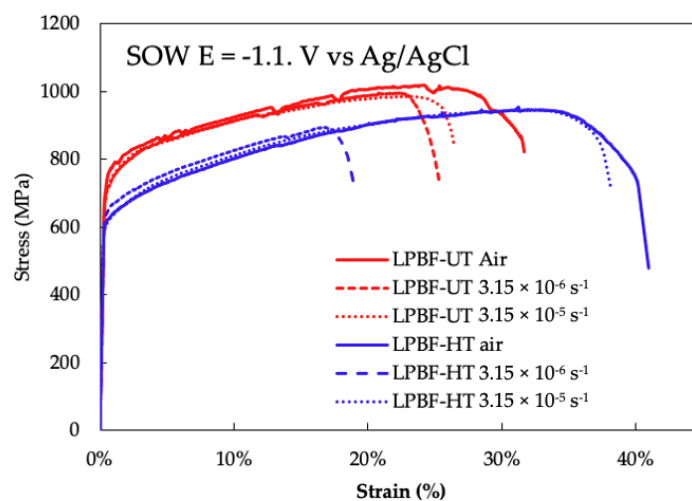
**Figure 2.** SSRT results of LPBF-UT (red line) and LPBF-HT (blue line) at  $3.15 \times 10^{-6} \text{ s}^{-1}$  in air, at  $3.15 \times 10^{-6} \text{ s}^{-1}$  in SOW under cathodic protection, and at  $3.15 \times 10^{-5} \text{ s}^{-1}$  after hydrogen pre-charging.

The SSRT curves are shown in Figure 2. The UT-LPBF specimen (red curves in Figure 2) tested in air at  $3.15 \times 10^{-6} \text{ s}^{-1}$  showed a very pronounced plastic region achieving 1018 MPa of ultimate stress and 32% of strain to failure. The tests in SOW were carried out at the same cathodic polarisation,  $-1.1 \text{ V}$  vs. SCE, and had the same duration (about 16 h), but with two different strain rates: the first at  $3.15 \times 10^{-6} \text{ s}^{-1}$  and the second at  $3.15 \times 10^{-5} \text{ s}^{-1}$ ; in this last case the specimen was pre-charged with hydrogen before starting the tensile test. The cathodic polarised specimen tested at the lower strain rate presented a reduction of the total strain with respect to the specimen tested in air, achieving a value equal to 25%, the specimen pre-charged with hydrogen showed less reduction of ductility (26%). The heat treatment (blue curves in Figure 2) decreased the yield and maximum stress of all specimens, and increased the ductility, which in air was 61% of total strain. The differences between the reduction of ductility with respect to air are more evident in these specimens (LPBF-HT): the specimens cathodically polarised in SOW and strained at  $3.15 \times 10^{-5} \text{ s}^{-1}$  presented a total elongation of 22%, whereas the pre-charged specimen showed a total strain of 50%. The reduction of area values are in agreement with the total elongation values, as summarized in Table 3.

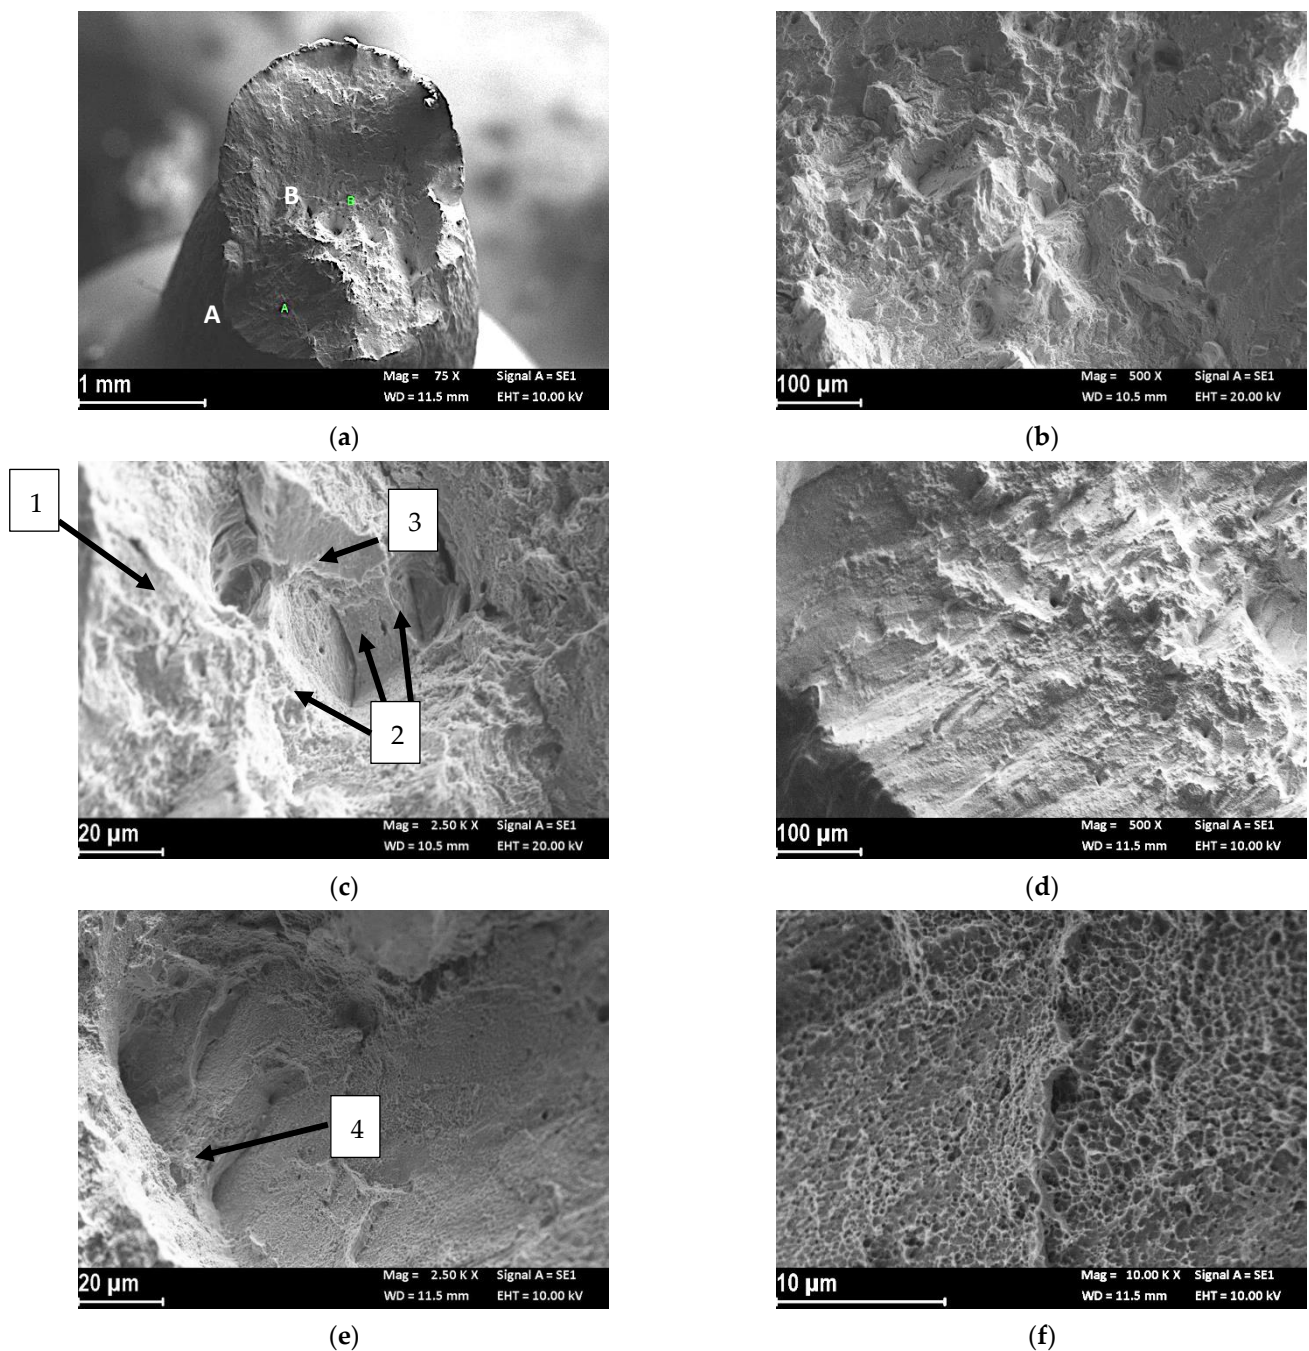
**Figure 3.** Secondary electron fractographic analysis of the UT-LPBF specimen after the SSRT test in air: (a) macro image; (b) close-up of the center of the specimen (zone B in (a)); (c) close-up at higher magnification of Figure 3b, the arrows indicate: (1) presence of large dimple associated to inclusion, (2) edge of the melt pool, and (3) low toughness zone; (d) close-up of zone A of (a) fracture zone of shearing; (e) close-up of (d) in which is evident the separation of the melt pools, (f) close-up of zone (4) in (e) in which are evident micro dimples in the separation of the melt pools.

Figure 3 shows the fracture morphology of the UT-LPBF specimen tested in air. The specimen did not have a perfectly regular cone/cup fracture surface (Figure 3a). In the center of the specimen, the fracture was characterized by irregular dimples of different sizes (zone B in Figure 3a and close up of Figure 3b,c) sometimes associated with inclusions (zone 1 in Figure 3c), or, more frequently to the border of the melt pools (zone 2 in Figure 3c). Analyzing the center of the specimen at high magnifications, areas of low toughness and points of cleavage almost appeared (zone 3 in Figure 3c). At the border of the specimen (zone A in Figure 3a) the fracture mode was due to shearing (Figure 3d). On the shearing zone there were micro-separations corresponding with either the edge of the melting pool (zone 4 in Figure 3e), or the dimples (Figure 3f). The different cracking behavior in different regions suggested that there were some zones more ductile than others in the specimen, as it was possible to observe by the sharp decrease in the stress vs. strain curves (Figure 2).

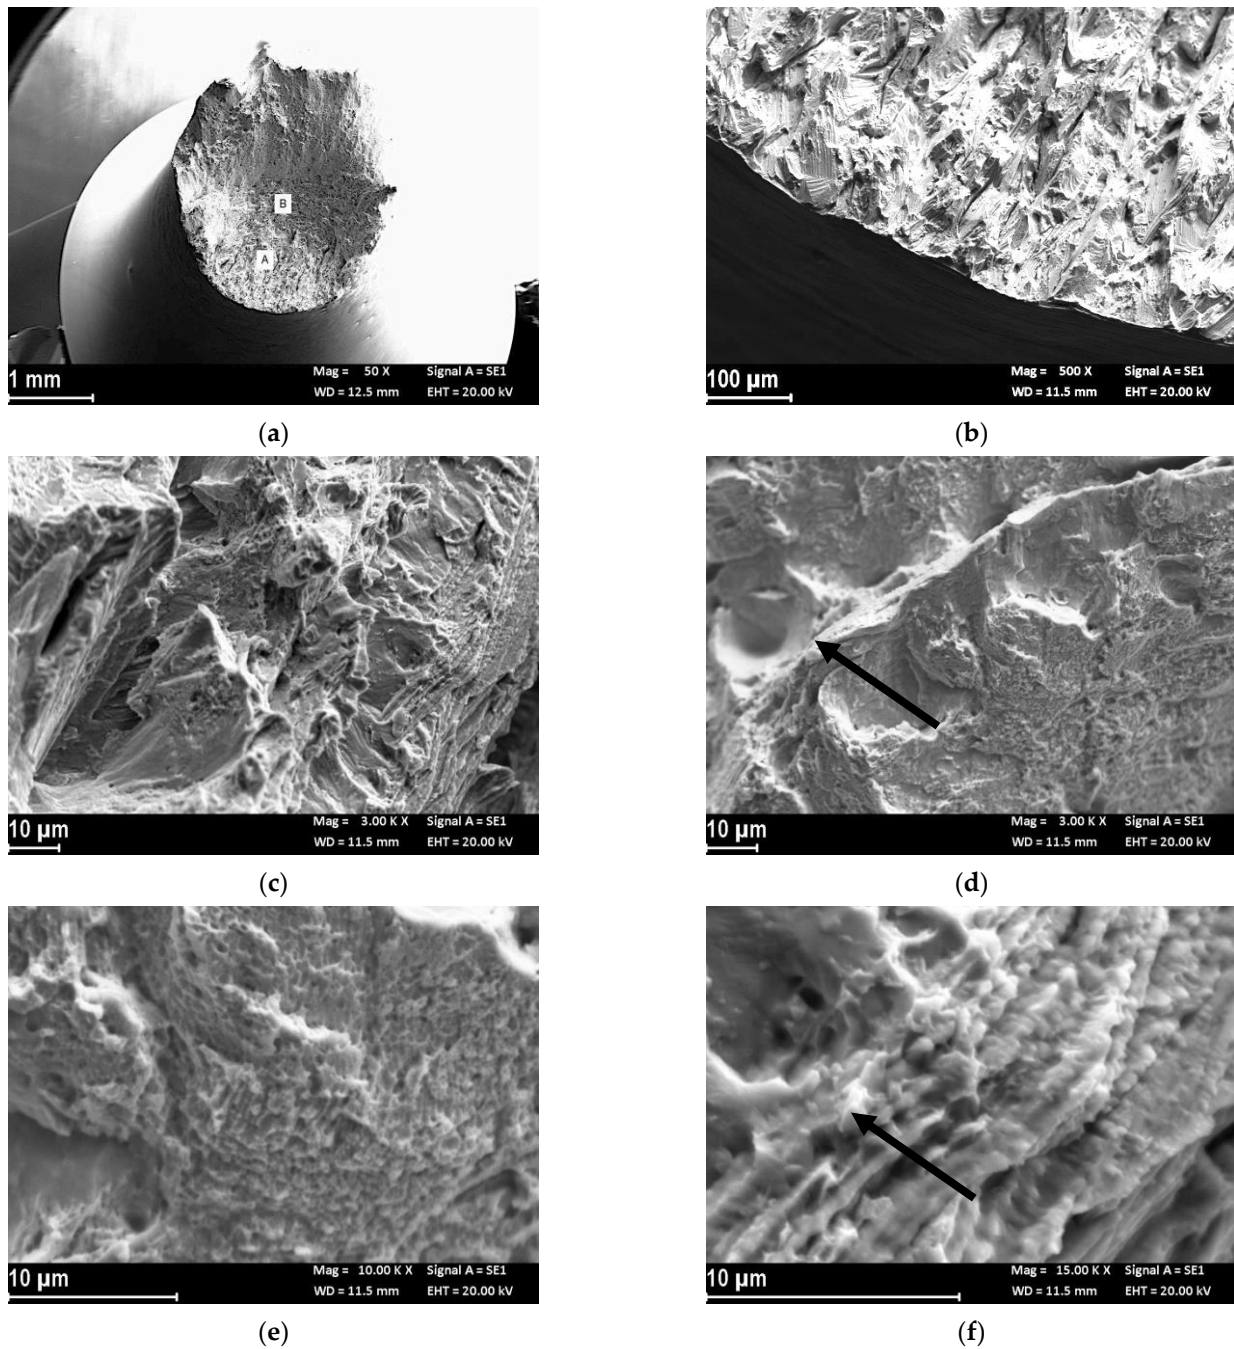
**Figure 4.** Secondary electron images of the fracture surface of UT-LPBF specimen after the SSRT test at strain rate  $3.15 \times 10^{-6} \text{ s}^{-1}$  in SOW and cathodic polarization at  $-1.1 \text{ V}$  vs.  $\text{Ag}/\text{AgCl}$ : (a) macro image; (b) close-up of the trigger zone (zone A in (a)) with brittle morphology; (c) close-up of (b) in which is evident a quasi-cleavage growth, (d) close-up of (b) in which is evident the separation of the melt pool (arrow) and presence of dimples in the upper melt pool; (e) close-up of the center of the specimen (zone B in (a)), presence of dimples and brittle zone; (f) close-up at higher magnification of (e) in which are evident the presence of intermetallic precipitates.

Figure 4a reports the macro image of the UT-LPBF specimen after the test in SOW and cathodic polarization of -1.1 V vs. Ag/AgCl. The specimen still showed plastic deformation, as can be seen from the reduction of area percentage shown in Table 3, but the fracture surface had a flat trigger area (zone A of Figure 4a), which extended to the center of the specimen (zone B of Figure 4a) and the final break was due to sliding by shearing. The trigger zone had a quasi-cleavage aspect (Figure 4b), which is typical of hydrogen embrittlement phenomena. The higher magnification details (Figure 4c) show the alternation of flat areas and small dimples. Microfractures were evident at the separations of the fusion wells, which changed the fracture propagation (Figure 4d). The fracture surface at the center of the specimen (zone B of Figure 4a) was mixed, with brittle area interspersed with small dimples (Figure 4e). The high-magnification image shows the presence of small intermetallic precipitates on the flat facets (Figure 4f).

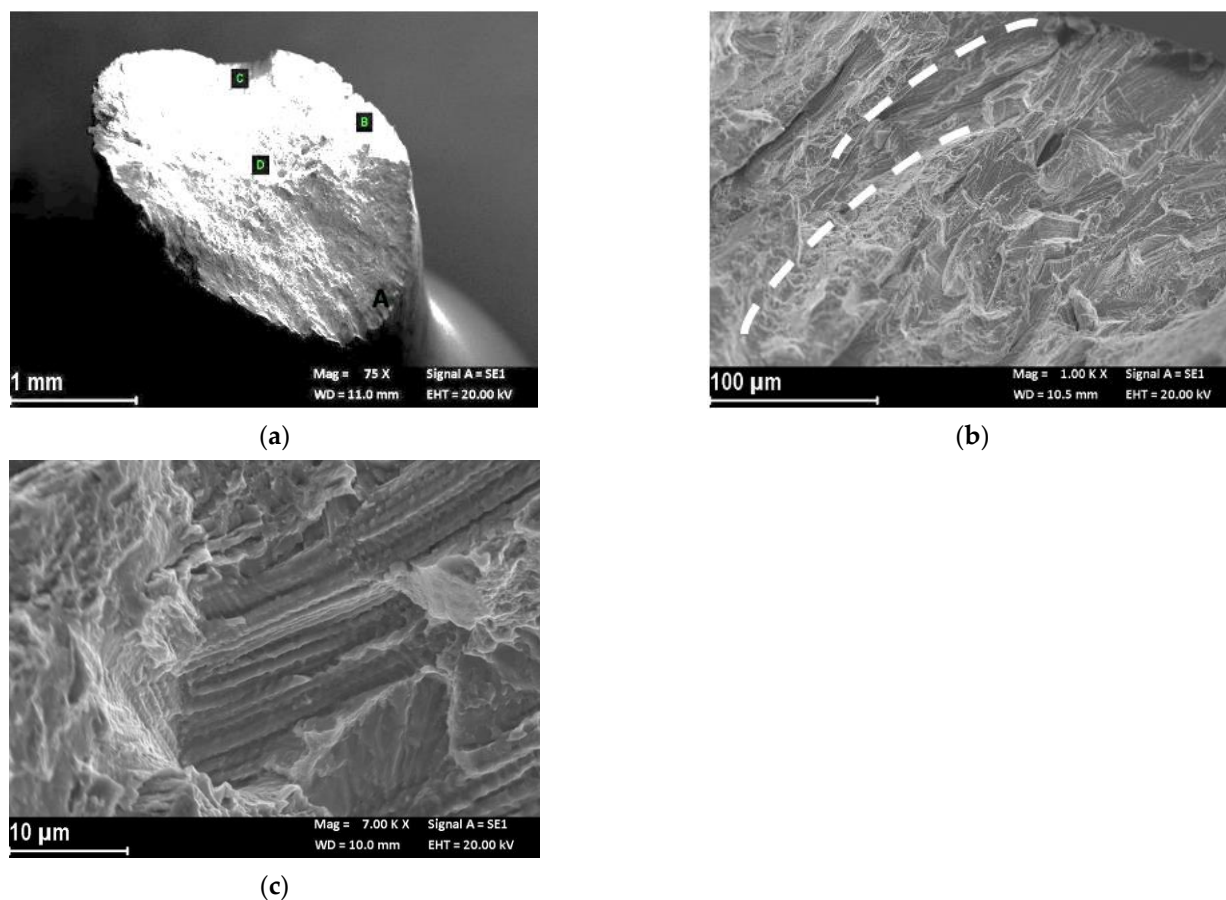
**Figure 5.** Fractographic analysis of the UT-LPBF specimen after the SSRT test at strain rate  $3.15 \times 10^{-5} \text{ s}^{-1}$  in SOW and cathodic polarization at  $-1.1 \text{ V}$  vs. Ag/AgCl after 16 h of hydrogen pre-charging: (a) macro image; (b) close-up of zone A, and (c) a similar morphology is observed in zone C; close-up of zone B; zone D in (a) is fully ductile.

Figure 5a shows the macro image of the fracture surface of the UT-LPBF specimen pre-charged with hydrogen for 16 h and then strained at  $3.15 \times 10^{-5} \text{ s}^{-1}$ . The fracture surface had some small trigger areas with a morphology typical of hydrogen embrittlement (zone A, B and C of Figure 5a; the close-up of zone A is shown in Figure 5b, the close-up of zone B is shown in Figure 5c), while the central area had a mixed fracture consisting of numerous dimples, small brittle facets and rare areas of quasi-cleavage. The final breakage of the specimen occurred by sharing. The value of the normalized reduction of area was very similar to that obtained in the previous case. At high magnification for areas A (Figure 5b), B (Figure 5c) and C of the specimen, a morphology similar to that observed in Figure 4 could be noted, with many brittle facets arranged perpendicularly to the direction of propagation of the fracture (along the dendritic growth) that occasionally jumped on a different plane, and a separation of the border of the melting pool (dotted line in Figure 5b).

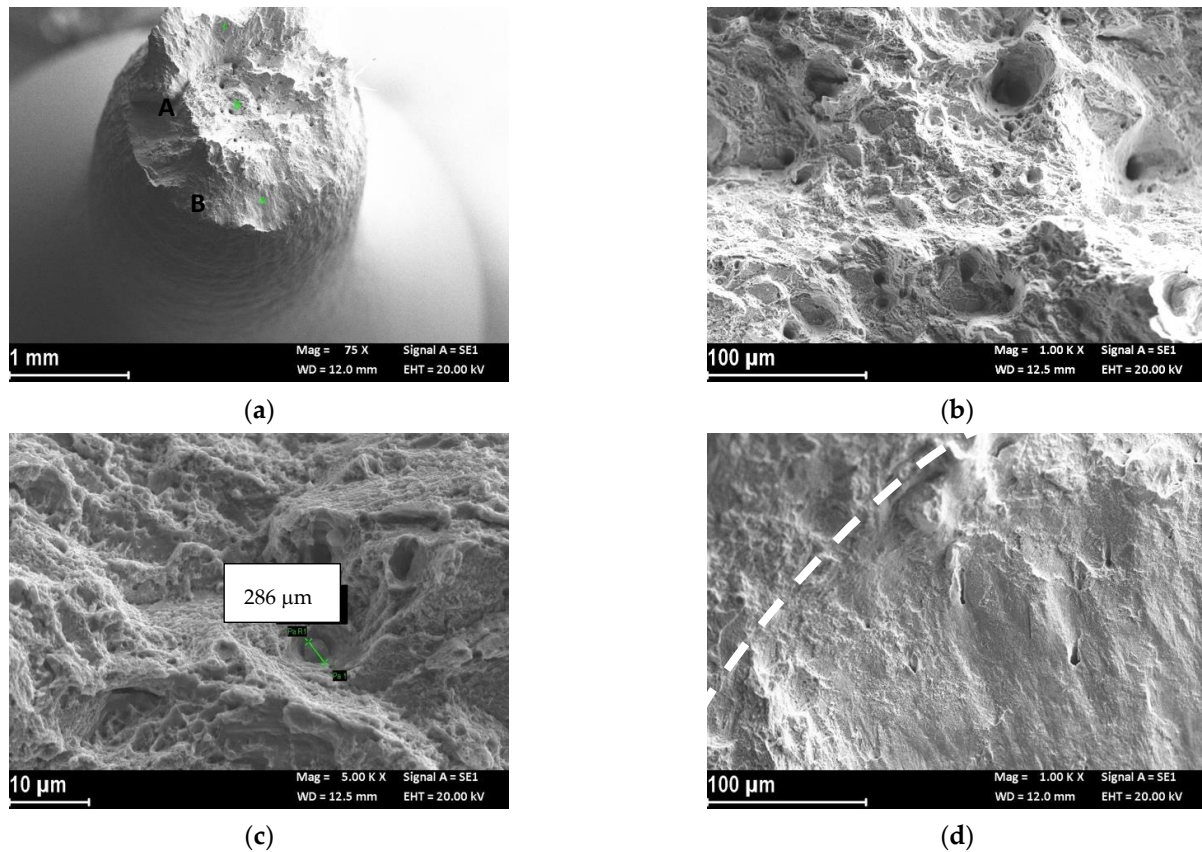
**Figure 6.** Fractographic analysis of the HT-LPBF specimen after the SSRT test in air: (a) macro image; (b) close up of the center of the specimen (zone A in (a)) with presence of dimples; (c) close-up of a large precipitate in (b); (d) close-up of the border of the specimen (zone B in (a)) in which is evident the change of fracture growth in the corresponding edge of the melt pool.

Figure 6a shows the fracture surface of the heat-treated specimens tested in air. The fracture surface had a typical cup and cone shape with a morphology in the center characterized by dimples of very variable dimensions (Figure 6b). Larger dimples were sometimes associated with large-sized precipitates (Figure 6c). The final fracture, also in this case, occurred by sliding by shearing (Figure 6d), with separations between the melt pools (dotted line in Figure 6d).

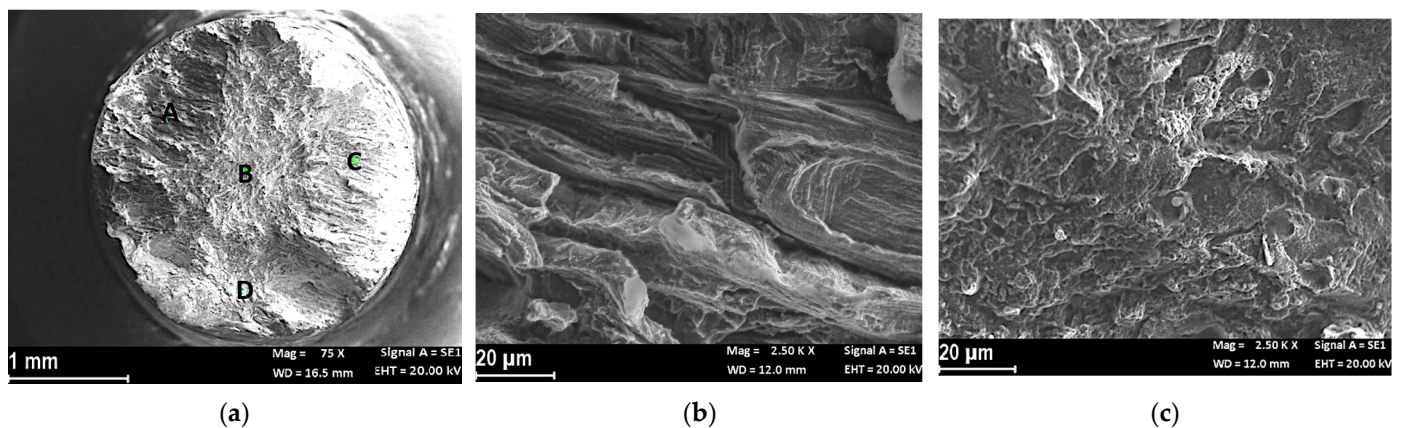
**Figure 7.** Fractographic analysis of the HT-LPBF specimen after the SSRT test at strain rate  $3.15 \times 10^{-6} \text{ s}^{-1}$  in SOW and cathodic polarization at  $-1.1 \text{ V}$  vs. Ag/AgCl: (a) macro image; (b) close-up of the trigger of the fracture (zone A of (a))—zone C has the same morphology of zone A; (c) close-up of the center of the specimen (zone B of (a))—a similar morphology is present in zone D of (a)).

The fracture surface of the heat-treated specimen at the end of the SSRT test with strain rate  $3.15 \times 10^{-6} \text{ s}^{-1}$  cathodically polarized at  $-1.1 \text{ V}$  vs. Ag/AgCl in SOW was totally flat (Figure 7a); there were two large trigger zones by hydrogen embrittlement (denoted with A in the Figure 7a) with a morphology similar to the UT specimens (Figure 7b), with flat facets arranged in a radial direction, separated by longitudinal microfractures and flat areas of cleavage. Even the center of the specimen appeared with a quasi-cleavage morphology (areas B and C—close-up in Figure 7c), with a sporadic presence of small dimples.

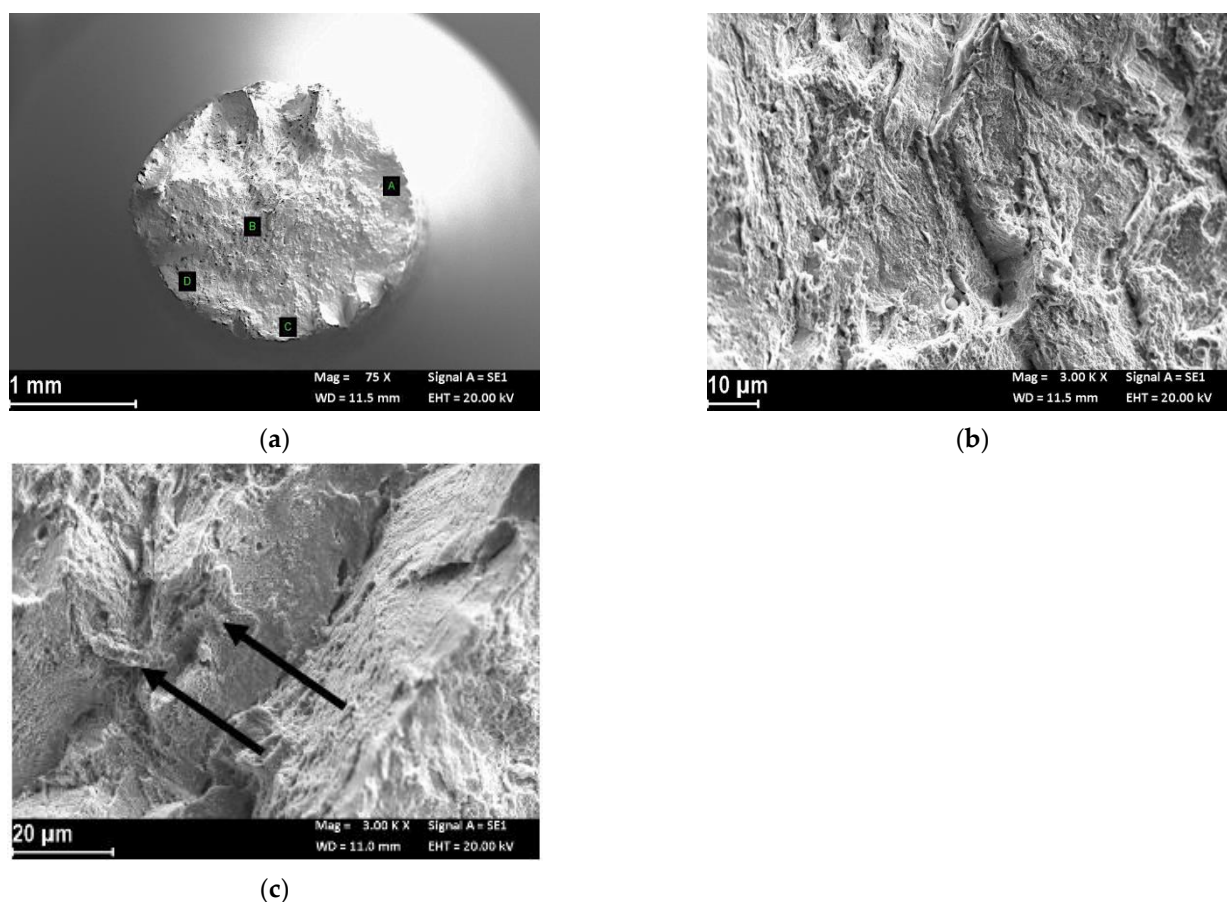
**Figure 8.** Fractographic analysis of the HT-LPBF specimen after the SSRT test at strain rate  $3.15 \times 10^{-5} \text{ s}^{-1}$  in SOW and cathodic polarization at  $-1.1 \text{ V}$  vs. Ag/AgCl after 16 h of hydrogen pre-charging: (a) macro image; (b) close up of the trigger of the fracture (zone A in (a)); (c) close-up of the center of the specimen (zone B in (a)), the arrows indicate second phases.

Finally, Figure 8a shows the fracture surface of the specimen preloaded with hydrogen for 16 h and then subjected to an SSRT test at a strain rate of  $3.15 \times 10^{-5} \text{ s}^{-1}$ . Contrary to the previous case, the fracture surface showed necking, with small triggers of HE on the lateral surface (zones C and D of Figure 8a) with a mixed morphology with dimples and small areas of quasi-cleavage (Figure 8b). Conversely, the center of the specimen displayed mainly small dimples, but with separations along the longitudinal axis of quasi-cleavage (Figure 8c).

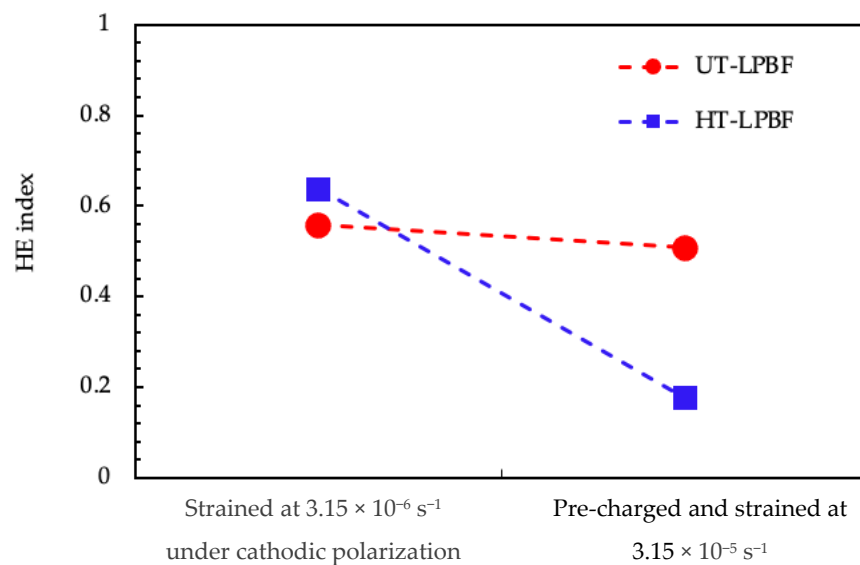
**Figure 9.** Hydrogen embrittlement index for the LPBF specimens after SSRT tests.

Alloy 625 underwent hydrogen embrittlement in SOW when cathodically polarized, as summarized in Figure 9 where the  $HE_{\text{index}}$  were reported. However, despite every specimen displaying evidence of hydrogen embrittlement, the highest susceptibility was generally identified for the cathodically polarized samples tested at  $3.15 \times 10^{-6} \text{ s}^{-1}$ .
