An aeroacoustics-based approach for wind turbine blade damage detection

Yanan Zhang*; Francesco Avallone; Simon Watson

Wind Energy Section, Faculty of Aerospace Engineering, Delft University of Technology, Delft, 2629HS, The Netherlands

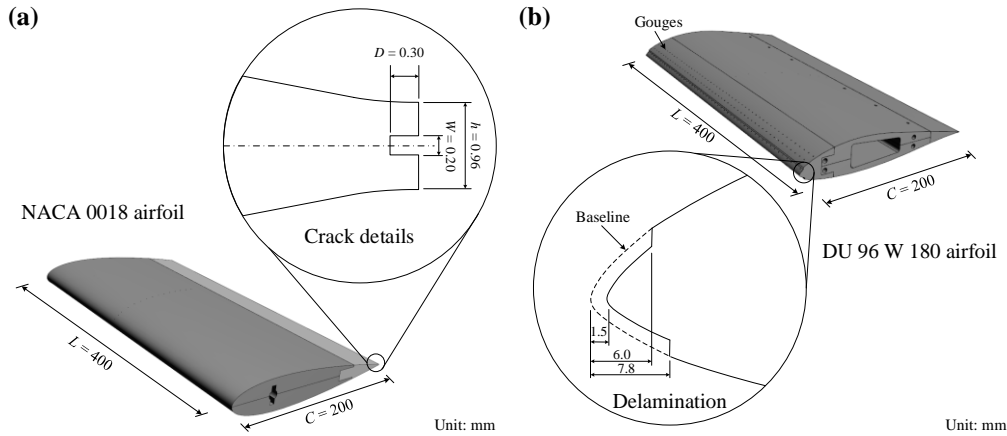
Figure 1. Test models: (a) An example for NACA 0018 airfoil with a 0.2 mm trailing edge crack; (b) an example for DU 96 W180 airfoil with leading edge erosion level 4.

Two airfoils, a NACA 0018 and a DU96 W180, with span length, L , of 400 mm and chord length, C , of 200 mm were investigated. The selection of these two types of airfoils is for comparison with previous studies on trailing-edge noise [15] and leading-edge erosion [16]. These two airfoils are modular with changeable trailing edge and leading edge parts, thus allowing the testing of different types and severities of damage. Figure 1 shows the test models.

Four damaged trailing edge parts for the NACA 0018 airfoil are investigated with crack width, W , of 0.2, 0.5, 1.0 and 2.0 mm (with scaling ratios of W/C equal to 0.10%, 0.25%, 0.50% and 1.0%, respectively). This leads to an effective trailing edge thickness, h , of 0.96, 1.26, 1.76 and 2.76 mm, respectively (giving scaling ratios of h/C equal to 0.48%, 0.63%, 0.88% and 1.38%, respectively). Figure 1(a) shows an example for the 0.2 mm width crack.

Leading edge erosion features for the DU96 W180 airfoil are simulated with gouges (1.0 mm diameter and depth) and coating delamination (1.5 mm depth). The gouges (G) are distributed within 10% and 13% of the chord on the suction and pressure surfaces, respectively. For different delamination levels (DL, DL+ and DL++), the delamination area is extended to 2, 4 and 6 mm on the suction side and

2.6, 5.2 and 7.8 mm on pressure side, respectively. The damage sizes are scaled based on eroded blades provided by 3M as reported in [16]. Figure 1(b) shows an example for erosion damage level 4. Details of each configuration are shown in Table 1.

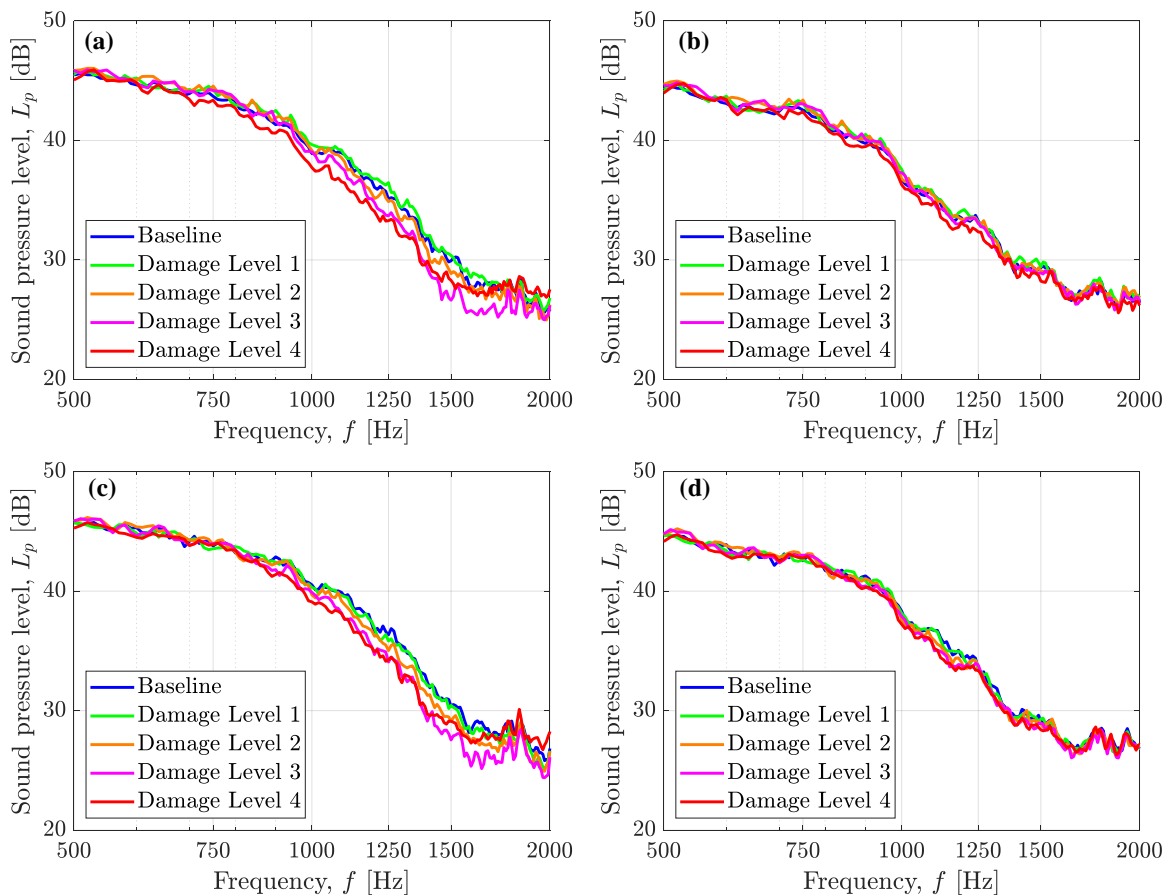
Figure 9. Spectra of sound pressure level for different erosion levels for 30 m/s mean flow velocity with grid #1 mounted at a 0° airfoil angle of attack: (a) at the leading edge on suction side; (b) at the trailing edge on the suction side; (c) at the leading edge on the pressure side; (d) at the trailing edge on the pressure side.

In Figure 9(a) and (c), the noise scattered from leading edge for different damage levels are shown. With the increase in damage level, the sound pressure level decays above 1000 Hz. For example, within the selected one-third octave band, the peak sound level within the integrated region at the leading edge for damage level 4 case is lower (49.23 dB) than that of the baseline (51.44 dB). This might be attributed to the increasing mean flow stagnation region [10] in front of the leading edge, where the chord-wise velocity goes to zero and the normal direction component increases. In such a stagnation region, the convection of turbulent velocity waves is weakened thus reducing the magnitudes of the turbulent velocities impinging the leading edge; as a consequence, the power of the noise scattered from the leading edge is also reduced.
