Raw Earth Construction Perspectives in Italy: An Overview Through the Rehabilitations of Casa Fenu in Villamassargia, Sardinia, and Casa di Teresa in Casalincontrada, Abruzzo

Martina Bocci

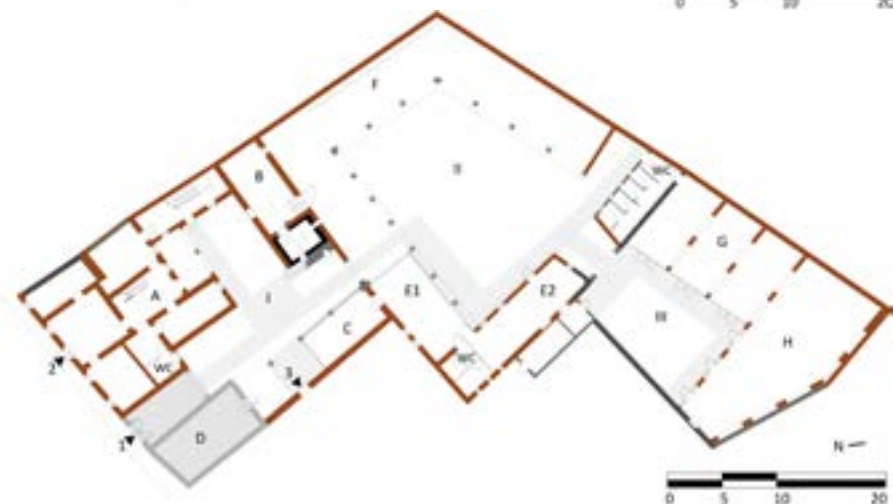
Figure 6: Project plan, ground floor.  
 Courtyard I: A) exhibition rooms and tourist agency; B) storerooms; C) tasting rooms; D) Villa Fenu; 1) portal and entrance hall to the courtyard; 2) main entrance; 3) connection to Villa Fenu.  
 Courtyard II: E1) cafeteria and E2) kitchens; F) exhibition area.  
 Courtyard III: G) workshop and laboratories; H) conference room.  
 Red: *ladiri* masonry; black: concrete; dark grey: stone masonry; grey: fired bricks and hollow bricks

The restoration was based on different approaches in each part of the complex (Figs. 5 and 6); raw earth was used even in partially or completely rebuilt parts.

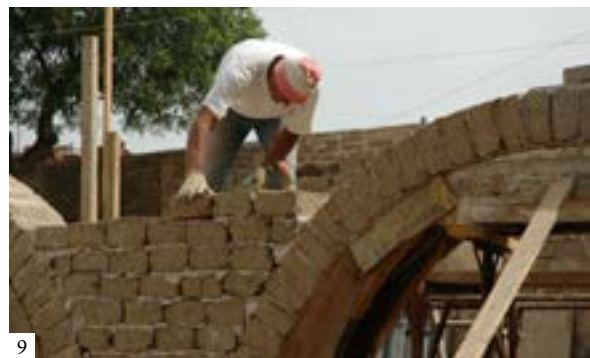
Figure 9: Laying of *ladiri* in the construction of the portion of the wall between two arches (Ignazio Garau)

Given their advanced state of decay, the remaining structures around courtyard III were demolished and reconstructed using *ladiri*. Fourteen arches (spanning about 2.5 m) in four parallel walls were built with unfired bricks (Fig. 9). Fired bricks were also used at certain points to counteract the thrust and to support the roof trusses (Fig. 10)

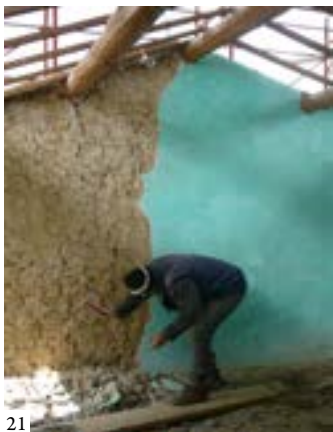
21

Figure 21: Removal of plaster in the west first floor room (CEDTerra)

The inner surfaces of the walls were in good condition but loose parts had to be removed from the outer walls (Fig. 21). Cracks and gaps were consolidated and new *massoni* were laid, made from a mixture of earth, sand, water, straw, and pure gypsum. For every 5 kg of mud mixed with straw, one 20x12 cm loaf-like brick was obtained. The bricks were left to cure overnight wrapped in straw and then laid (Figs. 22 and 23). A structural framework of twigs facilitated bonding with the existing masonry. The connection between the west and east blocks and the repair of the damaged chimney were executed using wooden frames filled with the *massoni* mixture, with wooden formwork. A wood bar was used to level the surface. Two tie-rods were fitted along the long side of the house.

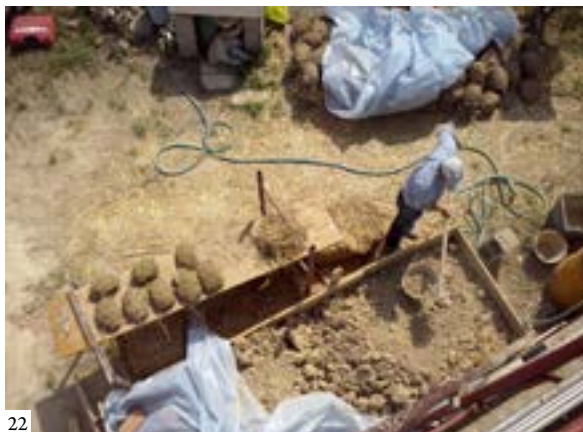
22

Figure 22: *Massoni* production cycle: reuse of earth, recycled from demolished parts and other collapsed buildings, making loaves and curing (CEDTerra)

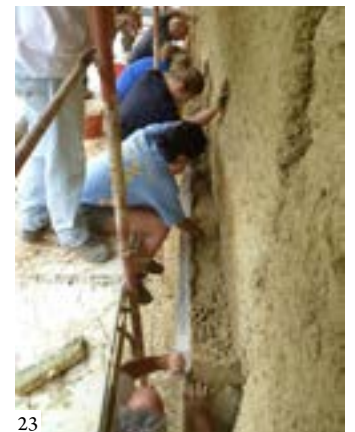
23

Figure 23: Laying of *massoni* by workshop participants: they can be thrown with force, to allow the release of excess water, or laid on beds of dry straw and pressed to adhere and penetrate each pore (CEDTerra)

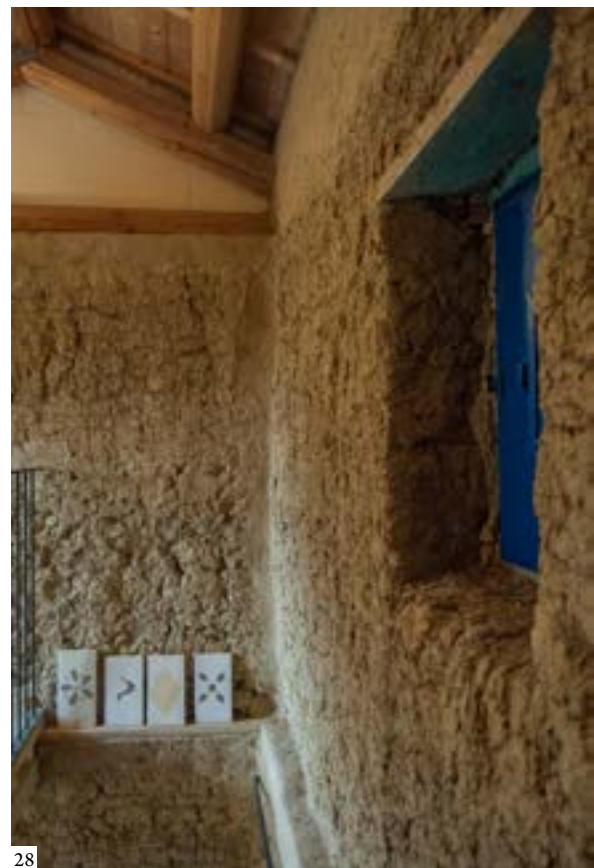
Figure 28: *Massoni* walls left without plaster on first floor to the west
