Raw Earth Construction Perspectives in Italy: An Overview Through the Rehabilitations of Casa Fenu in Villamassargia, Sardinia, and Casa di Teresa in Casalincontrada, Abruzzo

Martina Bocci

A detailed analysis of the rehabilitation processes of two publicly owned buildings in Sardinia and Abruzzo is taken as a basis for describing the background, difficulties and possible future developments of raw earth as a building material in Italy. Earthen construction techniques, despite a rich tradition and extensive documentation, are still considered outdated, and their use today requires a fortunate confluence of contextual factors. Archival research, literature review and a study of manuals were coupled with an examination of urban plans and public policies, as well as interviews with experts and stakeholders. This multi-approach research shows that there is a strong need to appropriate traditional knowledge so as to translate local skills into viable solutions able to meet today's needs. The key issue may be investment in training and dissemination. The mindset of the artisan, that of the *homo faber* (Sennet 2008), needs to be more widely associated with action toward sustainable loca

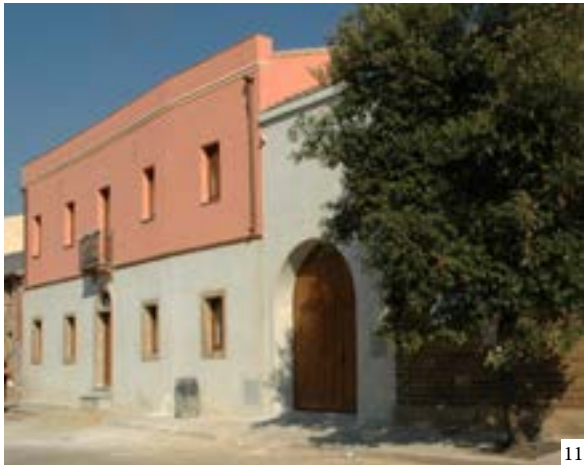
11

Figure 11: The colour of the main façade was chosen to match the shades found in other buildings in Via Santa Maria (Ignazio Garau)

A plaster made of earth, sand, and lime, plus natural fibers such as hay and straw, was applied on all walls. This was rendered with slaked lime and sand and finished with a smooth coat of long-aged slaked lime. The interior walls were limewashed, with color from natural earth pigments. The exterior walls were finished with two coats of a breathable, weather-resistant mixture of slaked lime, mineral additives, natural earths and oxides (Fig. 11).

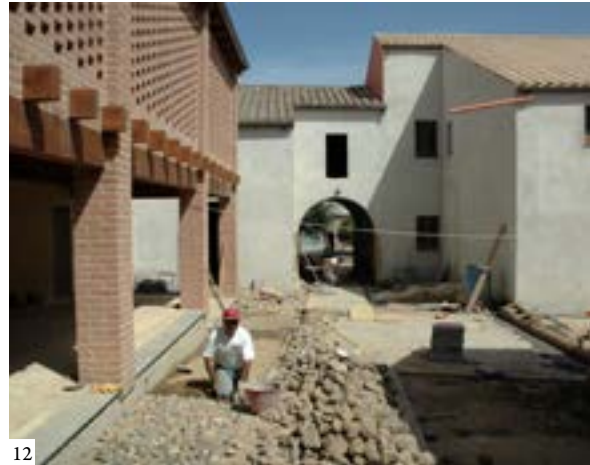
12

Figure 12: Various stages in the construction of roofs: reed mats above the battens, non-woven fabric and EPS foam panels with a bituminous sheathing, curved tiles laid on lime mortar (Ignazio Garau)

The roof structure was rebuilt with solid fir beams in the original configuration, while in the buildings by courtyard III the trusses were formed with laminated glulam beams. The roofing combines industrial and natural materials (Fig. 12). In the outdoor areas, the cobblestones were taken up and reused (Fig. 13). Irregular slabs of Serrenti trachyte were laid dry on the main paths.

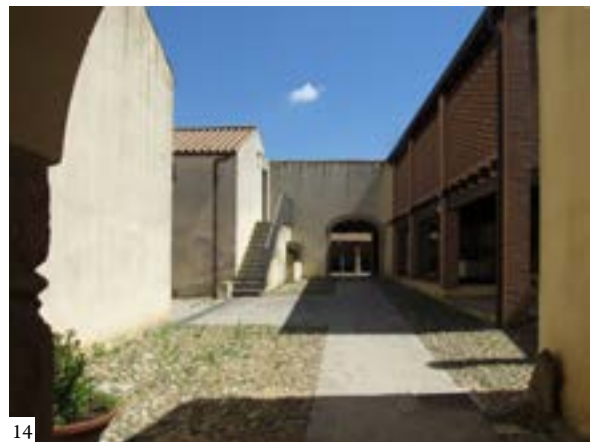
14

Figure 14: Courtyard I as seen from the entrance hall (1): on the left the staircase leading to building B, on the right building C made of fired bricks on the second floor, while glass curtain walls enclose the rooms on the ground floor (Ignazio Garau)
