Characterization of Tannic Acid-Coated AZ31 Mg Alloy for Biomedical Application and Comparison with AZ91

Keywords: magnesium alloys; polyphenols; controlled degradation rate; coating; corrosion; biomaterials

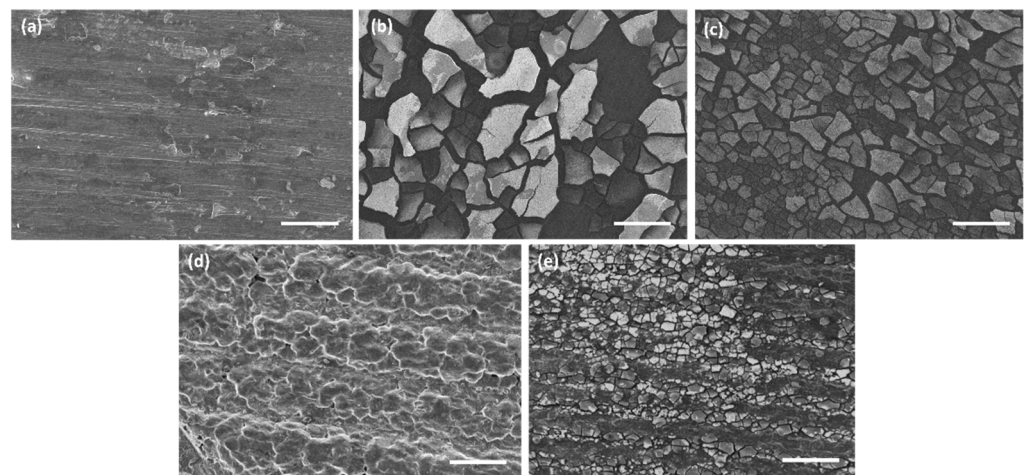
Figure 1. SEM images (100 \times) of (a) AZ91 uncoated, (b) AZ91TA_5, (c) AZ31 uncoated, (d) AZ31TA_5, (e) AZ31TA_20. Markers are 200 μ m each.

The AZ91 bare sample (Figure 1a) presents a rough surface that resembles the layered topology of the 3D-printed polymer pattern replicated by investment casting (Figure S1 in Supplementary Material). After tannic acid coating (Figure 1b) the main topography is maintained but plenty of micro-scales completely cover the surface, confirming surface reaction and coating, as reported in [20].

The surface of the bare AZ31 sample (Figure 1c) appears as a typical rolled metal with some scratches and scales, attributable to surface deformation and oxidation during working. After tannic acid coating in a 5 mg/mL solution for 3 h (Figure 1d), analogously to AZ91 substrates, a lot of big (hundreds of microns) scales cover the surface. When coating is performed in a 20 mg/mL TA solution for 30 min (Figure 1e), scales have smaller dimensions (not so far from the ones obtained on AZ91 samples) and cover the surface in a more homogeneous way (less detachment). The presence of the phenolic coating is also confirmed by EDS analyses (Table S1 in Supplementary Material), where an increase in the C content was detected after the treatments on both AZ31TA_5 and AZ31TA_20. No differences in the two coatings were observed in terms of the chemical composition.

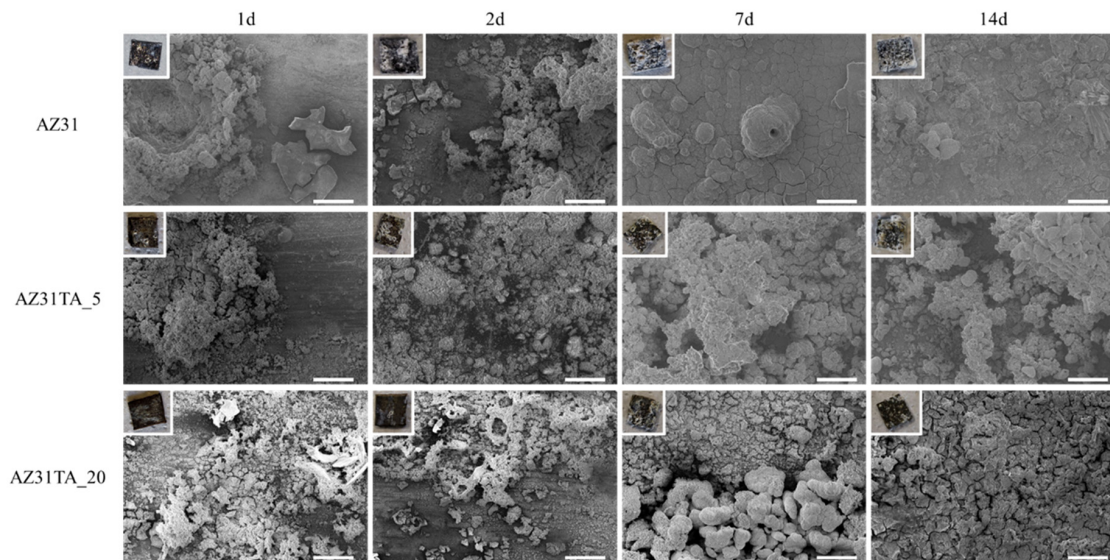
Figure 3. SEM images of AZ31, AZ31TA_5, and AZ31TA_20 samples after degradation in PBS at different time points, namely 1, 2, 7, and 14 days. Markers are 200 μm each. Optical pictures of the samples are shown in the insets of the images.

As possible to see by SEM micrographs (Figure 3), degradation products are promptly formed on the surface of both uncoated and coated AZ31 samples, as early as after 1 day of soaking in PBS. EDS chemical analysis (Table S2 in Supplementary Material) showed that the corroded layer is mainly formed by magnesium oxides and phosphate species [30]. The degradation products grew constantly with increased soaking time, covering all the surfaces with white oxide flakes, and were observed at a macroscopic scale (Figure 3 insets).

From the optical and SEM observation of the samples, it seems that a thicker and more compact oxide layer is formed on the surface of the bare AZ31 alloy, compared to the coated surfaces, and that the coating on AZ31TA_20 is more effective than the one on AZ31TA_5 to slow the corrosion of magnesium.

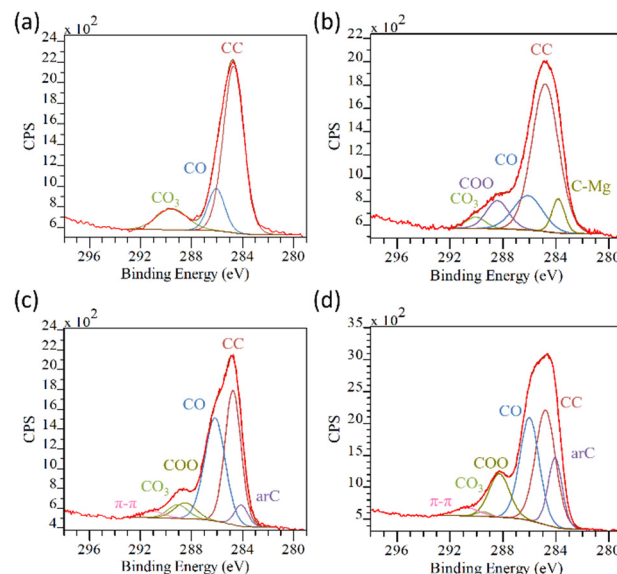
Figure 6. C1s peak deconvolution of: (a) AZ31; (b) AZ91; (c) AZ31TA_20; and (d) AZ91TA. In each image: red line: experimental spectrum; brown line: fitted spectrum; light brown line: baseline.

Further information on the surface chemistry can be drawn by analyzing the high-resolution peaks. Before coating, the C1s of both AZ31 and AZ91 (Figure 6a,b) are composed of signals arising mainly from carbonates (CO_3 , BE \approx 289–290 eV) and carbonaceous contaminations (CO, BE \approx 286 eV; COO, BE \approx 288 eV) [24]. A contribution by C-Mg bonds (BE \approx 284 eV) [35] is observed in the AZ91 pristine sample, probably due to some reaction occurring when the molten metal is cast into a ceramic mold with residues after burning a 3D polymeric pattern. The deposition of a TA-containing coating, following the surface modification, can be observed by the increase in the CO and COO components of the C1s peak (Figure 6c,d; Table S3 in Supplementary Material) and the appearance of the peaks related to aromatic C (arC, BE \approx 284 eV) [36] and the delocalized electron of the π - π aromatic bonds (BE \approx 291 eV) [37]. These chemical groups and bonds are very typical of the TA, as possible to see by its chemical formula (Figure S2 in Supplementary Material). The lower intensity of the TA peaks on coated AZ31 with respect to the coated AZ91 can be related to the presence of larger cracks in the coatings on the former surface, which therefore exposes uncoated parts, in agreement with the compositional results (Table 2).
