Characterization of Tannic Acid-Coated AZ31 Mg Alloy for Biomedical Application and Comparison with AZ91

Article

Abstract: Magnesium alloys are promising materials for bioresorbable implants that will improve patient life and reduce healthcare costs. However, their clinical use is prevented by the rapid degradation and corrosion of magnesium, which leads to a fast loss of mechanical strength and the formation of by-products that can trigger tissue inflammation. Here, a tannic acid coating is proposed to control the degradation of AZ31 and AZ91 alloys, starting from a previous study by the authors on AZ91. The coatings on the two materials were characterized both by the chemical (EDS, FTIR, XPS) and the morphological (SEM, confocal profilometry) point of view. Static degradation tests in PBS and electrochemical measurements in different solutions showed that the protective performances of the tannic acid coatings are strongly affected by the presence of cracks. The presence of fractures in the protective layer generates galvanic couples between the coating scales and the metal, worsening the corrosion resistance. Although degradation control was not achieved, useful insights on th

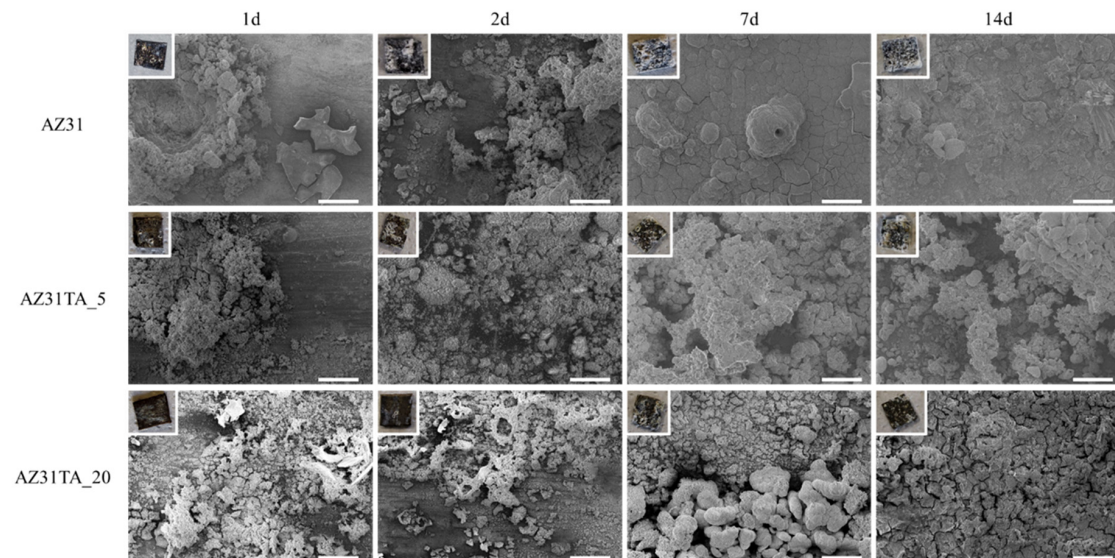
Figure 3. SEM images of AZ31, AZ31TA_5, and AZ31TA_20 samples after degradation in PBS at different time points, namely 1, 2, 7, and 14 days. Markers are 200 μm each. Optical pictures of the samples are shown in the insets of the images.

As possible to see by SEM micrographs (Figure 3), degradation products are promptly formed on the surface of both uncoated and coated AZ31 samples, as early as after 1 day of soaking in PBS. EDS chemical analysis (Table S2 in Supplementary Material) showed that the corroded layer is mainly formed by magnesium oxides and phosphate species [30]. The degradation products grew constantly with increased soaking time, covering all the surfaces with white oxide flakes, and were observed at a macroscopic scale (Figure 3 insets).

From the optical and SEM observation of the samples, it seems that a thicker and more compact oxide layer is formed on the surface of the bare AZ31 alloy, compared to the coated surfaces, and that the coating on AZ31TA_20 is more effective than the one on AZ31TA_5 to slow the corrosion of magnesium.
