# Effectiveness of Nanotechnology Treatments in Composite Aircraft Applications

**Abstract:** This paper aims to verify the effectiveness of a process of superficial protection based on nanotechnologies produced by 4Ward360 and specifically developed for aeronautical applications on composite material aircraft. The Dardo aircraft, a composite VLA category manufactured by CFM Air, was taken as a reference case and two application/investigation areas were identified. The potential anticorrosive behavior of the nanotechnology treatment was investigated when applied to the metal joints of the aircraft, such as the wing–fuselage attachments usually made of Al-2024-T3 aluminum alloy. Furthermore, the potential increased effectiveness in cleaning was investigated as another possible application concerning the parts made of composite material both solid and in a sandwich configuration and the plexiglass parts of the canopy.

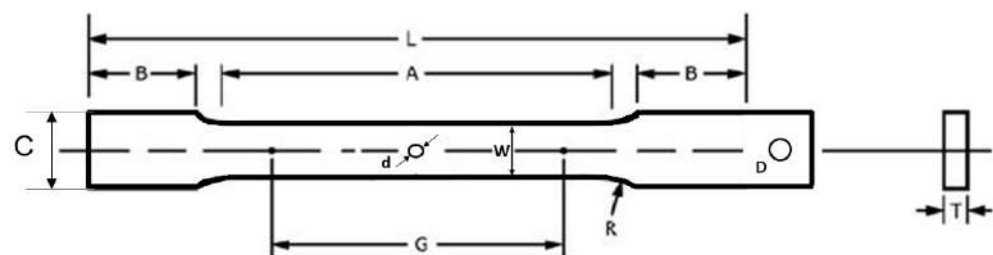
**Figure 2.** Specimen's geometry definition.

The dimensions of each specimen can be deduced from Figure 2 and Table 1. The standard specimens were modified by introducing two holes, a central one of 2 mm necessary to increase the stress intensity factor and therefore limit the duration of the next fatigue test. A second hole of 5 mm was present at one end to allow immersion in the corrosion tank.

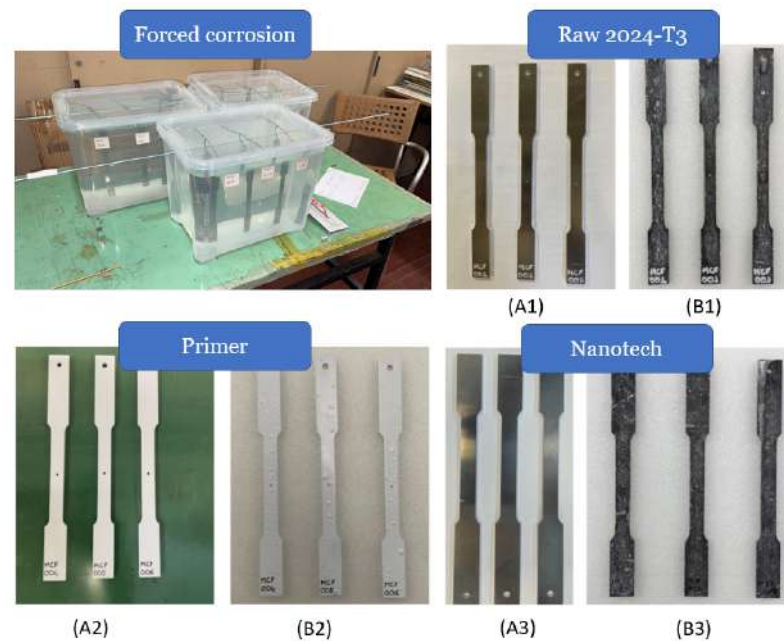
**Figure 3.** Specimens: (A1–A3) before corrosion; (B1–B3) after corrosion. “Raw 2024-T3”: aluminum without corrosion protection; “Primer”: aluminum treated with a standard primer; “Nanotech”: aluminum treated with nanotechnology.

In image (A) of Figure 3, it is possible to observe the aluminum specimens marked with the identification code, before immersion in the bath and in (B) immediately after the phase of extraction from the corrosive bath. A loss of luster was noted for the raw aluminum specimens, a darker coloring and the presence of numerous encrustations of salt as well as a lower smoothness to the touch. A loss of luster was noted for the Al-primer together with surface bubble formation as previously mentioned. Finally, for the specimens treated with nanotechnologies, a loss of luster of the metal and a darker coloration were noted but with less formation of salt encrustations. Also in that case, a reduction in smoothness was found.

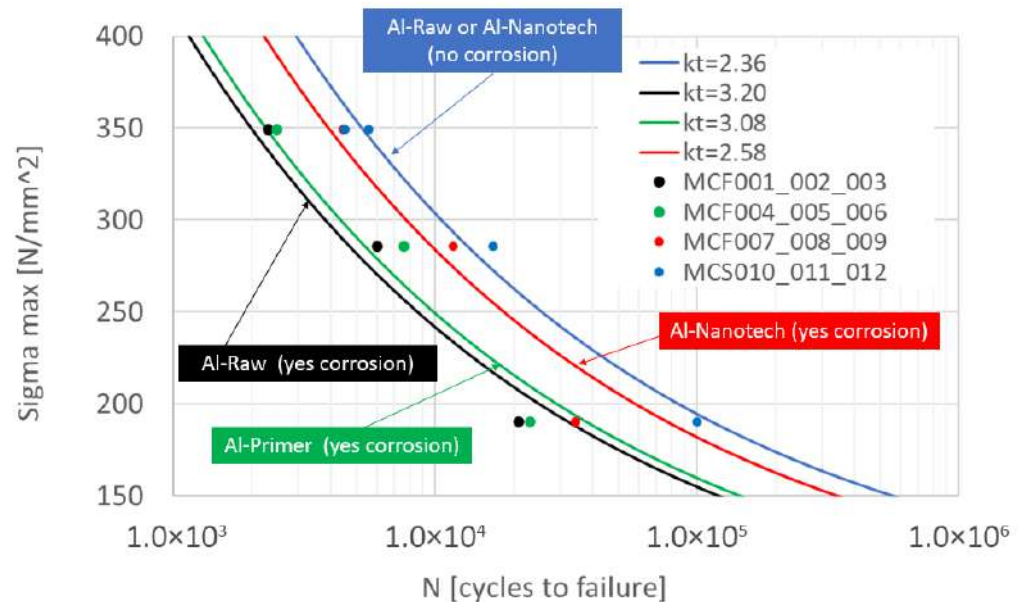
**Figure 8.** S-N curve: blue: no corrosion; black: corroded specimens; green: primer protection; red: nanotechnology protection.

Figure 8 shows the S-N curves considered for the different cases discussed. In blue are the specimens not subject to corrosion, in black are the corroded and unprotected specimens, in green are the specimens protected with primer, and finally, in red are the specimens protected with nanotechnologies and subjected to the corrosion test. In all specimens subjected to corrosive immersion, a greater effect of corrosion was observed at lower loads (load types 2 and 3), confirming not only an increase in the stress concentration factor ( $kt$ ) but also a change in the slope, as indicated also in [9].

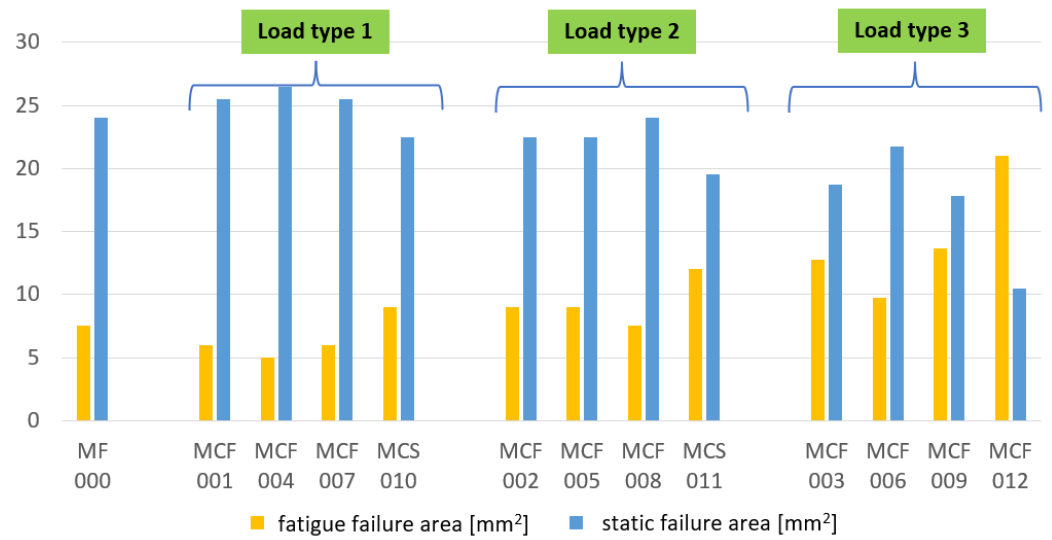
Figure 9. Comparison of failure areas for each type of load.

From Figure 9, where the results are divided by specimen category, it is possible to observe that, as could be expected, the extent of the fatigue failure section was more significant when the specimen under consideration was subjected to a lower stress: a lower mechanical load means a higher number of cycles, therefore a greater failure area due to fatigue. The graph also highlights what has already been observed previously: in each group of specimens, the best resistance to mechanical stress was always obtained with nanotechnology coating protection.

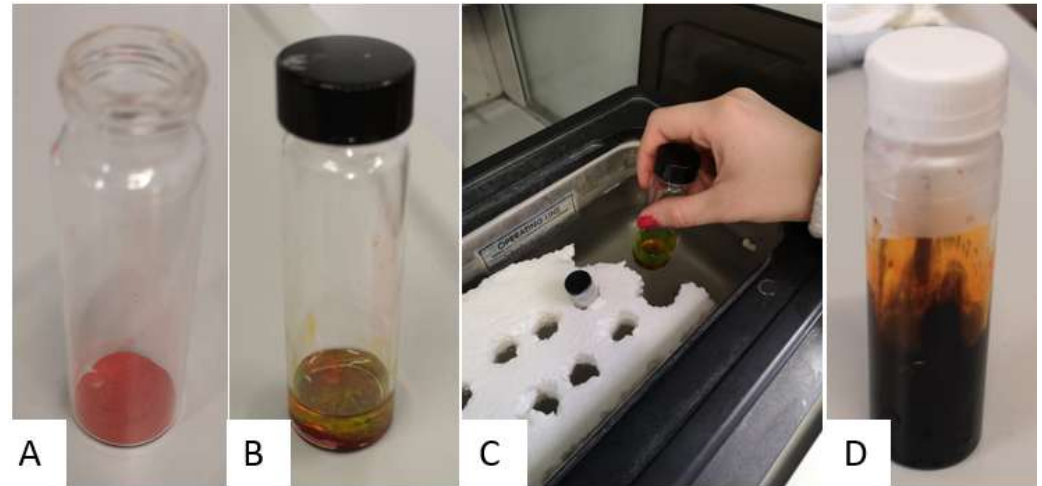
**Figure 14.** Foulant solution preparation: (A) sodium fluorescein (B) mixture of 1% sodium fluorescein and 98% of PEG400 (C) ultrasound sonicator (D) final mixture with addition of 1% black dye .

The fouling agent was a mixture consisting of 98% polyethylene glycol (PEG 400), 1% black dye, and 1% sodium fluorescein (Figure 14A). Sodium fluorescein was combined

with polyethylene glycol inside a small container (Figure 14B) and the mixture was made homogeneous by means of an ultrasound sonicator alternating mixing periods with stop periods (Figure 14C). Last, the black dye was added. The mixture thus produced had to be stored in the sealed container for at least one night before use (Figure 14D).

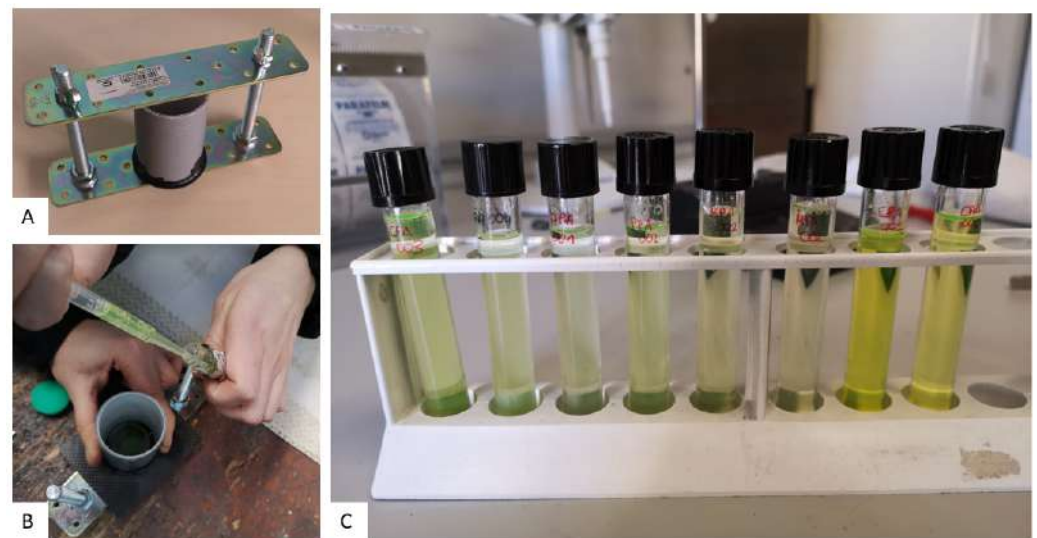
**Figure 16.** Extraction of residual dirt: (A,B) extraction fixture; (C) test rack with solution samples.

With the same amount of time to carry out the cleaning procedure, it can be noted that the Al2024 sample treated with nanotechnologies had a 16% increase in dirt removed, and the raw carbon treated with nanotechnologies had a 7% increase in dirt removed. The painted carbon treated with nanotechnologies had a 15% increase in dirt removed. Finally, the plexiglass treated with nanotechnologies had a decrease in dirt eliminated of 23%. Despite the apparently negative result obtained on the plexiglass, the results obtained on the composite and on the metal are promising in terms of efficacy of nanotechnology in terms of cleaning improvement. Likely, the ability of surfaces treated with nanotechnologies to be easier to clean (at least for CFC and Al2024) is due to the hydrophobicity characteristic that silicon nanoparticles are capable of attributing to the substrate on which they are applied. This property is also observable in Figure 15 where a visual comparison is made on the distribution of dirt in one treated and one untreated specimen. Extraction of the residual dirt and solution samples preparation is shown in Figure 16.
