# Effectiveness of Nanotechnology Treatments in Composite Aircraft Applications

**Abstract:** This paper aims to verify the effectiveness of a process of superficial protection based on nanotechnologies produced by 4Ward360 and specifically developed for aeronautical applications on composite material aircraft. The Dardo aircraft, a composite VLA category manufactured by CFM Air, was taken as a reference case and two application/investigation areas were identified. The potential anticorrosive behavior of the nanotechnology treatment was investigated when applied to the metal joints of the aircraft, such as the wing–fuselage attachments usually made of Al-2024-T3 aluminum alloy. Furthermore, the potential increased effectiveness in cleaning was investigated as another possible application concerning the parts made of composite material both solid and in a sandwich configuration and the plexiglass parts of the canopy.

## 2. The Dardo Aircraft

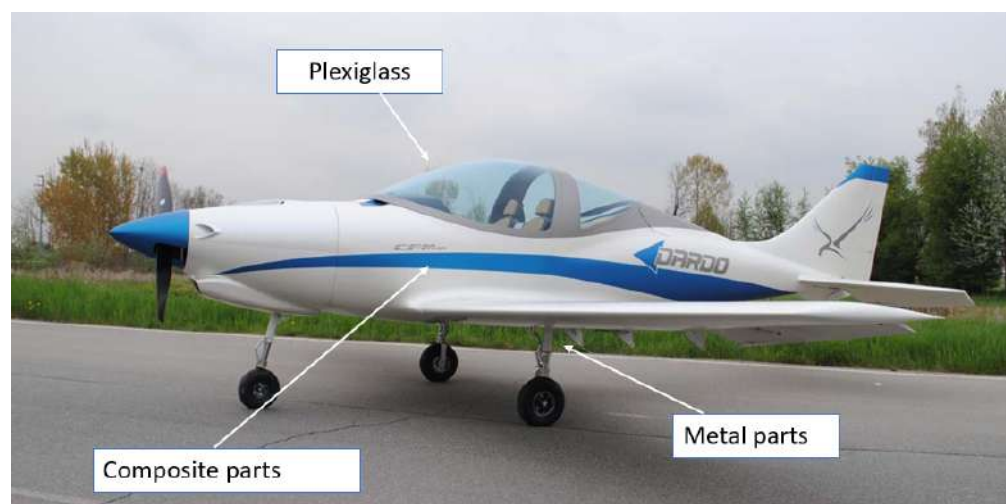
Figure 1. Dardo aircraft.

The Dardo aircraft (Figure 1) is a light aircraft designed to operate from short fields as are typically found in logistically austere environments. It is able to operate up to a service ceiling of 12,000 ft, and never exceeds a speed of 170 KCAS. It must also carry a max fuel content of 80 Kg that allows for an endurance of 4 h. The nominal range is in the order of 350 NM.

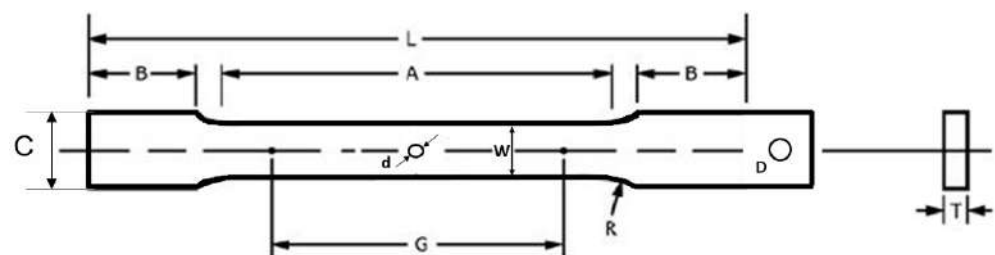
**Figure 2.** Specimen's geometry definition.

The dimensions of each specimen can be deduced from Figure 2 and Table 1. The standard specimens were modified by introducing two holes, a central one of 2 mm necessary to increase the stress intensity factor and therefore limit the duration of the next fatigue test. A second hole of 5 mm was present at one end to allow immersion in the corrosion tank.

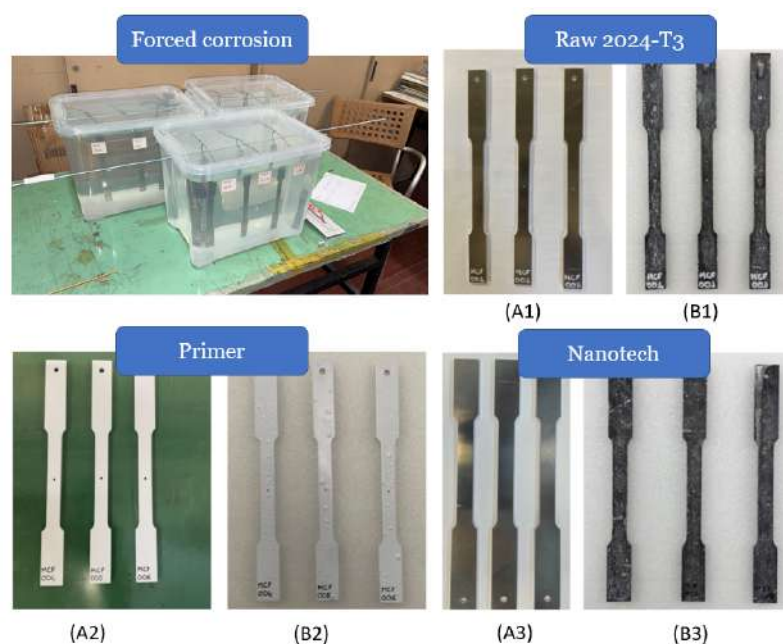
**Figure 3.** Specimens: (A1–A3) before corrosion; (B1–B3) after corrosion. “Raw 2024-T3”: aluminum without corrosion protection; “Primer”: aluminum treated with a standard primer; “Nanotech”: aluminum treated with nanotechnology.

In image (A) of Figure 3, it is possible to observe the aluminum specimens marked with the identification code, before immersion in the bath and in (B) immediately after the phase of extraction from the corrosive bath. A loss of luster was noted for the raw aluminum specimens, a darker coloring and the presence of numerous encrustations of salt as well as a lower smoothness to the touch. A loss of luster was noted for the Al-primer together with surface bubble formation as previously mentioned. Finally, for the specimens treated with nanotechnologies, a loss of luster of the metal and a darker coloration were noted but with less formation of salt encrustations. Also in that case, a reduction in smoothness was found.

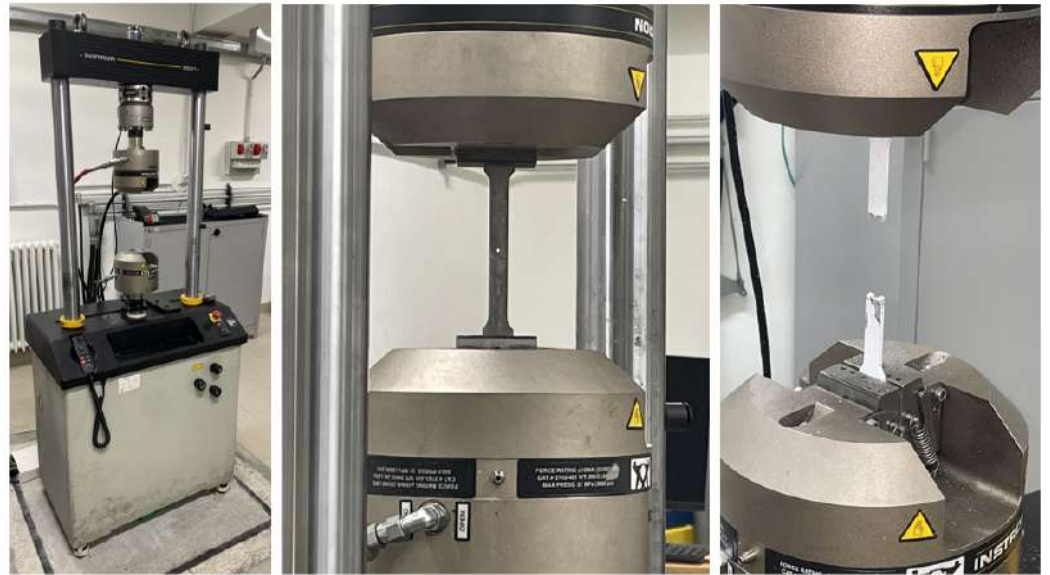
Figure 4. Specimen installed in the fatigue test machine.

The INSTRON 8801 machine (Figure 4), available at Politecnico di Torino-DIMEAS structural laboratories, was used to carry out the fatigue tests. In addition to the 9 specimens subjected to corrosive treatment, the other 4 specimens were added, bringing the total of those mechanically tested to 13 in order to have a direct comparison between the same types of surface coatings with the only discriminating factor being the corrosive process undergone. All the samples reported in Table 2 were subjected to the fatigue test, highlighting those that underwent the corrosive process. Table 2 also shows the three selected load levels, the maximum and minimum force of the applied cycle, and the frequency of load application. The need to conduct fatigue tests, operating with three different load levels, arises from the need, albeit with the limitation of the reduced number of specimens, to approach the definition of the S-N curves [10,16].

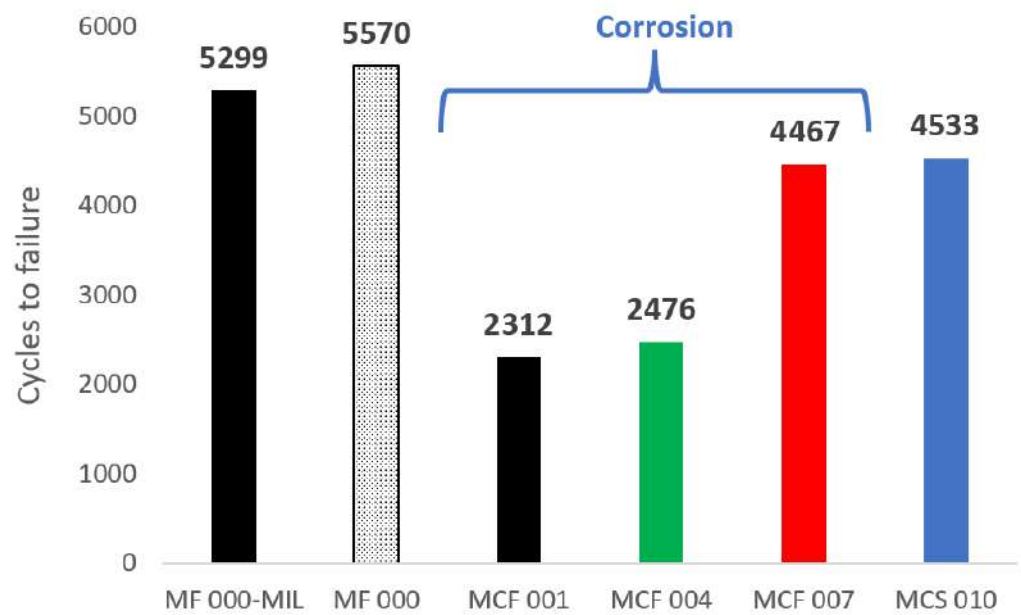
Figure 5. Load type 1:  $F_{max} = 11, \text{ kN}$   $F_{min} = 0, \text{ and kN}$   $f = 5 \text{ Hz}$ .

Figure 5 presents the number of cycles to failure of the specimens subjected to load type 1 corresponding to  $F_{max} = 11$  kN,  $F_{min} = 0$  kN, and a frequency of  $f = 5$  Hz. The specimens subjected to corrosion are also indicated. For this load, we note a significant reduction in fatigue life for the untreated MCF001 specimen and also for the Al-Primer specimen (MCF04) compared to the uncorroded case MF000, demonstrating the evident reduction in fatigue life due to the corrosion effect. The specimen treated with nanotechnologies (MCF007) in this case had a very similar behavior to that of the specimen of the same category not subjected to the corrosion process (MCS10), demonstrating an increased protective property against corrosion with an increase in fatigue life of +48% compared to raw Al, of +44% with respect to Al-Primer, and a small reduction of  $-1.44\%$  when considering the uncorroded Nanotech specimen.

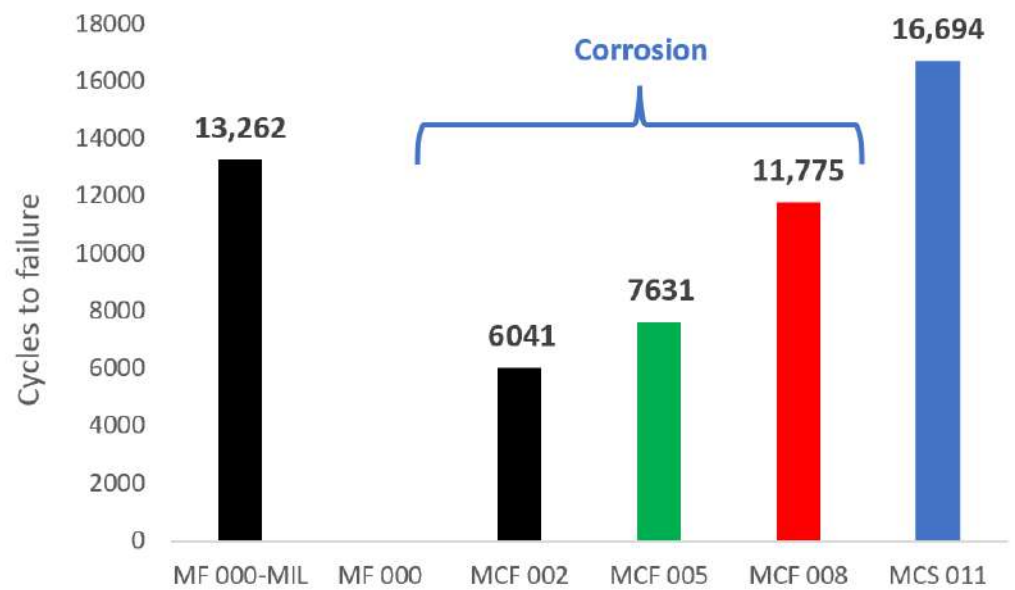
Figure 6. Load type 2:  $F_{max} = 9 \text{ kN}$ ,  $F_{min} = 0 \text{ kN}$ , and  $f = 5 \text{ Hz}$ .

The results relating to the intermediate load level indicated with type 2 and corresponding to  $F_{max} = 9$  kN,  $F_{min} = 0$  N, and a frequency of  $f = 5$  Hz are shown in Figure 6. Also in this case, an excellent behavior of the specimens treated with nanotechnologies and subjected to the corrosion process can be noted. In particular, the MCF008 specimen had an increase in life of +48% compared to raw aluminum (MCF002), +35% compared to the specimen treated with primer (MCF05), and a reduction of  $-29\%$  compared to the specimen treated with nanotechnology but not corroded (MCS11). Finally, considering the lowest load level indicated in Figure 7 with type 3 and corresponding to a cycle defined by  $F_{max} = 6$  kN,  $F_{min} = 0$  N, and a frequency of  $f = 5$  Hz, we still noticed a better behavior of the specimen treated with nanotechnologies albeit reduced compared to the previous case. In this case the MCF009 specimen had an increased fatigue life compared to raw aluminum (MCF003) of +39%, while compared to the primer (MCF006), the life increase was 33%, and the reduction compared to the uncorroded case (MCS012) increased to  $-66\%$ .

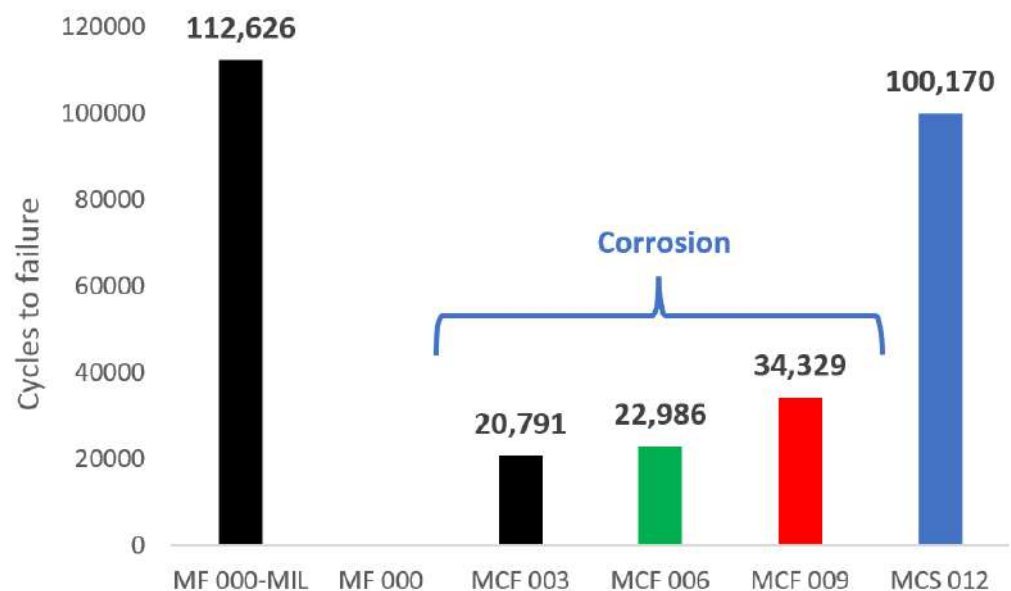
**Figure 7.** Load type 3:  $F_{max} = 6$  kN,  $F_{min} = 0$  kN,  $f = 5$  Hz.

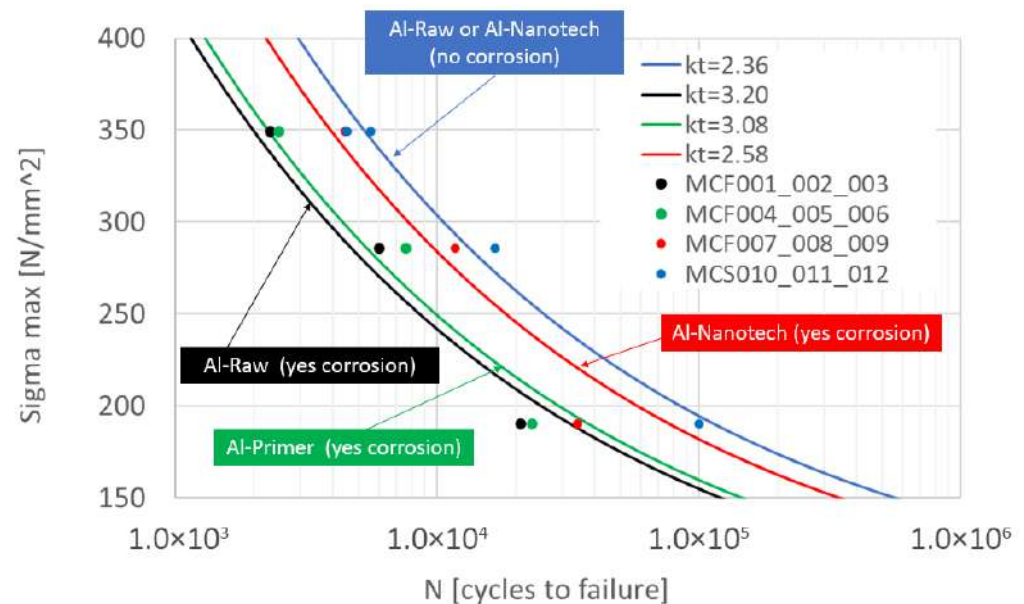
**Figure 8.** S-N curve: blue: no corrosion; black: corroded specimens; green: primer protection; red: nanotechnology protection.

Figure 8 shows the S-N curves considered for the different cases discussed. In blue are the specimens not subject to corrosion, in black are the corroded and unprotected specimens, in green are the specimens protected with primer, and finally, in red are the specimens protected with nanotechnologies and subjected to the corrosion test. In all specimens subjected to corrosive immersion, a greater effect of corrosion was observed at lower loads (load types 2 and 3), confirming not only an increase in the stress concentration factor ( $kt$ ) but also a change in the slope, as indicated also in [9].

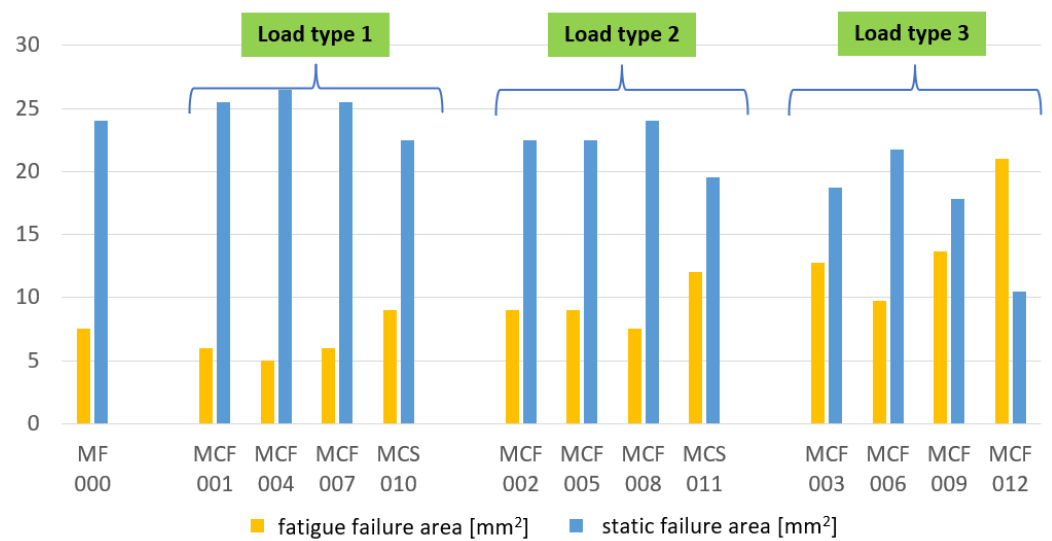
Figure 9. Comparison of failure areas for each type of load.

From Figure 9, where the results are divided by specimen category, it is possible to observe that, as could be expected, the extent of the fatigue failure section was more significant when the specimen under consideration was subjected to a lower stress: a lower mechanical load means a higher number of cycles, therefore a greater failure area due to fatigue. The graph also highlights what has already been observed previously: in each group of specimens, the best resistance to mechanical stress was always obtained with nanotechnology coating protection.

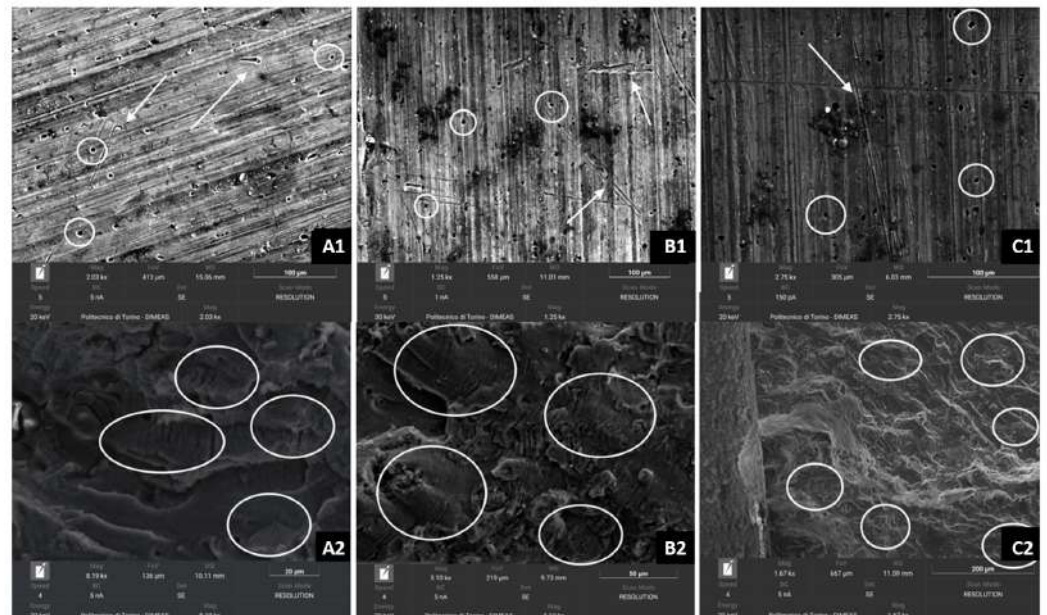
Figure 10. SEM analysis: (A1,A2) MCF002; (B1,B2) MCF005; (C1,C2) MCF008.

From the electron microscope (SEM) analysis, as reported in Figure 10, production damage (scratches and streaks) could be seen on all specimens subjected to corrosion as well as signs of surface pitting [19]; however, they were more consistent in size and number in the case of raw aluminum and primer treatment, where a detachment from the metal surface was observed. Pitting corrosion also occurred in the case of aluminum treated with nanotechnologies, but with characteristics at first sight decidedly more limited than what occurred in the other two cases.

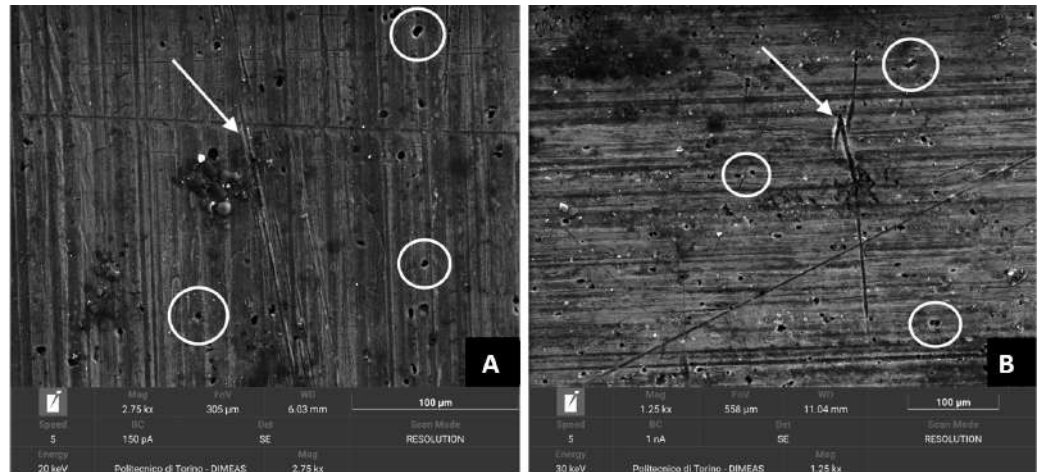
**Figure 11.** Specimen surfaces MCF 008 (A) and specimen MCF 012 (B).

Considering the limited number of specimens considered in this study and observing Figure 11, it can be cautiously stated that at the same magnification, the corroded specimen, MCF 008, had the same number of holes and imperfections as the uncorroded one, MCS 012, both treated with nanotechnology, and only increased in size. The raw aluminum samples showed notable differences: an increase in the number of imperfections in the corroded sample, MCF 002, compared to its uncorroded counterpart, MF 000. This aspect shows a general improvement in the ability to resist corrosion for the nanotechnology-treated specimens.

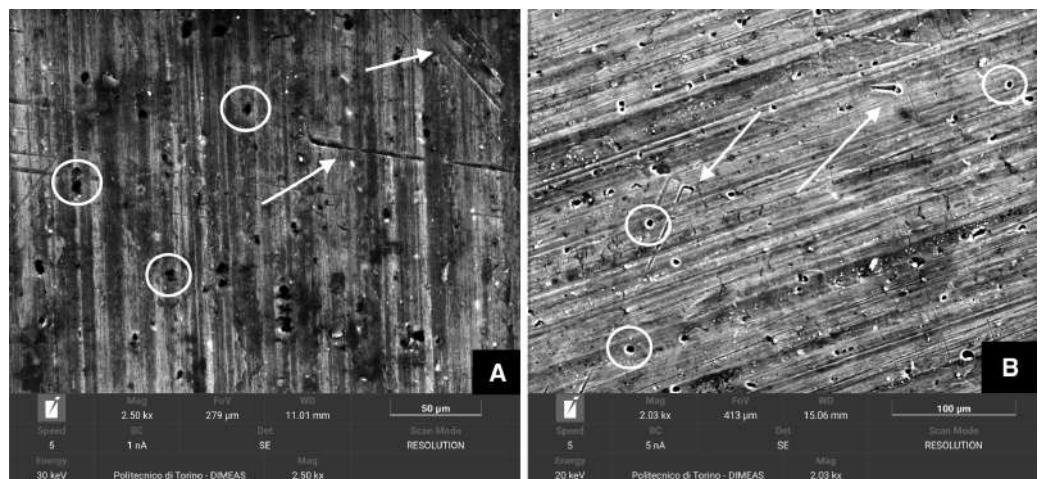
**Figure 12.** Specimen surfaces MF 000 (A) and specimen MCF 002 (B).

The analysis conducted by an SEM microscope provided better evidence of how corrosion affected the surface finish of the metal: to observe the same type of damage related to the machining and fabrication of the metal specimens, the corroded raw aluminum specimen, MCF 002, was analyzed at a lower magnification, compared to the uncorroded raw aluminum specimen, MF 000, see Figure 12.

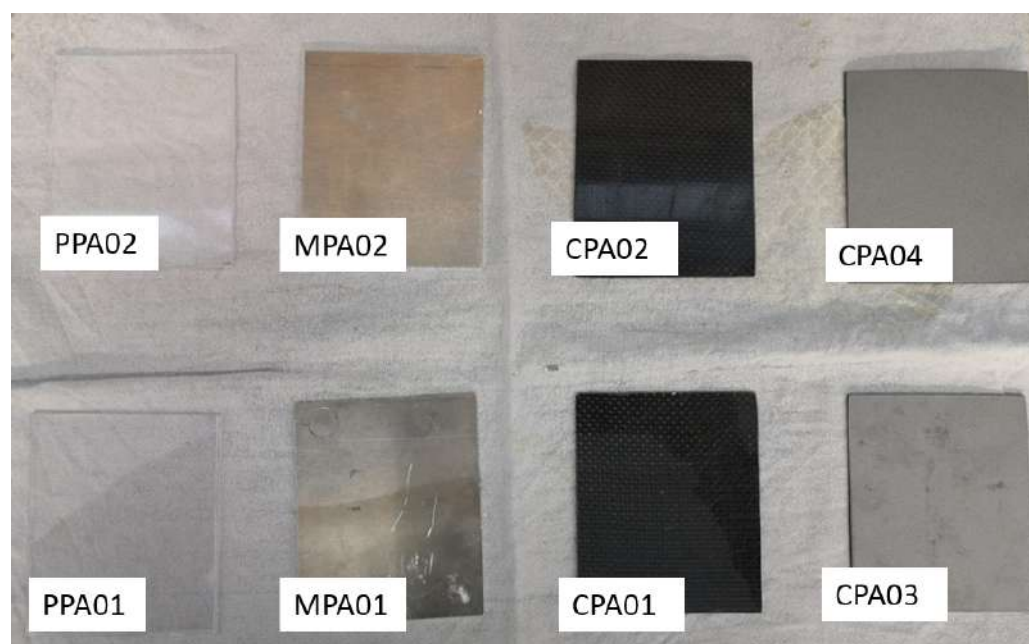
**Figure 13.** Specimens under cleaning tests, see Table 4 for label definitions.

Table 4 and Figure 13 show the specimens subjected to cleaning tests.

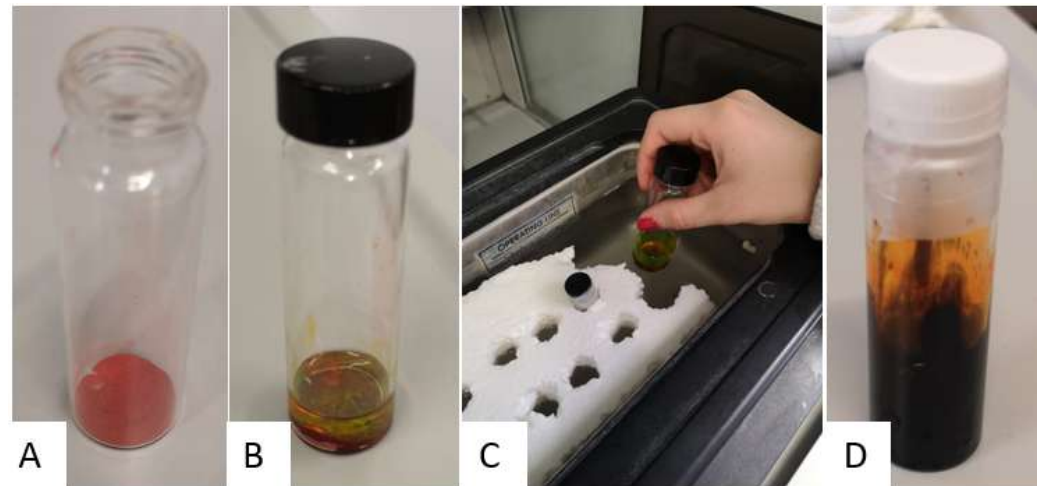
**Figure 14.** Foulant solution preparation: (A) sodium fluorescein (B) mixture of 1% sodium fluorescein and 98% of PEG400 (C) ultrasound sonicator (D) final mixture with addition of 1% black dye .

The fouling agent was a mixture consisting of 98% polyethylene glycol (PEG 400), 1% black dye, and 1% sodium fluorescein (Figure 14A). Sodium fluorescein was combined

with polyethylene glycol inside a small container (Figure 14B) and the mixture was made homogeneous by means of an ultrasound sonicator alternating mixing periods with stop periods (Figure 14C). Last, the black dye was added. The mixture thus produced had to be stored in the sealed container for at least one night before use (Figure 14D).

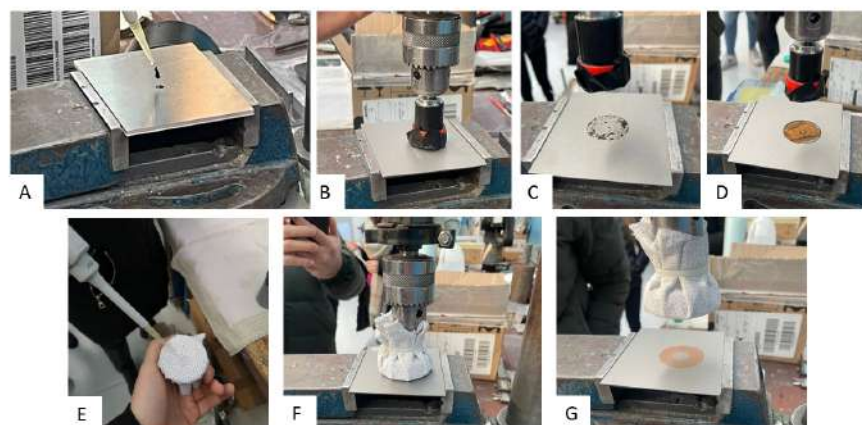
**Figure 15.** Dirtying procedure (A–D) and cleaning procedure (E–G).

The application of the foulant agent started by positioning the specimens to be treated on the work table and filling the tip of the 0.025 mL repeating pipette with the foulant solution. A series of drops were dropped until an 80  $\mu$ L drop was deposited approximately in the center of each specimen.

The dirt head consisted of a 30 mm diameter polishing head with a Teflon adhesive tape glued to the relative surface to make it impermeable to the foulant agent. The cleaning head consisted of a 50 mm polishing head covered with four layers of cotton fabric, previously left for one night in a desiccator loaded with a saturated solution of potassium carbonate, with a humidity level of approximately 45%. The specimen had to be arranged in such a way that the foulant head rested exactly by gravity above the drop of dirt. The spindle was then started and left to act for one minute. Finally, the covered cleaning head was used after the cleaning tissue had been moistened in the center with 0.025 mL of water. The cleaning head was left to work for 22 s. At the end of the procedure, the cleaning head was removed without friction.
