Plasma-wall interaction on the divertor tiles of JET ITER-like wall from the viewpoint of micro/nanosopic observations

# Plasma-Wall Interaction on the Divertor Tiles of JET ITER-Like Wall from the Viewpoint of Micro/Nanoscope Observations

Micro/nanoscope observations on the surface of the divertor tiles used in the first campaign (2011-2012) of the JET tokamak with ITER-like Wall (JET ILW) have been carried out by means of several material analysis techniques. Previous results from the inner divertor were reported for a single poloidal section of the tile numbers 1, 3 and 4, i.e., upper, vertical and horizontal targets, respectively. The formation of the thick stratified mixed-material deposition layer on tiles 1 and 4, and strong erosion on tile 3 were identified. This contribution is mostly focused on the outer divertor: tiles 6, 7 and 8. In contrast to the inner tile, remarkable surface modifications have not been observed on the vertical target (tiles 7 and 8) where sputtering erosion and impurity deposition would have been almost balanced. Only a specific part of tile 6 (horizontal target) located near the exhaust channel was covered with a stratified (“geological-like”) mi

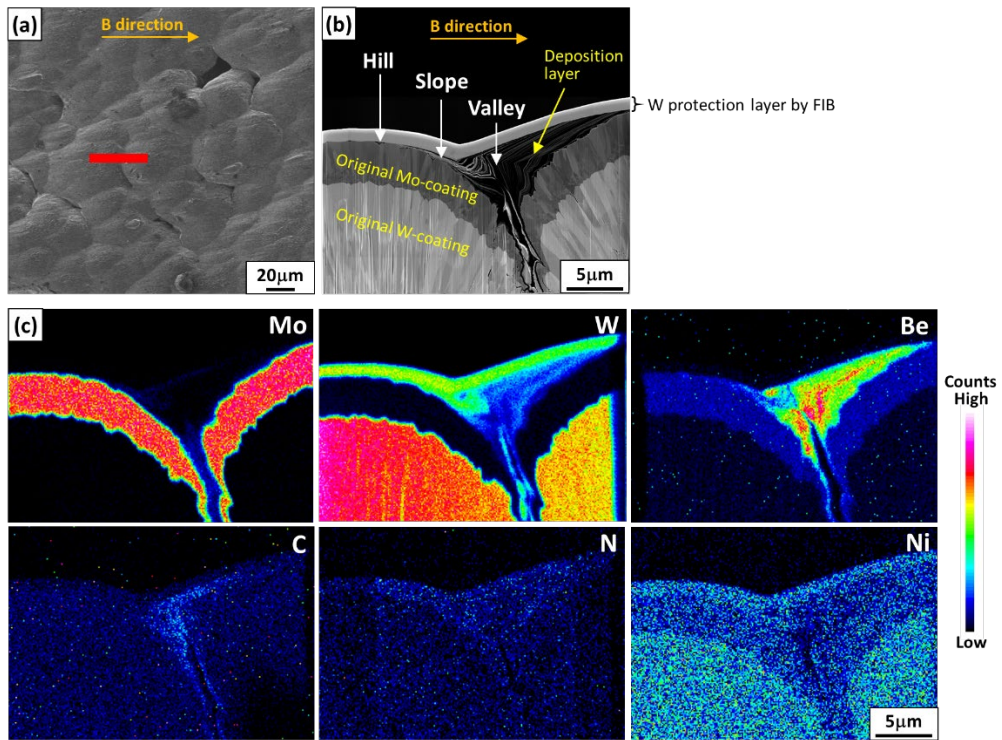
Fig. 6 One column wide

- Fig. 6 (a) SIM image of the surface of the 3-6a sample. (b) A corresponding cross-sectional SEM image extracted from the red rectangle area in the SIM image

of (a). (c) EPMA mappings.

For more precise analysis of the local erosion and deposition effects in micrometer scale, cross-sectional SEM observation and EPMA analysis were conducted. Fig. 6-(a) shows the SIM image of the 3-6a sample. This image is not in the exact same position with Fig. 5, but is almost the same area and geometry. A cross-sectional SEM image extracted from the red rectangle position is marked in Fig. 5-(a) by means of FIB technique shown in Fig. 5-(b). The W protection layer was artificially created on the top surface of the sample against the Ga fabrication ion beam in the FIB device. The hill, slope and valley as mentioned in Fig. 5 can be clearly identified in this cross-sectional image. It is clear that the hill position cannot see any deposition. On the other hand, thickness of the deposition layer is gradually increased from the slope to the valley positions. The deposition layer on the valley position has complex multilayer structure. For confirming the element distribution in the deposition layer, the EPMA analysis was conducted in the same cross-sectional sample of Fig. 6-(b). Fig. 6-(c) shows the EPMA element mapping of the deposited elements of Mo, W, Be, C, N and Ni. Although the EDS analysis of Fig. 5 was not able to identify the Be deposition, it is confirmed that the majority of the deposited element is Be, and certain amounts of W, C, N, and Ni are also deposited together with Be. Judging from the deposition feature of both Figs. 5 and 6, incoming direction of the impurities and plasma particles flow could be from the left hand side to the right hand side of the SEM images. This direction qualitatively agrees with the magnetic field line direction of the JET tokamak. Such local erosion deposition phenomena would be caused by a shallow connection angle of the magnetic field line to the tile surface. The results as shown in Figs. 5 and 6 are very interesting because both erosion and deposition simultaneously occurred in the

very local area around the  $\sim 10 \mu\text{m}$  square. Due to the shallow incident angle of the impurities and plasma particles, the hill position would enhance the erosion by plasma influx. On the other hand, since the slope and valley positions were located on a shadow area of the hill, sputtering erosion could be suppressed. In contrast, impurity deposition was enhanced.
