Material migration and fuel retention studies during the JET carbon divertor campaigns

Fusion
JET
Divertor
Carbon
Plasma-facing components

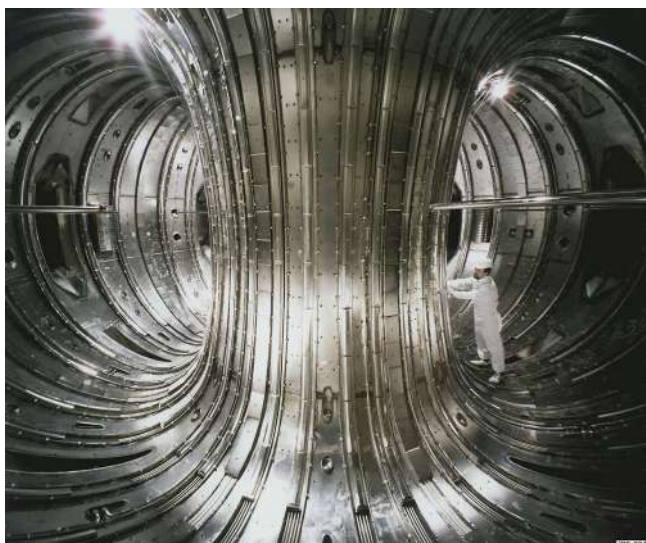
Fig. 2. Interior of the JET vessel in the 1983–84 campaign.

During the 1983–4 operations, even though the discharges were purely ohmic as no additional heating had yet been installed, significant melt damage was observed at the inner vessel wall on bellows protection plates, which were the items at largest radius – i.e. closest to the plasma. To prevent such damage, during the 1984 shutdown carbon tiles were installed that covered the inner wall of JET. The tiles were flat graphite plates fitted so that every tile in each toroidal row was at the same major radius. This meant that the joint between adjacent tiles in the row were at slightly larger radius than the centres of the tiles, and ions travelling toroidally along field lines could impinge on the edges of each tile. As a result, in the subsequent campaign the most prominent edges received very high power loads leading to massive erosion and causing carbon impurity levels in the plasma to reach uncontrollable levels (referred to as “carbon blooms” [4]). In an emergency shutdown the carbon tiles at the inner wall were replaced with poloidal rows of ridged tiles, with the spaces between filled with (flat) tiles set back at a smaller radius, so that field lines were always incident at a small angle to the tangent to the tile surface.

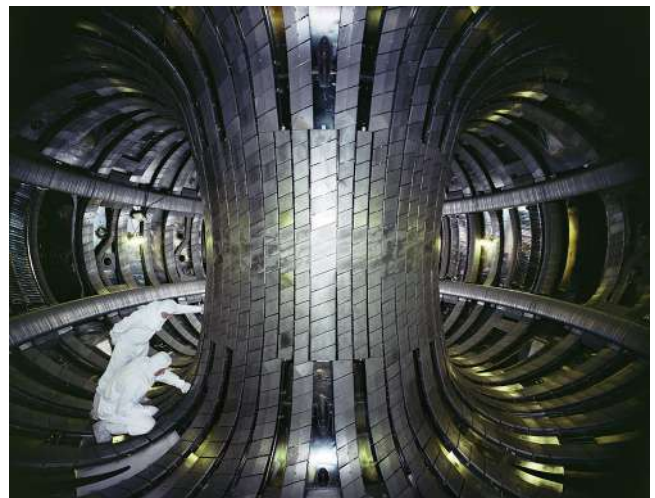
Fig. 3. Interior of the JET vessel in 1987.

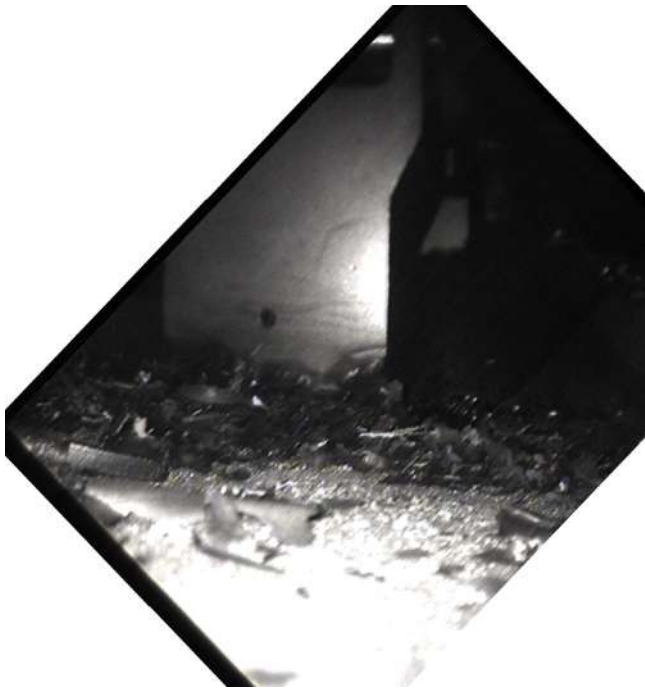
Fig. 19. Flakes piled behind a divertor support leg, observed using an endoscope in 1999.

There was a significant accumulation of flakes and dust on the divertor floor next to the inner louvres, much of which appeared to have resulted from spalling of deposits from the louvres themselves; there were no flakes observed on or near the outer louvres. All the flakes from the inner divertor corner were collected after the tile carriers were removed (all round the torus) using a vacuum cleaner, weighed and a sample analysed at AEA, Winfrith. The analysis showed that the flakes were carbon with a very high D and T content: based on the sample analysed, the 152 g collected contained 0.52 g tritium, giving a specific activity of 1.3 TBq g^{-1} for the flakes [30]. This reduced the missing T to ~ 3 g. The way the louvres are angled, most material spalling from their blades would fall into the void under the divertor. If it is assumed that all the missing T is in flakes that have fallen below the divertor, there would need to be ~ 1 kg of flakes similar to those collected at the inner divertor corner [31]. In the next intervention (in 1999) an endoscope was fed through the louvres to see if there were indeed flakes in the sub-divertor volume. As the endoscope was being fed through the gap between the divertor structure and the inner divertor coil housing flakes could be seen balanced on each bolt head and ledge, and on the floor of the vessel (which under the inner divertor is sloping towards the lowest point which is approximately beneath the outer divertor) there were piles of flakes behind every obstacle, for example divertor

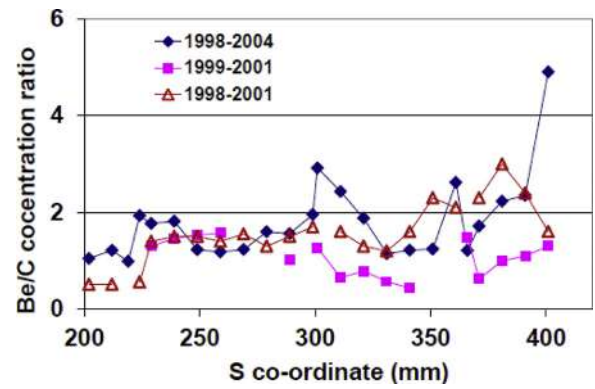
Fig. 31. Be/C ratios determined by NRA for Tile 1 - examples from different operational campaigns. The apron is between s-coordinates 162 and 222 mm and the front face of the tile from 222 to 431 mm.

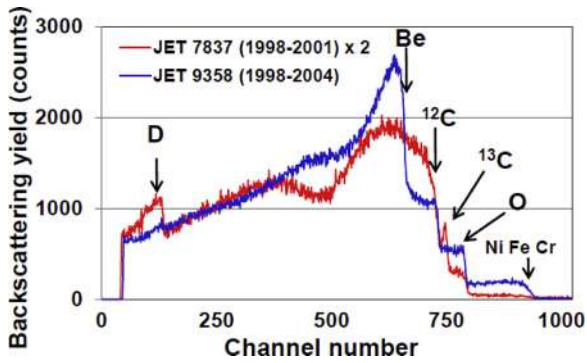
Fig. 33. RBS spectra from the upper part of the front face of Tile 3 for tiles removed in 2001 and in 2004. The arrows indicate the high energy edge of the feature characteristic of that element.

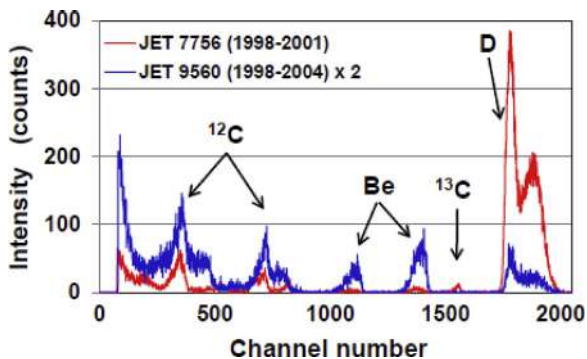
Fig. 34. NRA spectra from the upper part of the front face of tile 3 for tiles removed in 2001 and in 2004 (note: the 2004 spectrum is expanded by a factor of two along the y-axis to reduce overlapping with the 2001 spectrum).

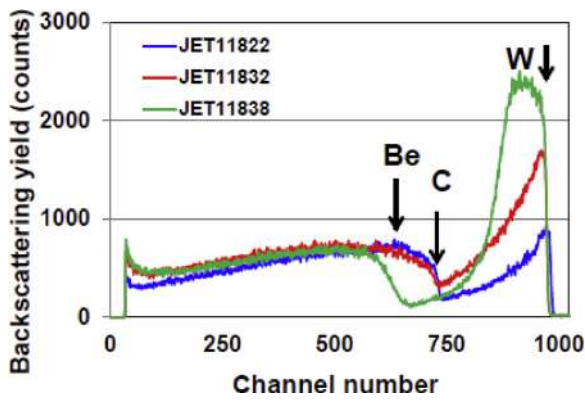
Fig. 42. RBS spectra from the centre (poloidally) of the W-coated stripes on LBSRP Tile 14 WR (a) on the thinner coating (JET11822), (b) on the plasma-exposed part of the thicker coating (JET11832), (c) on the shadowed part of the thicker coating JET11838). The arrows indicate the high energy edge of the feature characteristic of that element.

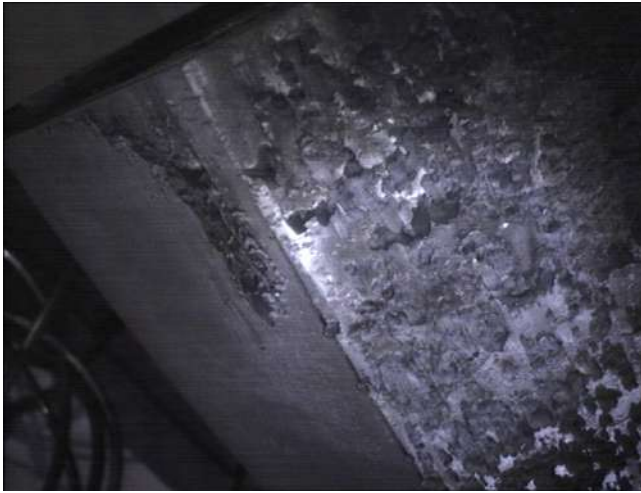
Fig. 45. View of part of the apron of a Tile 1 (right-hand side) and the upper front face of the tile (towards the left-hand side) during the 2007 JET shutdown inspection, showing spalling deposits. The tile had been exposed 1998–2007.

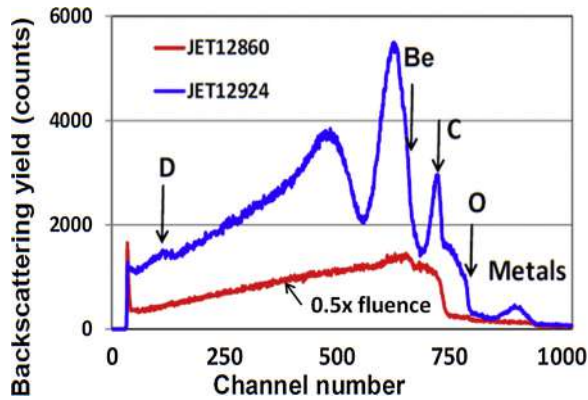
Fig. 46. RBS spectra from the lower part of the front face (JET12924) and from the apron (JET12860, recorded for only half the beam fluence of JET12924 for clarity) of Tile 2IWG1A exposed 2005–7. The arrows indicate the high energy edge of the feature characteristic of that element.

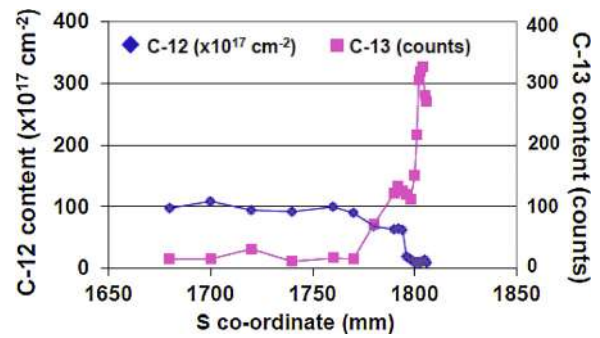
Fig. 57. Plot of ^{13}C and ^{12}C measured by NRA across Tile 2ONG7A, showing that the deposit at the top edge is almost exclusively ^{13}C and not ^{12}C .

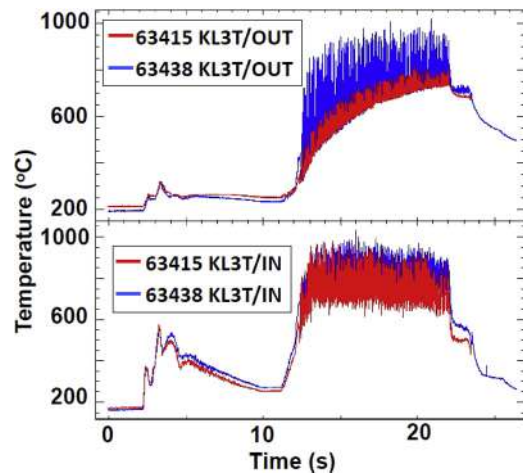
Fig. 58. Maximum temperatures measured with an infra-red camera during selected pulses during the ^{13}C puffing experiments at the end of the 2002–4 campaign. The upper part shows the maximum temperature in the outer divertor during pulse 63415 (red curve) and 63438 (blue curve). The lower part shows the maximum temperature in the inner divertor during pulse 63415 (red curve) and 63438 (blue curve) (For interpretation of the references to colour in this figure legend, the reader is referred to the web version of this article).

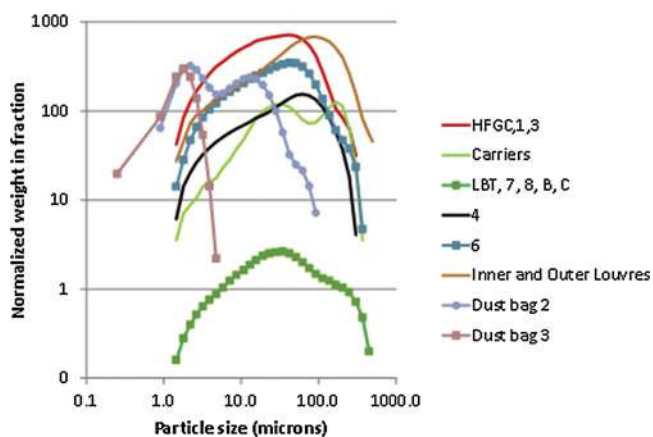
Fig. 60. Particle Sizing Data - Results given as weight in the particular size fraction multiplied by the total weight of the dust sample collected versus the particular size fraction in microns.

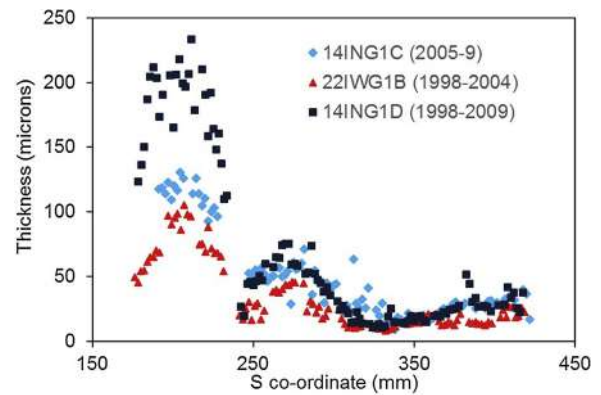
Fig. 61. Film thicknesses from optical microscopy of sections for Tiles 1 removed after operational periods 1998–2004 (Module 22), 1998–2009 (Module 14) and 2004–9 (Module 14).
