Tunnel convergence monitoring by radar interferometry / Barla, M., Aiassa, S., Antolini, F., Twardzik, M., Cecchetti, M.. - In: PROCEDIA STRUCTURAL INTEGRITY. - ISSN 2452-3216. - 62:(2024), pp. 1097-1104. (Il Fabre Conference – Existing bridges, viaducts and tunnels: research, innovation and applications (FABRE24) Genova (Ita) 12-15 febbraio 2024) [10.1016/j.prostr.2024.09.145].

II Fabre Conference – Existing bridges, viaducts and tunnels: research, innovation and applications (FABRE24)

## Tunnel convergence monitoring by radar interferometry

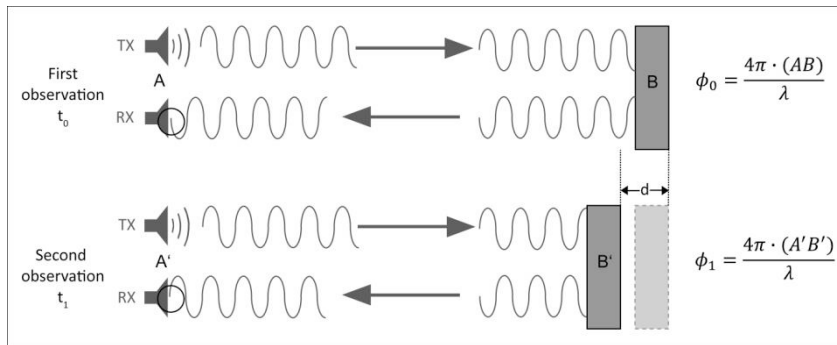
Fig. 1. Relation between the phase difference and the displacement of an object during two consecutive GB-InSAR observations.

The Ground-Based Interferometric Synthetic Aperture Radar (GB-InSAR) is an active radar-based remote sensing system, designed in general terms to monitor the displacements of objects (Rudolf et al. 1999). By using the SAR technique (Curlander & McDonough, 1991) which combines multiple coherent range images of the scenario taken from slightly different positions, the radar systems become able not only to measure the sensor-to-target distances but also to map the monitored scenario in two dimensions. The SAR images are hence two-dimensional complex images where each pixel contains two main information i.e., the amplitude and the phase components of the radar signal. The radiometric amplitude is directly related to the power of the back-scattered signal from all the objects contained in each resolution cell (represented as a pixel in the SAR image) while the phase of each pixel is related to the sensor-target distances and it can be exploited to obtain the accurate position of each target. By using at least two GB-InSAR images of the same object acquired at different times, it is possible to exploit the phase difference to retrieve the variation of the sensor-target distances of each homologous pixel, using the equation (1):

This relation shows that the interferometric phase  $\phi$  of every pixel of the radar image depends on the wavelength of the radar signal ( $\lambda$ ) and is directly related to the difference paths of the sensor-to-target distances  $AB$  and  $A'B'$ , e.g., the displacement that occurred between the first observation at time  $t_0$  and the second observation at time  $t_1$  as shown in Fig. 1. The monitoring of the displacement is limited to one dimension, i.e., the Line Of Sight (LOS) of the sensor. Only the projected component of the real displacement vectors along the LOS can be monitored.

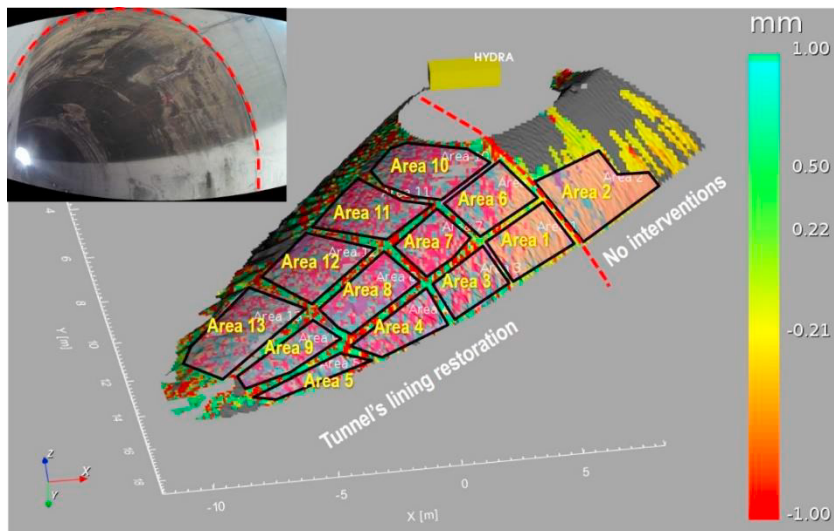
Fig. 3. LOS displacement map of the tunnel's lining projected over a 3D point cloud obtained after a monitoring period of 15 days.

Fig. 3 shows the LOS displacement map superimposed over the 3D point cloud of the tunnel obtained from the laser scanner coupled with the radar sensor. Using the installation geometry previously described, a spatially continuous map of the tunnel crown and the upper portion of the sidewalls was obtained. The different colors of each

pixel represent the cumulated LOS displacement measured during the period (15 days) after the completion of the stitching and sealing of the main cracks and the installation of suspended steel ribs in the monitored tunnel section. Negative displacement corresponds to a reduction of the sensor-to-target distance and corresponds to an increase in the tunnel convergence, i.e., a reduction of the diameter or a specific chord of the tunnel. The analysis of the map indicates that the LOS displacement of each pixel in the monitoring period analyzed was maintained in the range of  $\pm 1.5$  mm.

In addition to the pixel-by-pixel analysis, to better analyze the displacement patterns retrieved from the monitoring, the tunnel's crown and sidewalls were subdivided into 13 different areas corresponding to specific tunnel sectors. It is worth noting that area #2 was not directly affected by the restoration works since it is enclosed in the recent tunnel extension. For all 13 areas, it was then possible to obtain a specific time series by averaging all the pixels that are included as shown in Fig.4. The time series of the LOS displacement show a direct correlation between the increases in the displacement of some areas, i.e., the onset of the acceleration, and the working phases in the tunnel as highlighted by the pink polygons in Fig. 4. This is particularly evident in areas 3, 7 11 (located at a distance of about 7-8 m from the radar system), and 9 (located at a distance of about 20 m from the radar) where the stitching and sealing of the main cracks and the installation of suspended steel ribs were completed. As can be seen from the camera pictures included in Fig. 4, different kinds of equipment as telescopic handlers and aerial platforms were used to access the tunnel crown and the upper portions of the sidewalls. The machinery remains in the radar field of view for different hours causing some of the spikes which can be seen in the time series. The areas not directly involved in the work (for instance areas 1 and 2) did not show any particular acceleration phase, and the final LOS displacement remained in the range  $\pm 0.2$  mm, i.e., very close to the accuracy of the system.

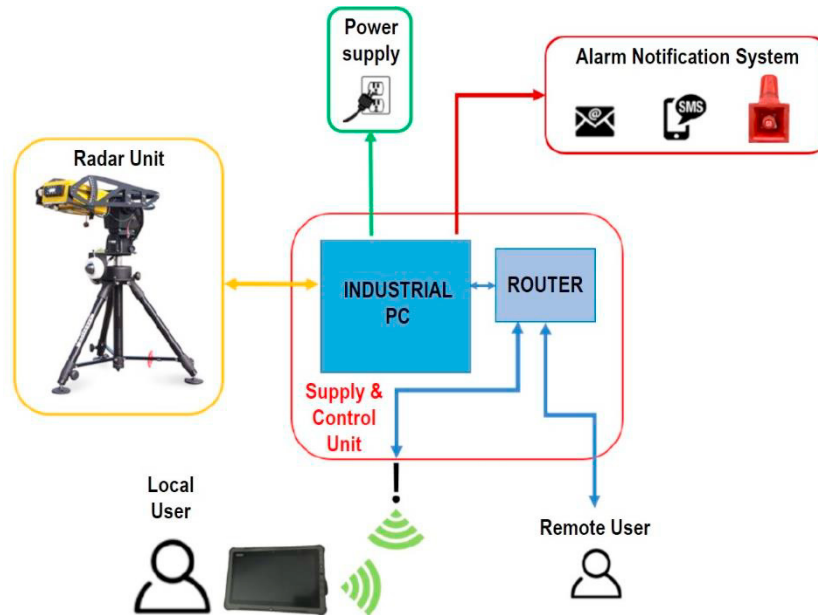
Fig. 5. Schematic outline of an EWS based on GB-InSAR monitoring to be applied to major tunnel rehabilitation works.

The tested GB-InSAR system is already engineered to allow its use for EWS purposes as shown in Fig. 5: the survey unit installed in the tunnel is operated by an industrial PC coupled with a router. Even though the system is equipped with batteries, power supply is required. The system can be managed remotely both by local users through a specific Wi-Fi connection and by remote users through the Internet. The specific software running on the PC manages and controls the radar system and processes in real-time all the acquired data to obtain displacement and velocity maps of the monitored scenario. User-defined displacement or velocity thresholds can be selected to activate the alarm notification system: whenever these thresholds are exceeded email and SMS can be sent to specific recipients and an alarm coupled with a flashing light installed in the work site can be activated. Using this configuration is then

possible to warn the workmanship when anomalous trends caused by sudden lining deformations are detected. To minimize the potential disturbances of the machinery and the equipment in the SAR images and the consequent overestimation of the LOS displacement, the cumulative displacement or the average velocity of selected points or specific areas over short time intervals (6-24h) can be used despite the limitation in reconstructing the complete displacement/velocity time series on the monitored scenario.
