Tunnel convergence monitoring by radar interferometry

Tunnel convergence monitoring by radar interferometry / Barla, Marco; Aiassa, Santina; Antolini, Francesco; Twardzik, Matthias; Cecchetti, Matteo. - In: *PROCEDIA STRUCTURAL INTEGRITY*. - ISSN 2452-3216. - 62:(2024), pp. 1097-1104. ( II Fabre Conference – Existing bridges, viaducts and tunnels: research, innovation and applications (FABRE24) Genova (Ita) 12-15 febbraio 2024) [10.1016/j.prostr.2024.09.145].

II Fabre Conference – Existing bridges, viaducts and tunnels: research, innovation and applications (FABRE24)

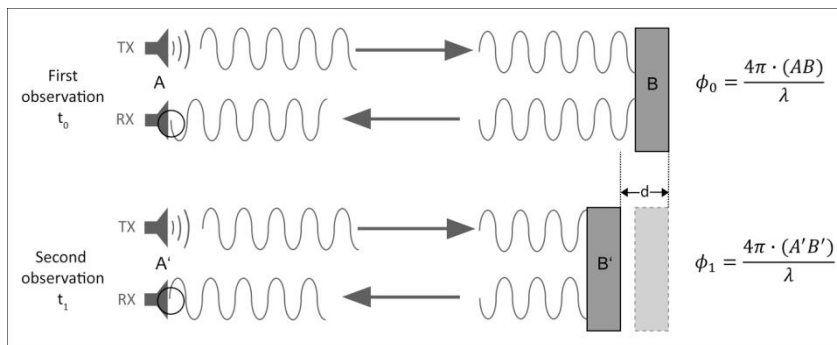
Fig. 1. Relation between the phase difference and the displacement of an object during two consecutive GB-InSAR observations.

The Ground-Based Interferometric Synthetic Aperture Radar (GB-InSAR) is an active radar-based remote sensing system, designed in general terms to monitor the displacements of objects (Rudolf et al. 1999). By using the SAR technique (Curlander & McDonough, 1991) which combines multiple coherent range images of the scenario taken from slightly different positions, the radar systems become able not only to measure the sensor-to-target distances but also to map the monitored scenario in two dimensions. The SAR images are hence two-dimensional complex images where each pixel contains two main information i.e., the amplitude and the phase components of the radar signal. The radiometric amplitude is directly related to the power of the back-scattered signal from all the objects contained in each resolution cell (represented as a pixel in the SAR image) while the phase of each pixel is related to the sensor-target distances and it can be exploited to obtain the accurate position of each target. By using at least two GB-InSAR images of the same object acquired at different times, it is possible to exploit the phase difference to retrieve the variation of the sensor-target distances of each homologous pixel, using the equation (1):

This relation shows that the interferometric phase  $\phi$  of every pixel of the radar image depends on the wavelength of the radar signal ( $\lambda$ ) and is directly related to the difference paths of the sensor-to-target distances  $AB$  and  $A'B'$ , e.g., the displacement that occurred between the first observation at time  $t_0$  and the second observation at time  $t_1$  as shown in Fig. 1. The monitoring of the displacement is limited to one dimension, i.e., the Line Of Sight (LOS) of the sensor. Only the projected component of the real displacement vectors along the LOS can be monitored.

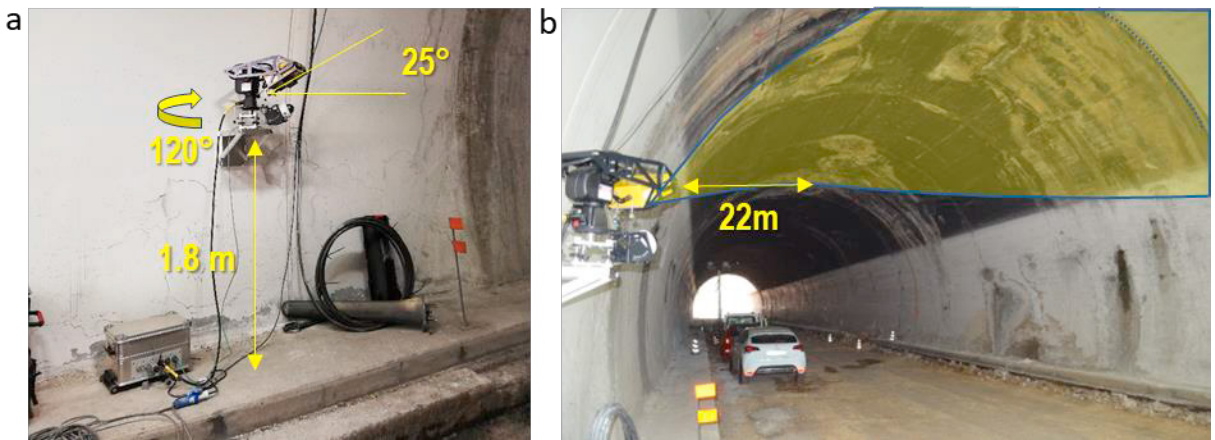
Fig. 2. (a) View of the Hydra-U installation point and (b) view of the monitored tunnel sector.

The equipment used for the experimental activities was a specifically designed ground-based radar called HYDRA-U optimized for use in underground applications. The instrument is composed of a radar head equipped with two antennas (one for signal transmission and one for receiving) mounted on a pan/tilt unit capable of rotating the radar unit thus realizing the synthetic aperture. The motion of the radar antenna over a circular trajectory provides finer angular resolution than conventional beam-scanning radars. The circular trajectory used for obtaining the synthetic aperture (often denoted as ArcSAR) permits a more compact design of the radar and a wider-angle coverage compared to the traditional linear SAR. An IR camera and a laser scanner are also coupled with the radar sensor. The instrument is completed by a power supply and control unit. The system was installed along one sidewall of the tunnel using a metallic shelf as shown in Fig. 2a. By tilting the radar head  $25^\circ$  from the horizontal and by using a synthetic aperture equal to  $120^\circ$  it was possible to monitor the tunnel crown and one sidewall up to a distance of about 22 m from the radar installation point (Fig. 2b). The accuracy of the displacement measurement along the LOS depends on the wavelength of the radar signal and is equal to  $\pm 0.1$  mm.

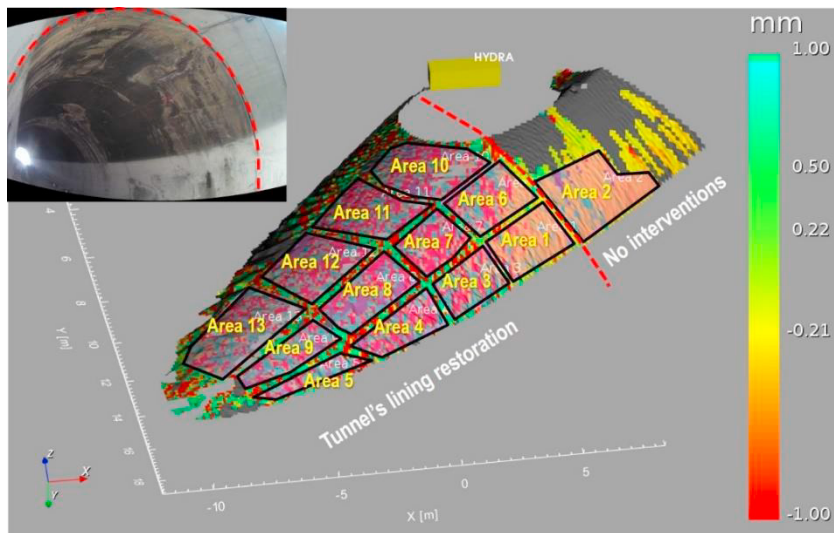
Fig. 3. LOS displacement map of the tunnel's lining projected over a 3D point cloud obtained after a monitoring period of 15 days.

Fig. 3 shows the LOS displacement map superimposed over the 3D point cloud of the tunnel obtained from the laser scanner coupled with the radar sensor. Using the installation geometry previously described, a spatially continuous map of the tunnel crown and the upper portion of the sidewalls was obtained. The different colors of each

pixel represent the cumulated LOS displacement measured during the period (15 days) after the completion of the stitching and sealing of the main cracks and the installation of suspended steel ribs in the monitored tunnel section. Negative displacement corresponds to a reduction of the sensor-to-target distance and corresponds to an increase in the tunnel convergence, i.e., a reduction of the diameter or a specific chord of the tunnel. The analysis of the map indicates that the LOS displacement of each pixel in the monitoring period analyzed was maintained in the range of  $\pm 1.5$  mm.

In addition to the pixel-by-pixel analysis, to better analyze the displacement patterns retrieved from the monitoring, the tunnel's crown and sidewalls were subdivided into 13 different areas corresponding to specific tunnel sectors. It is worth noting that area #2 was not directly affected by the restoration works since it is enclosed in the recent tunnel extension. For all 13 areas, it was then possible to obtain a specific time series by averaging all the pixels that are included as shown in Fig.4. The time series of the LOS displacement show a direct correlation between the increases in the displacement of some areas, i.e., the onset of the acceleration, and the working phases in the tunnel as highlighted by the pink polygons in Fig. 4. This is particularly evident in areas 3, 7 11 (located at a distance of about 7-8 m from the radar system), and 9 (located at a distance of about 20 m from the radar) where the stitching and sealing of the main cracks and the installation of suspended steel ribs were completed. As can be seen from the camera pictures included in Fig. 4, different kinds of equipment as telescopic handlers and aerial platforms were used to access the tunnel crown and the upper portions of the sidewalls. The machinery remains in the radar field of view for different hours causing some of the spikes which can be seen in the time series. The areas not directly involved in the work (for instance areas 1 and 2) did not show any particular acceleration phase, and the final LOS displacement remained in the range  $\pm 0.2$  mm, i.e., very close to the accuracy of the system.

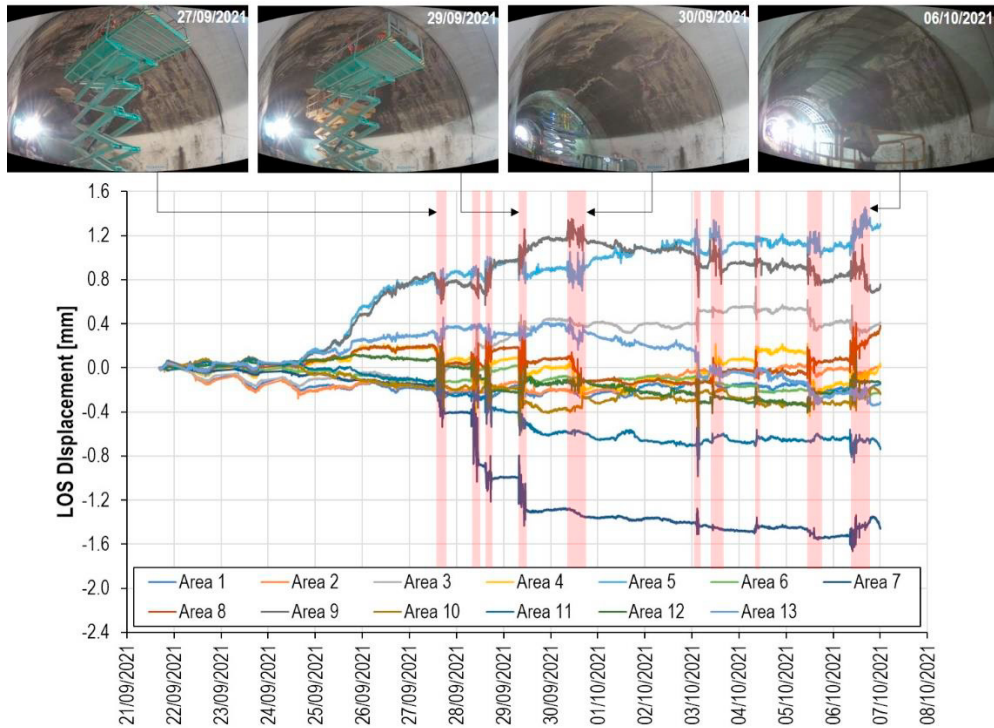
Fig. 4. LOS displacement time series of the 13 different areas of Fig. 3 (15 days) related to the main work phases carried inside the tunnel (pink polygons). Above the graph, some pictures taken by the camera during the work are shown.

It should be noted that the continuous presence of machinery and heavy equipment in the monitored scenario during the main working phases always determines a noise increase in the radar images and therefore in the time series as shown in Fig.4. This effect is caused by the high signal backscattering from the metallic surfaces of the objects that are in the radar field of view. On the contrary, objects passing in front of the radar sensor for a short period do not influence the radar measurements. Therefore, some of the spikes shown in the time series are related to the aforementioned disturbances which could determine a slight overestimation of the LOS displacement.

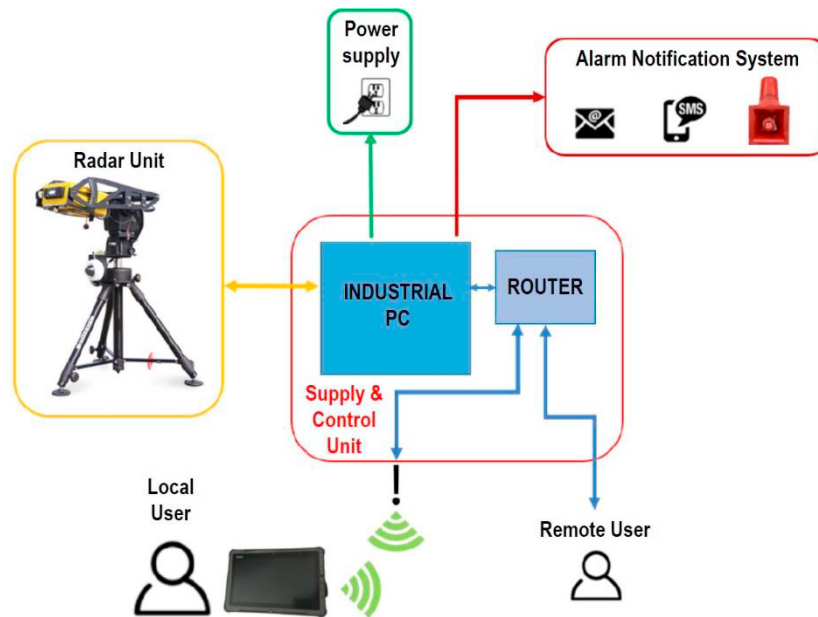
Fig. 5. Schematic outline of an EWS based on GB-InSAR monitoring to be applied to major tunnel rehabilitation works.

The tested GB-InSAR system is already engineered to allow its use for EWS purposes as shown in Fig. 5: the survey unit installed in the tunnel is operated by an industrial PC coupled with a router. Even though the system is equipped with batteries, power supply is required. The system can be managed remotely both by local users through a specific Wi-Fi connection and by remote users through the Internet. The specific software running on the PC manages and controls the radar system and processes in real-time all the acquired data to obtain displacement and velocity maps of the monitored scenario. User-defined displacement or velocity thresholds can be selected to activate the alarm notification system: whenever these thresholds are exceeded email and SMS can be sent to specific recipients and an alarm coupled with a flashing light installed in the work site can be activated. Using this configuration is then

possible to warn the workmanship when anomalous trends caused by sudden lining deformations are detected. To minimize the potential disturbances of the machinery and the equipment in the SAR images and the consequent overestimation of the LOS displacement, the cumulative displacement or the average velocity of selected points or specific areas over short time intervals (6-24h) can be used despite the limitation in reconstructing the complete displacement/velocity time series on the monitored scenario.
