Plasma enhanced chemical vapor deposition (PECVD) of SiO_x thin films on Portuguese limestone: An experimental study

Plasma enhanced chemical vapor deposition (PECVD) of SiO_x thin films on Portuguese limestone: An experimental study / Ding, Y., Grassini, S., Angelini, E., Schiavon, N.. - In: JOURNAL OF CULTURAL HERITAGE. - ISSN 1296-2074. - ELETTRONICO. - 70:(2024), pp. 281-292. [10.1016/j.culher.2024.10.001]

Journal of Cultural Heritage

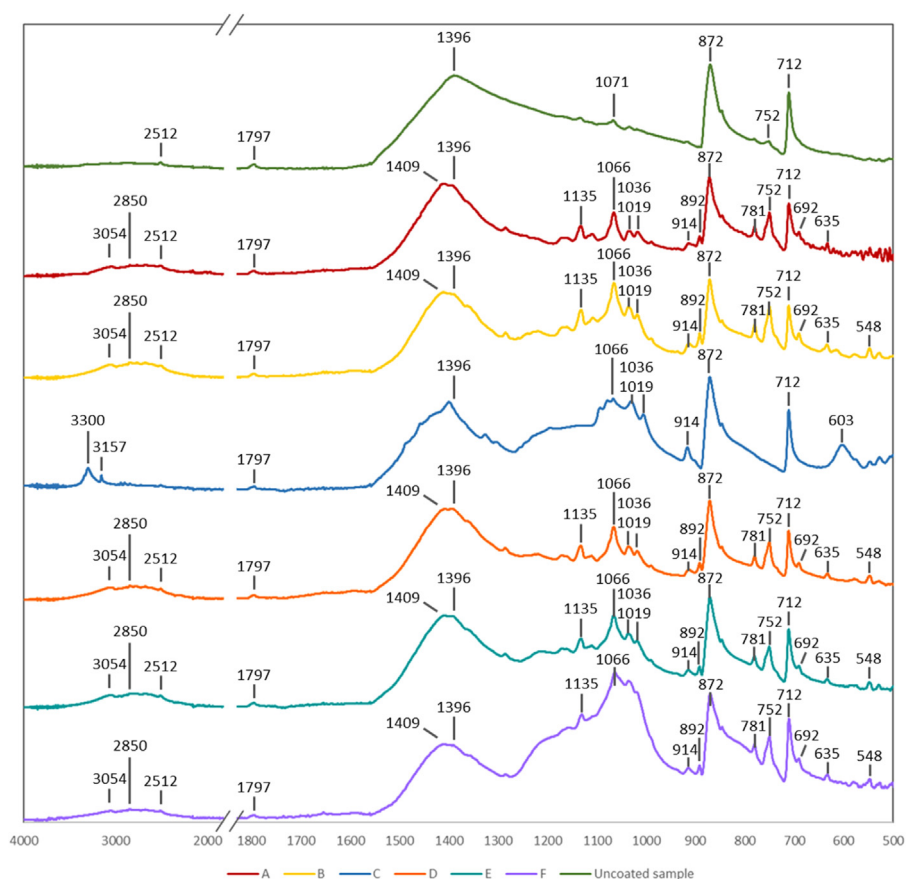
Fig. 3. ATR-FTIR spectra recorded on an uncoated sample and on SiO_x thin film coated samples (A1, B1, C1, D1, E1, F1) in the conditions listed in Table 1.

structure of the deposited layer. Fig. 3 shows the ATR-FTIR spectra recorded on the SiO_x film coated limestone samples (A1, B1, C1, D1, E1, F1) under the experimental conditions shown in Table 1, compared with the spectrum of the uncoated sample surface. Limestone without film deposition was characterized by absorption bands at wavenumbers 2514 cm⁻¹, 1795 cm⁻¹, 1396 cm⁻¹, 872

cm^{-1} , 712 cm^{-1} , which are typical bands of low-magnesium calcite, while the small peak at 1072 cm^{-1} can be attributed to the presence of minor quartz [RRUFF ID: R040070.1] [59,60,61]. FTIR bands at 1070 cm^{-1} and 782 cm^{-1} can be attributed to quartz [RRUFF ID: R040031.1]. On the SiO_x deposited samples, a broad Si-O symmetric stretching peak at 1066 cm^{-1} was detected [62]. The broad curve between 3300 and 2200 cm^{-1} relates to O-H stretching [63]. The peak at 1132 cm^{-1} is associated with the C-O stretching bond [64], and the peak at 781 cm^{-1} is attributed to the stretching mode of the transversal optic phonons ($\text{SiC}(\text{TO})$) and the deformation of Si-CH₃ and a simple stretching of Si-C bond [65,66]. The experimental findings confirm the presence of SiO_x film on the limestone surface, with some of the $-\text{OCH}_3$ groups unreacted from the TEOS precursor. In particular, by increasing the input power and the oxygen content in the plasma, an increase in the features of Si-O-Si is observed, while the presence of Si-C bonds in the film structure decreases, as the increase of power favours the removal of both associated and isolated hydroxyl groups during the deposition process [67].
