Durability of flax textile-reinforced mortar systems / Trochoutsou, N., Baldassari, M., Monaco, A., Cornetti, P., Guadagnini, M.. - ELETTRONICO. - (2024). (Sixth International Conference on Sustainable Construction Materials and Technologies (SCMT6) Lyon (France) 9-14 June 2024) [10.18552/2024/SCMT/327].

## **DURABILITY OF FLAX TEXTILE-REINFORCED MORTAR SYSTEMS**

This paper presents the preliminary results of an experimental programme on the tensile performance of flax-TRM systems subjected to accelerated ageing. Composites consisting of two layers of flax textiles embedded in a lime-based mortar were conditioned in water for 1000 h and 2000 h at controlled temperatures of 23°C and 40°C. Bare textiles were also conditioned in a lime solution for the same duration and temperature conditions to assess and decouple the deterioration mechanisms at the textile and composite scale. The mechanical behaviour of both unconditioned and aged textiles and composites was characterised through uniaxial tensile tests. Based on the preliminary results of this study, the key degradation mechanisms seem to mainly involve the textile reinforcement. The tested FTRM systems exhibited a strength reten

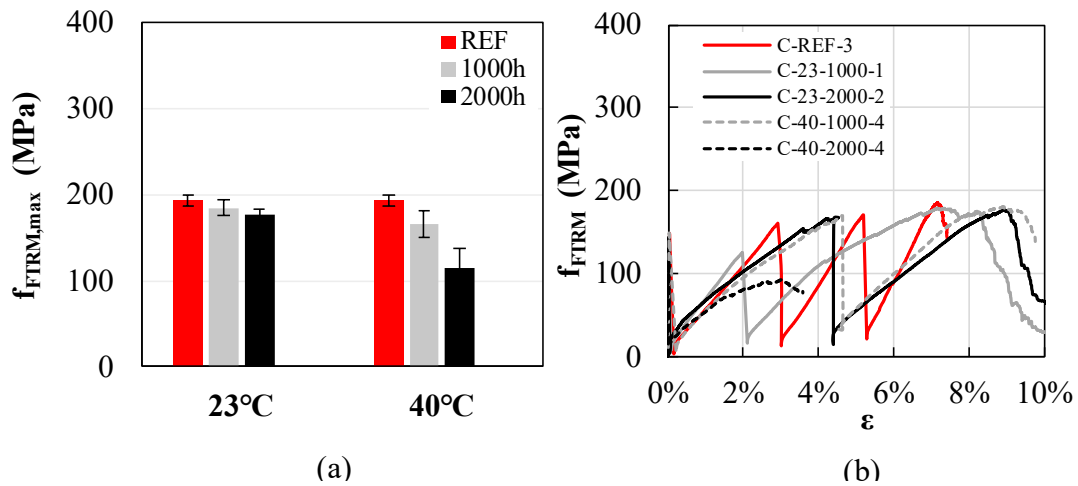
Figure 3. (a) Tensile strength of FTRM composites versus temperature and exposure duration; (b) typical tensile stress-strain of representative specimens from each conditioning protocol

The results of the tensile tests on the FTRM coupons are summarised in Table 3 in terms of average maximum strength at cracking,  $f_{cr}$ , and at failure,  $f_{FTRM,max}$ , corresponding strains,  $\epsilon_{cr}$  and  $\epsilon_{FTRM,max}$ , exploitation ratio of the textile,  $\eta = f_{FTRM,max}/f_{t,max}$ , and strength retention ( $f_{FTRM,max}/f_{FTRM,max(REF)}$ ). The stress was calculated by dividing the load by the cross-sectional area of the textile (accounting for two layers of reinforcement), while the exploitation ratio was calculated as the ratio of the maximum strength developed by the FTRM composite to that developed by the bare textile exposed to the same environment. Figure 3a compares the average values of  $f_{FTRM,max}$ , while Figure 3b shows the tensile stress-strain response of representative composites subjected to the examined conditioning protocols.

In general, accelerated ageing resulted in a loss of tensile strength, which was minimal after exposure to 23°C ( $\leq -10\%$  after 2000 h) and more significant after exposure to 40°C, ( $-40\%$  after 2000 h). Regardless of the conditioning protocol, all specimens failed due to fibre rupture after distinct large cracks were formed in the composites. However, the different exposure conditions affected the crack development stage, with conditioned specimens being characterised by the development of two major cracks, typically close to the gripping tabs, which widened significantly during the test. Exposure to harsher environments (40°C, 2000 h) led to a composite performance with no strain hardening and absence of the crack development stage, indicating that the significant degradation occurring in the fibres, also evidenced by the reduction in the ultimate tensile strength of the composite, resulted in a further reduction of the actual reinforcement ratio.
