Tensile behavior of flax textile reinforced lime-mortar: Influence of reinforcement amount and textile impregnation

Tensile behavior of flax textile reinforced lime-mortar: Influence of reinforcement amount and textile impregnation / Ferrara, G., Pepe, M., Martinelli, E., Tolêdo Filho, R.D.. - In: CEMENT & CONCRETE COMPOSITES. - ISSN 0958-9465. - 119:(2021). [10.1016/j.cemconcomp.2021.103984]

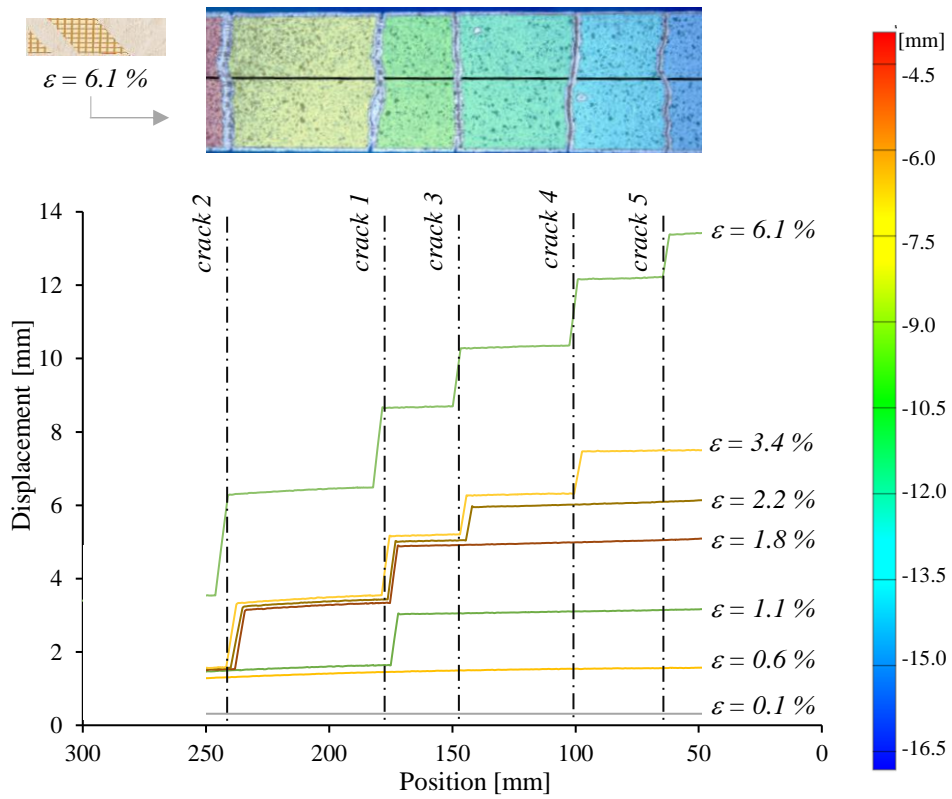
Figure 11. DIC analysis for cracks analysis performed on Flax TRM.

16 Furthermore, a more fundamental analysis is presented based on the Digital Image Correlations
17 (DIC) analysis executed during the tensile tests. A representative example of this analysis is shown
18 in **Figure 11**. The implementation of a DIC analysis leads to identifying the load level at which cracks
19 open, the evolution of **crack numbers** (and, hence, average spacing) and their width development up
20 to failure. **Figure 12** shows, for each series, the evolution of crack spacing during the tests in
21 correlation with the axial strain.

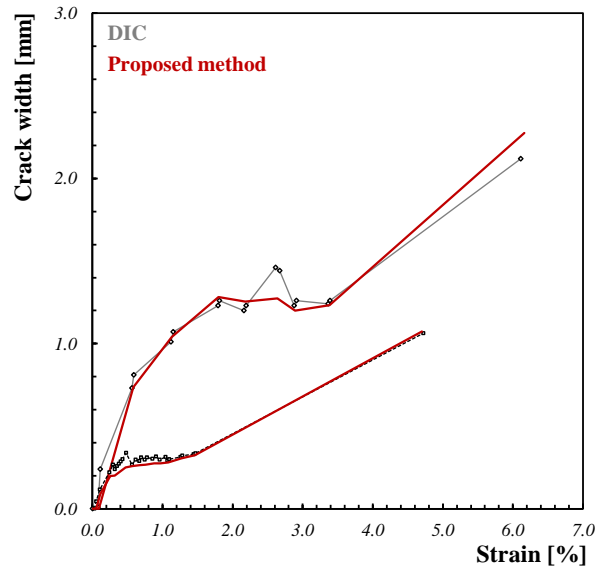
2 **Figure 13.** Crack width evaluation: comparison between the proposed method vs DIC analysis.

1 where ε_1 is the strain value at the transition point between *Stages I* and *II*, L is the free length of the
 2 specimen, $n_{cracks,\varepsilon}$ is the number of cracks developed along the free length at the generic deformation
 3 stage (ε). This relationship was obtained by assuming that the entire elastic deformation of the matrix
 4 to be exploited during the *Stage I*, and that in the next *Stages II* and *III*, the axial displacement is
 5 entirely due to the deformation of the textile. This assumption well suits the case in which the flax
 6 textile is characterized by a significantly lower stiffness with respect to the hydraulic lime mortar
 7 matrix. The accuracy of the adopted procedure is confirmed by comparing the average crack width
 8 development obtained with both the presented eq. (1) and the DIC analysis (**Figure 13**).

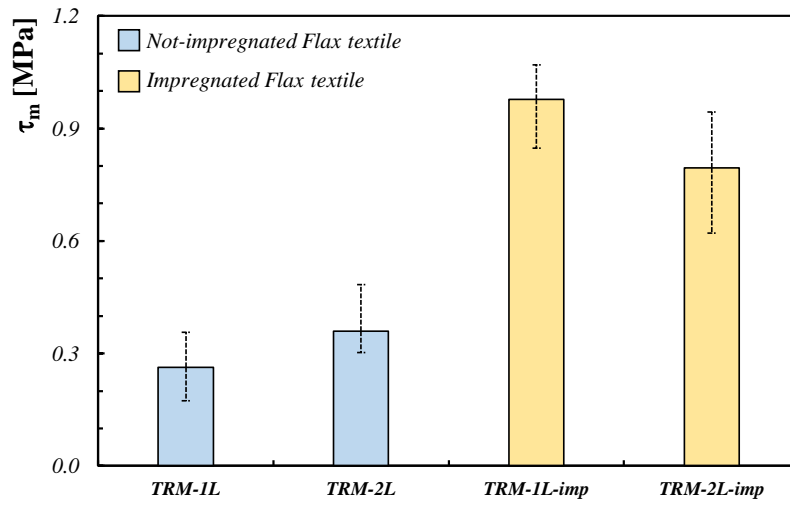
8 The histograms in **Figure 17** clearly show that the impregnation treatment performed on the
9 Flax textile significantly improves the bond of the reinforcement embedded within the lime-based
10 matrix. It was found that the τ_m is around three times higher in the case of impregnated TRM series.
11 The quality of the proposed estimation is confirmed by the fact that the bond strength calculated with
12 the above-mentioned procedure is almost independent from the reinforcement ratio (i.e., 1 or 2 layers
13 of flax textiles) but it is governed by the adoption of the impregnation process.
