Tensile behavior of flax textile reinforced lime-mortar: Influence of reinforcement amount and textile impregnation

Tensile behavior of flax textile reinforced lime-mortar: Influence of reinforcement amount and textile impregnation / Ferrara, Giuseppe; Pepe, Marco; Martinelli, Enzo; Tolêdo Filho, Romildo Dias. - In: CEMENT & CONCRETE COMPOSITES. - ISSN 0958-9465. - 119:(2021). [10.1016/j.cemconcomp.2021.103984]

6 *In this context, this paper investigates the mechanical properties of a Textile-Reinforced Mortar (TRM)*
7 *system produced with Flax textile embedded within a hydraulic lime-based mortar. The research aims at*
8 *revealing the influence of either the reinforcement amount and the applied pre-treatment of the textile on the*
9 *resulting tensile response and the cracking patterns exhibited by these TRM systems. The analysis of the results*
10 *presented herein allows to have a comprehensive overview of the feasibility of using flax textiles for*
11 *strengthening a retrofitting of existing structures.*

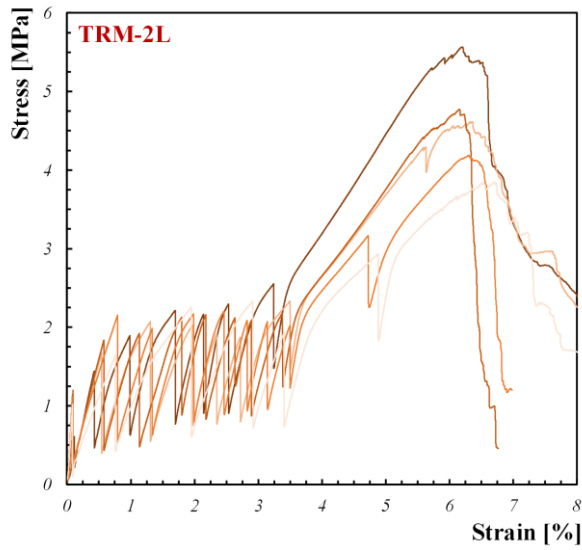
1 **Figure 8.** Stress-strain response for (a) Flax TRM-1L, (b) Flax TRM-1L-imp, (c) Flax TRM-2L and
 2 (d) Flax TRM-2L-imp.

21 The stress-strain curves reported in **Figure 8** can be identified by means of some relevant
22 parameters such as normal maximum stress σ_{max} , the strain at failure (ε_{max}) corresponding to the
23 maximum load (P_{max}) and maximum displacement (d_{max}) respectively, and, the maximum stress
24 achieved in the textile at failure ($\sigma_{max,txt}$) and the failure mode (either A, or B). The average value, as
25 well as the coefficient of variation (cv) obtained in the present study, are summarized in **Table 3**.

13 The stress-strain response concerning the series *Flax TRM-1L* (**Figure 8a**) is characterized by a first
14 linear branch followed by either one or two significant drops in load, corresponding to the occurrence
15 of cracks in the matrix. A premature failure mode occurred due to a slipping of the textile in one of
16 the gripping areas of the specimens.

17 The stress-strain curves concerning the series *Flax TRM-2L* (**Figure 8b**) exhibited a behavior
18 comparable to the typical tri-phase response of TRMs in tension described in Section 3.2. For this
19 series, the failure mode was characterized by the tensile failure of the textile in one of the sections in
20 proximity of the plates in the gripping area. Unavoidably, due to absence of clamping systems at the
21 edges of the specimens, a partial slipping of the textile in the gripping areas must have occurred as
22 well.

6 The stress-strain curves for either the Flax *TRM-1L-imp* (**Figure 8c**) and Flax *TRM-2L-imp*
7 (**Figure 8d**) highlight that, due to the lower stiffness of the textile (with respect to the mortar) at low
8 strain levels, the *Stage II* was characterized by a significant drop in load corresponding to the
9 occurrence of a crack within the matrix. In both series the failure occurred with the rupture of the
10 textile yarns (*mode A*).

10 The stress-strain response of Flax *TRM-1L* (**Figure 8a**) and Flax *TRM-1L-imp* (**Figure 8c**) series
11 emphasized a different mechanical behavior of the two systems showing that the use of impregnated
12 textile affected the mechanical behavior in tension. Flax *TRM-1L* specimens are characterized by the
13 development of either one or two cracks (**Figure 8a**), and by a failure mode due to the loss of textile-
14 to-matrix bond in the gripping areas, while Flax *TRM-1L-imp* specimens are characterized by a clear
15 three-phases response with a much higher number of cracks developed in the *Stage II*, and a failure
16 mode with the rupture of the textile (**Figure 8c**).

6 Regarding the TRM with 2 textile layers, the Flax *TRM-2L* (**Figure 8b**) and Flax *TRM-2L-imp*
7 (**Figure 8d**) series show a stress-strain curve characterized by the three stages, in which the
8 occurrence of cracks causes significant drop in loads and the failure occurs with the tensile rupture
9 of the textile in a section in proximity of the gripping area. P_{max} value was about 10% lower in the
10 *TRM-2L-imp* series when compared to the *TRM-2L* one (**Table 4**). This is due to the lower tensile
11 strength of the impregnated flax textile with respect to the dry textile. Indeed, the two systems showed
12 similar efficiency in terms of exploitation ratio, with a main value of 59% and 65% respectively for
13 the series *TRM-2L* and *TRM-2L-imp* (**Figure 9c**).
