THE BUILDING MATERIALS OF THE LORENESE FORTS OF THE TUSCAN COAST

Silvia Rescic, Fabio Fratini, Manuela Mattone

Abstract: This work examines the natural and artificial stone materials (mortars and bricks) used in the construction of the fortifications realized by the Grand Duke of Tuscany Pietro Leopoldo between 1786 and 1793 along the Tuscan coast. The aim is to verify the possible relationship between the materials used and the stone resources and raw materials (clays for bricks and limestone for the production of lime) of the individual territories, or to ascertain a standardised use of materials, with origin from a single production centre. Furthermore, the state of conservation of these fortifications in relation to decay phenomena will be examined, trying to highlight the influence of environmental factors and the characteristics of the stone materials.

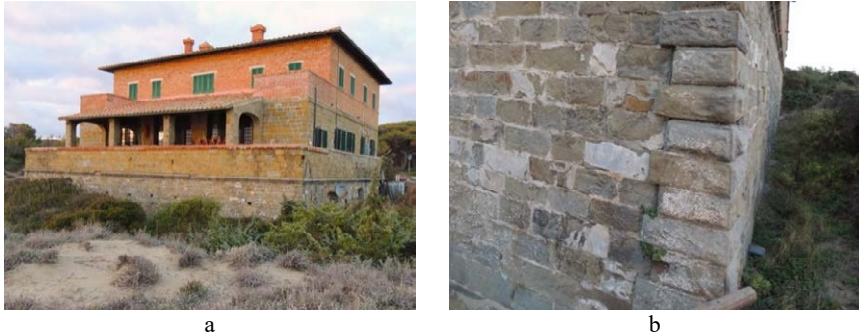
The building is located at the back of a low coastal dune, about 20 metres from the shoreline. The complex is composed by two adjoining buildings. The first consists of a bastion facing the sea, with a scarp at the base, above which there is a terrace covered by a loggia with a sloping roof (Fig. 3a). The second, at the rear, is a building with a square plan covered by a four-sloping roof. The rampart of the bastion, partially covered by sand, is made up of well-cut Pietra Serena sandstone ashlar. A stringcourse in the same material separates the rampart from the parapet wall, made of well-cut sandstone blocks of Pietra Bigia [12]. The crowning of the parapet is made of knife-laid bricks. The corners of the

bastion are in rusticated Pietra Serena. The building behind it is made up of ashlar of Pietra Bigia on the first floor and bricks on the second floor. Pietra Bigia was also used for the columns of the loggia. The sandstone ashlars, when not protected by calcite veins, are strongly eroded (Fig. 3b). The bedding mortar joints, with a thickness of $0.5 \div 1$ cm, generally exhibit a high degree of cohesion.

Figure 3 – Forte delle Marze (a); detail of the Pietra Serena ashlars of the bastion scarp wall (b).

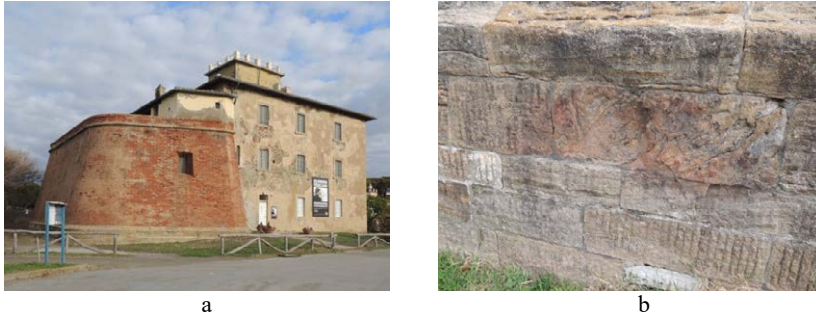
The bricks of the south-facing bastion are often spalling and honeycombed with eroded mortar joints. In some places, particularly in the south-eastern corner, they have been replaced. The Pietra Panchina of the rampart kerb and the stringcourse cornice are generally in good condition. However, exfoliation

phenomena can be observed when the ashlars are laid parallel to the surface of the masonry (Fig. 4b). Some replacements and cement additions are also evident.

Figure 4 – Forte di Marina di Bibbona (a); particular of exfoliation phenomena caused by improperly installed Pietra Panchina (b).

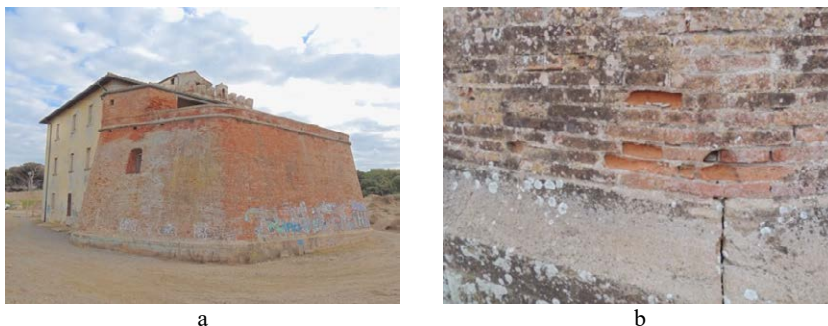
The bricks and the Pietra Panchina of the lower part of the bastion have been affected by graffiti. They are both very porous materials, and a cleaning operation is hardly able to remove them. Regarding natural decay, the bricks on

the south-facing side of the bastion are often heavily eroded or showing spalling and honeycombing phenomena. Erosion affects also many mortar joints and there are numerous incongruous interventions such as reintegration of the joints and filling of missing bricks made with cement mortar. The part of the bastion facing north-east is covered with lichen (Fig. 5b). The Pietra Panchina of the rampart kerb and the stringcourse cornice are generally in good condition, and often the surface finish of the ashlar with ribbon and vertical grooves is still visible.

Figure 5 – Forte di Marina di Castagneto (a); particular of biological growth phenomena (lichens) and brick erosion (b).
