THE BUILDING MATERIALS OF THE LORENESE FORTS OF THE TUSCAN COAST

Abstract: This work examines the natural and artificial stone materials (mortars and bricks) used in the construction of the fortifications realized by the Grand Duke of Tuscany Pietro Leopoldo between 1786 and 1793 along the Tuscan coast. The aim is to verify the possible relationship between the materials used and the stone resources and raw materials (clays for bricks and limestone for the production of lime) of the individual territories, or to ascertain a standardised use of materials, with origin from a single production centre. Furthermore, the state of conservation of these fortifications in relation to decay phenomena will be examined, trying to highlight the influence of environmental factors and the characteristics of the stone materials.

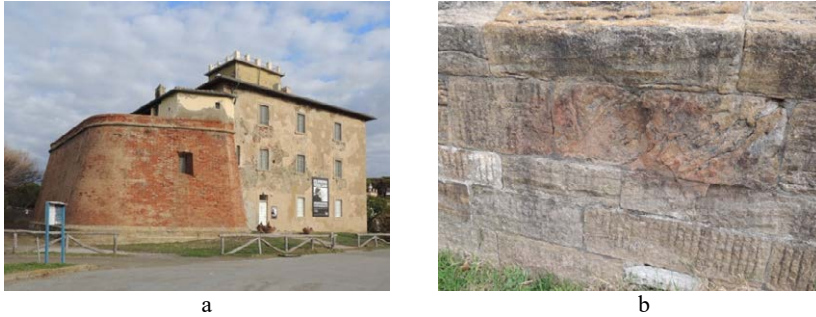
The bricks of the south-facing bastion are often spalling and honeycombed with eroded mortar joints. In some places, particularly in the south-eastern corner, they have been replaced. The Pietra Panchina of the rampart kerb and the stringcourse cornice are generally in good condition. However, exfoliation

phenomena can be observed when the ashlars are laid parallel to the surface of the masonry (Fig. 4b). Some replacements and cement additions are also evident.

Figure 4 – Forte di Marina di Bibbona (a); particular of exfoliation phenomena caused by improperly installed Pietra Panchina (b).

result of the forts' new environment, brought about by the retreat of the coastline. These include biological growth. Some forms of decay are also due to human activity, such as the improper installation of stone ashlar or the destructive actions of vandals who have defaced the masonry with graffiti.
