Studies on Shape Optimization of Repair Patches for Damaged Composites

## STUDIES ON SHAPE OPTIMIZATION OF REPAIR PATCHES FOR DAMAGED COMPOSITES

**Abstract.** *Due to the increasing development of health monitoring and damage detection techniques, the assessment of damage presence and its shape is a viable option to continuously evaluate the structural integrity of composite components. Along with such tool, one could employ repair patch techniques in order to restore, or locally improve, the originally designed strength of a damaged composite component. This approach would imply in the use of a composite repair patch capable of increasing the stiffness of a damaged component with minimal material addition, resulting in the minimization of costs with component replacements and extend the structures life. In this context, the present work exposes initial studies concerning simple repair shapes optimization applied to damaged composite materials. The main objective of this research is to propose an optimization procedure capable of specifying suitable patch shapes to be applied in a pre-assessed damaged area of a laminated component. The optimization formulation was defined conside

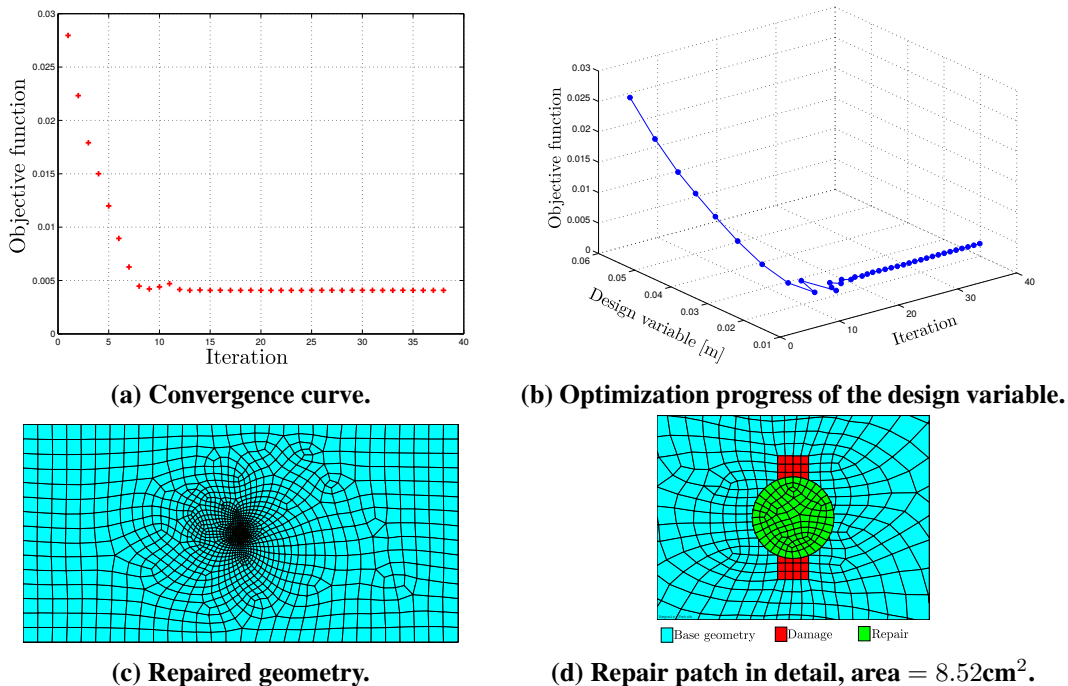
Considering the geometry of Fig. 1, the optimized circular repair patch shape obtained is presented in Fig. 3. Convergence curve, design variable evolution are presented as well.

Figure 3: Optimum configuration with circular repair  $R = 16.47\text{mm}$ .

The circular repair shape that minimizes the objective function has a total area equal to 8.52cm<sup>2</sup>. Note that the damage area was not fully covered by this patch. This indicates that a wider circle patch implies in excessive mass gain.

The length of damaged area covered by both repair patches, circular and square, was practically identical. Due to the geometrical restriction imposed by the predefined patch shapes, the complete damage overlay was not achieved. Once the objective function of Eq. 1 takes into account the modal response of the structure, the increasing of the component stiffness by means of material (repair) addition also impose the increment of inertia. This implies in the need of equilibrium between repaired components stiffness and mass. The lack of material distribution in the extremes of the damage area directly implies in stress concentration. However, considering that the employed optimization formulation does not focus on SIF reduction, this is an expected outcome.

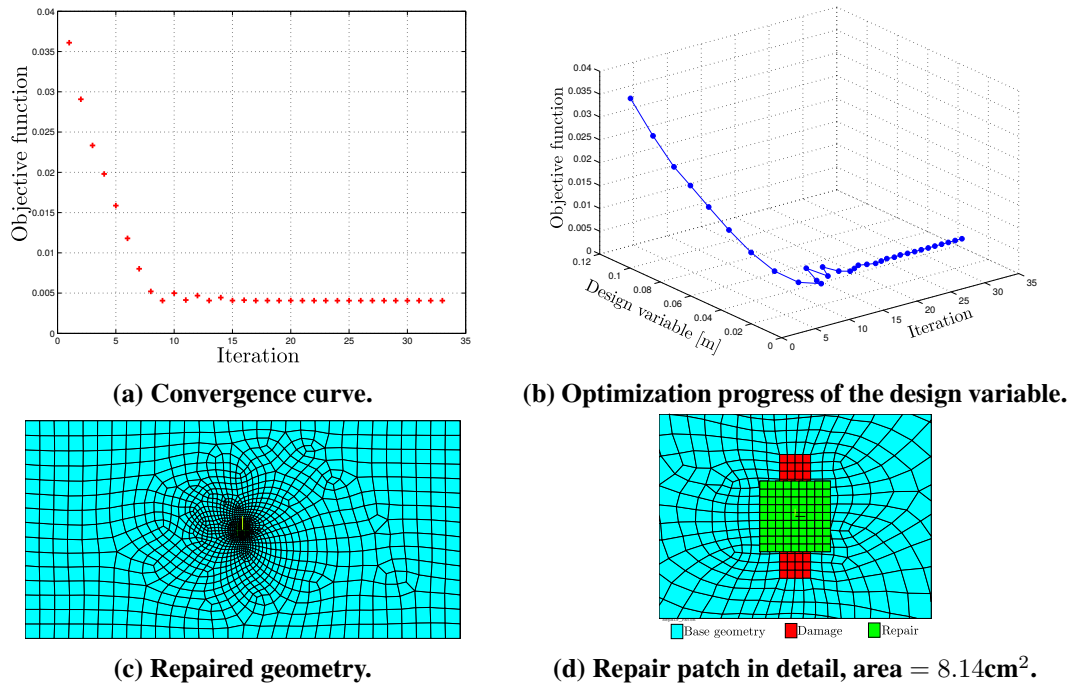
Figure 4: Optimum configuration with square repair with side  $l_r = 28.53\text{mm}$ .

Analogously to the case of a circular repair patch, the optimization algorithm was applied to a square repair patch. The optimized configuration for this patch shape is presented in Fig. 4. Once more, the convergence curve and design variable evolution are presented as well.

The square repair shape that minimizes the objective function has a total area equal to 8.14cm<sup>2</sup>, which is approximately 4.5% less than the circular repair area. Similar to the results for the circular patch, the damage area was not fully covered by this repair geometry.
