Effectiveness of Nanotechnology Treatments in Composite Aircraft Applications

Abstract: This paper aims to verify the effectiveness of a process of superficial protection based on nanotechnologies produced by 4Ward360 and specifically developed for aeronautical applications on composite material aircraft. The Dardo aircraft, a composite VLA category manufactured by CFM Air, was taken as a reference case and two application/investigation areas were identified. The potential anticorrosive behavior of the nanotechnology treatment was investigated when applied to the metal joints of the aircraft, such as the wing–fuselage attachments usually made of Al-2024-T3 aluminum alloy. Furthermore, the potential increased effectiveness in cleaning was investigated as another possible application concerning the parts made of composite material both solid and in a sandwich configuration and the plexiglass parts of the canopy.

Keywords: composite aircraft; nanotechnology treatment; corrosion; fatigue life

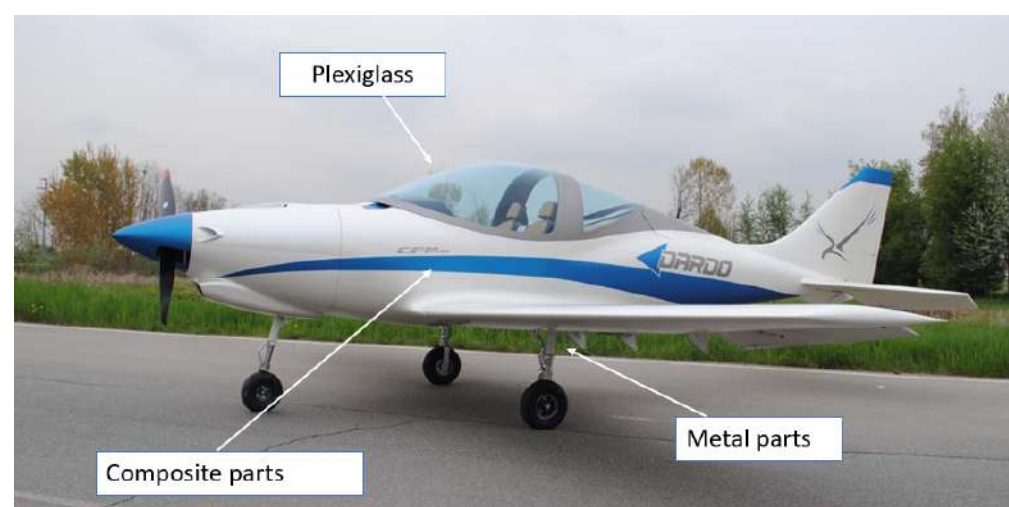
The Dardo aircraft (Figure 1) is a light aircraft designed to operate from short fields as are typically found in logistically austere environments. It is able to operate up to a service ceiling of 12,000 ft, and never exceeds a speed of 170 KCAS. It must also carry a max fuel content of 80 Kg that allows for an endurance of 4 h. The nominal range is in the order of 350 NM.

Figure 1. Dardo aircraft.

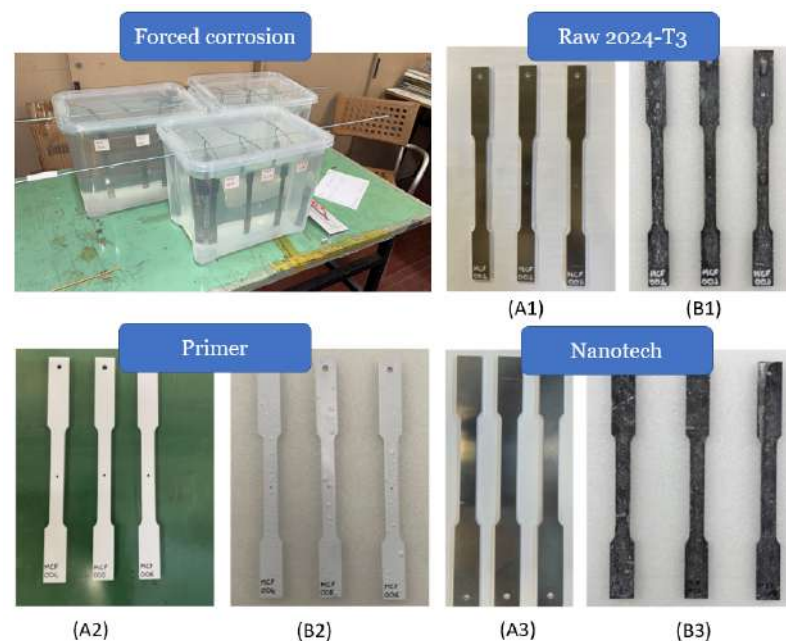
In image (A) of Figure 3, it is possible to observe the aluminum specimens marked with the identification code, before immersion in the bath and in (B) immediately after the phase of extraction from the corrosive bath. A loss of luster was noted for the raw aluminum specimens, a darker coloring and the presence of numerous encrustations of salt as well as a lower smoothness to the touch. A loss of luster was noted for the Al-primer together with surface bubble formation as previously mentioned. Finally, for the specimens treated with nanotechnologies, a loss of luster of the metal and a darker coloration were noted but with less formation of salt encrustations. Also in that case, a reduction in smoothness was found.

Figure 3. Specimens: (A1–A3) before corrosion; (B1–B3) after corrosion. “Raw 2024-T3”: aluminum without corrosion protection; “Primer”: aluminum treated with a standard primer; “Nanotech”: aluminum treated with nanotechnology.

In the three tanks, it was possible to observe some important characteristics: all three tanks showed an accumulation of sodium chloride at the bottom in correspondence to each sample, as if each one had attracted the salt to itself, which had no way of adhering completely to the metal surface, precipitating into the solution. It should be noted that the solute accumulations were more consistent in the untreated raw aluminum specimens and in the nanotechnology-treated ones, while on those treated with the primer, there were no traces of salt evidence, but they could already show bubbles of the surface treatment.

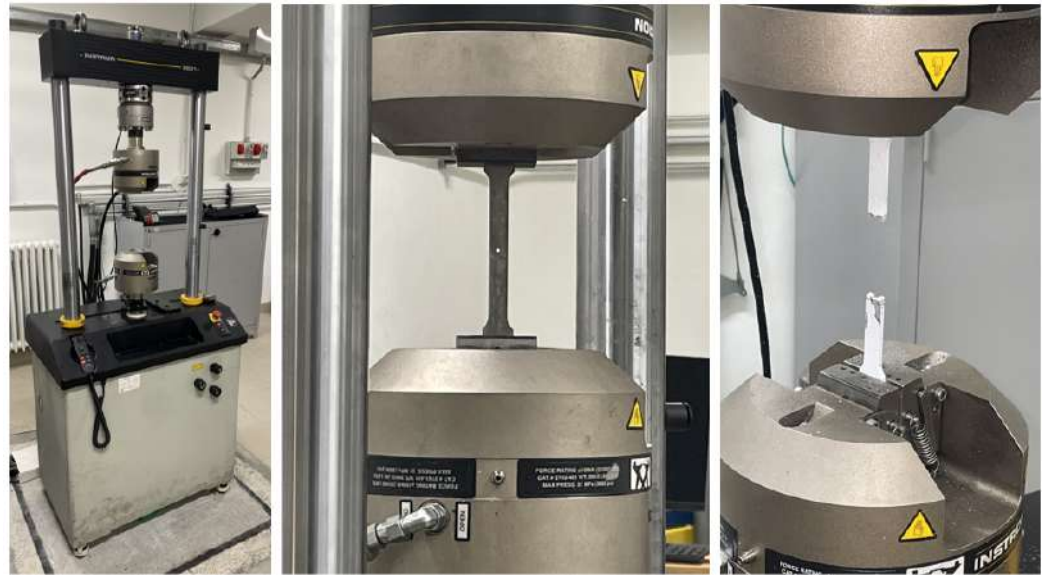
The INSTRON 8801 machine (Figure 4), available at Politecnico di Torino-DIMEAS structural laboratories, was used to carry out the fatigue tests. In addition to the 9 specimens subjected to corrosive treatment, the other 4 specimens were added, bringing the total of those mechanically tested to 13 in order to have a direct comparison between the same types of surface coatings with the only discriminating factor being the corrosive process undergone. All the samples reported in Table 2 were subjected to the fatigue test, highlighting those that underwent the corrosive process. Table 2 also shows the three selected load levels, the maximum and minimum force of the applied cycle, and the frequency of load application. The need to conduct fatigue tests, operating with three different load levels, arises from the need, albeit with the limitation of the reduced number of specimens, to approach the definition of the S-N curves [10,16].

Figure 4. Specimen installed in the fatigue test machine.

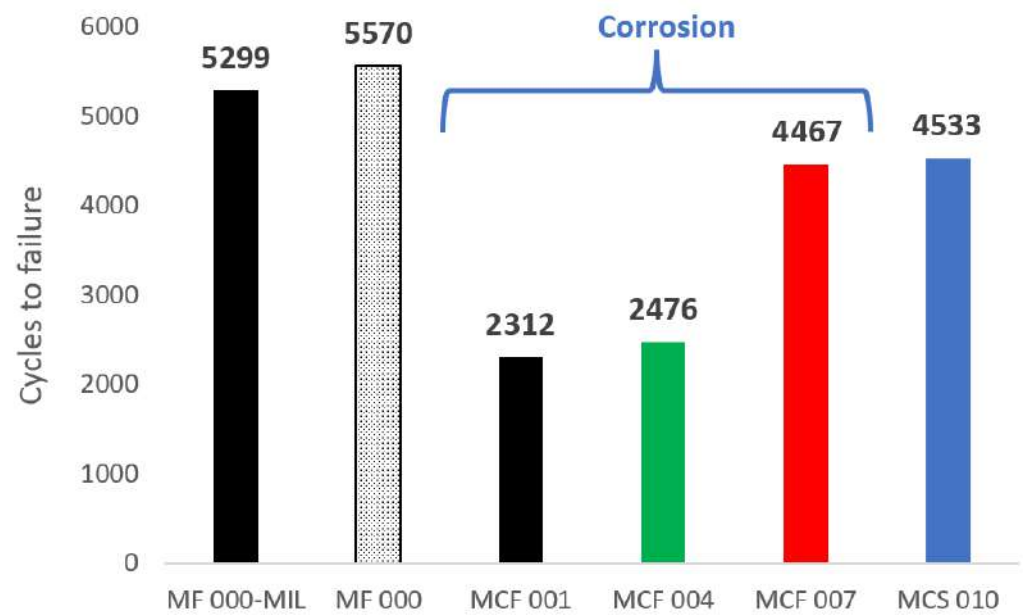
Figure 5 presents the number of cycles to failure of the specimens subjected to load type 1 corresponding to $F_{max} = 11$ kN, $F_{min} = 0$ kN, and a frequency of $f = 5$ Hz. The specimens subjected to corrosion are also indicated. For this load, we note a significant reduction in fatigue life for the untreated MCF001 specimen and also for the Al-Primer specimen (MCF04) compared to the uncorroded case MF000, demonstrating the evident reduction in fatigue life due to the corrosion effect. The specimen treated with nanotechnologies (MCF007) in this case had a very similar behavior to that of the specimen of the same category not subjected to the corrosion process (MCS10), demonstrating an increased protective property against corrosion with an increase in fatigue life of +48% compared to raw Al, of +44% with respect to Al-Primer, and a small reduction of −1.44% when considering the uncorroded Nanotech specimen.

Figure 5. Load type 1: $F_{max} = 11$, kN $F_{min} = 0$, and kN $f = 5$ Hz.

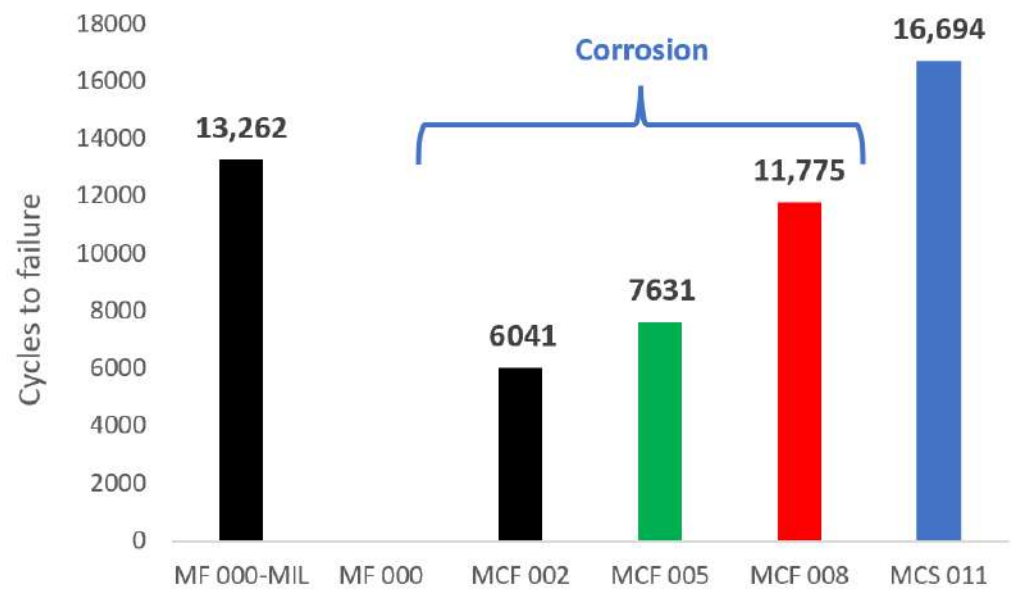
The results relating to the intermediate load level indicated with type 2 and corresponding to $F_{max} = 9$ kN, $F_{min} = 0$ N, and a frequency of $f = 5$ Hz are shown in Figure 6. Also in this case, an excellent behavior of the specimens treated with nanotechnologies and subjected to the corrosion process can be noted. In particular, the MCF008 specimen had an increase in life of +48% compared to raw aluminum (MCF002), +35% compared to the specimen treated with primer (MCF05), and a reduction of −29% compared to the specimen treated with nanotechnology but not corroded (MCS11). Finally, considering the lowest load level indicated in Figure 7 with type 3 and corresponding to a cycle defined by $F_{max} = 6$ kN, $F_{min} = 0$ N, and a frequency of $f = 5$ Hz, we still noticed a better behavior of the specimen treated with nanotechnologies albeit reduced compared to the previous case. In this case the MCF009 specimen had an increased fatigue life compared to raw aluminum (MCF003) of +39%, while compared to the primer (MCF006), the life increase was 33%, and the reduction compared to the uncorroded case (MCS012) increased to −66%.

Figure 6. Load type 2: $F_{max} = 9$ kN, $F_{min} = 0$ kN, and $f = 5$ Hz.

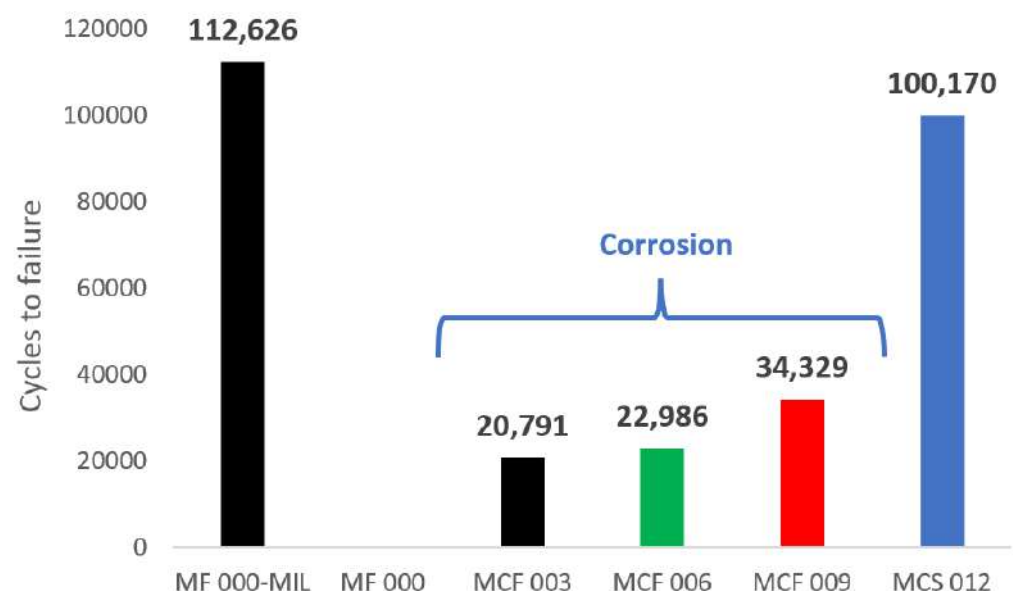
Figure 7. Load type 3: $F_{max} = 6$ kN, $F_{min} = 0$ kN, $f = 5$ Hz.

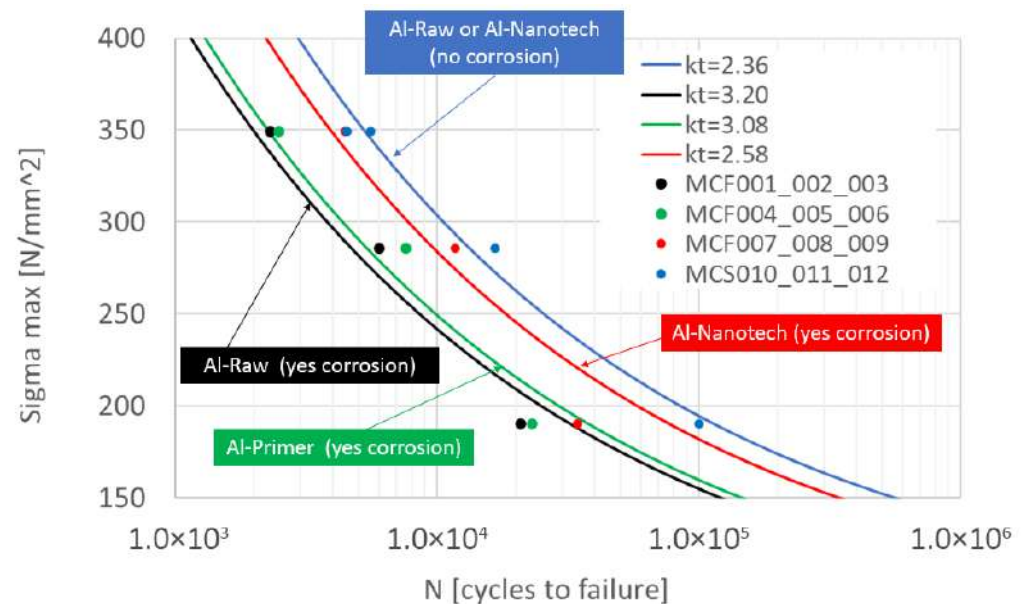
Figure 8 shows the S-N curves considered for the different cases discussed. In blue are the specimens not subject to corrosion, in black are the corroded and unprotected specimens, in green are the specimens protected with primer, and finally, in red are the specimens protected with nanotechnologies and subjected to the corrosion test. In all specimens subjected to corrosive immersion, a greater effect of corrosion was observed at lower loads (load types 2 and 3), confirming not only an increase in the stress concentration factor (kt) but also a change in the slope, as indicated also in [9].

Figure 8. S-N curve: blue: no corrosion; black: corroded specimens; green: primer protection; red: nanotechnology protection.

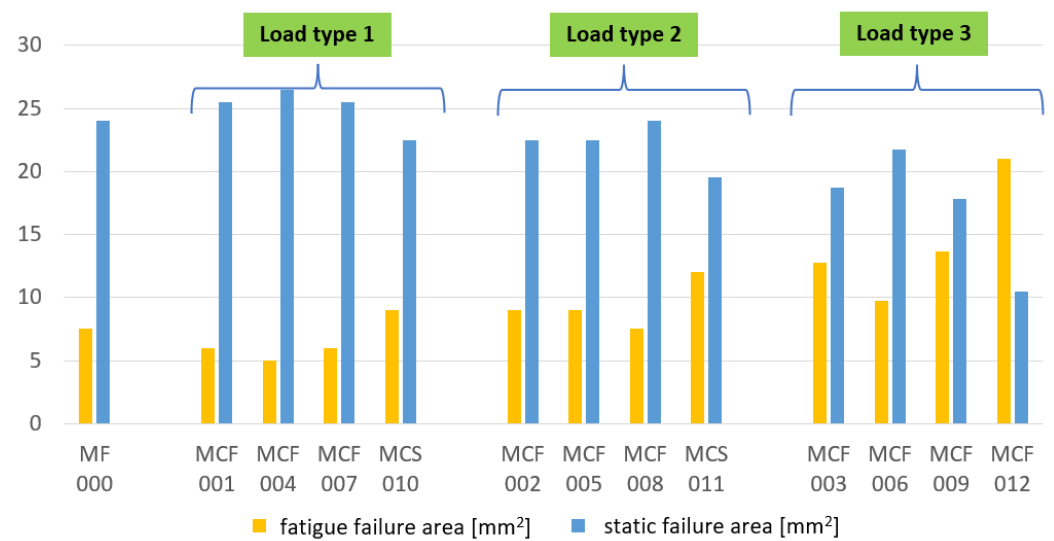
From Figure 9, where the results are divided by specimen category, it is possible to observe that, as could be expected, the extent of the fatigue failure section was more significant when the specimen under consideration was subjected to a lower stress: a lower mechanical load means a higher number of cycles, therefore a greater failure area due to fatigue. The graph also highlights what has already been observed previously: in each group of specimens, the best resistance to mechanical stress was always obtained with nanotechnology coating protection.

Figure 9. Comparison of failure areas for each type of load.

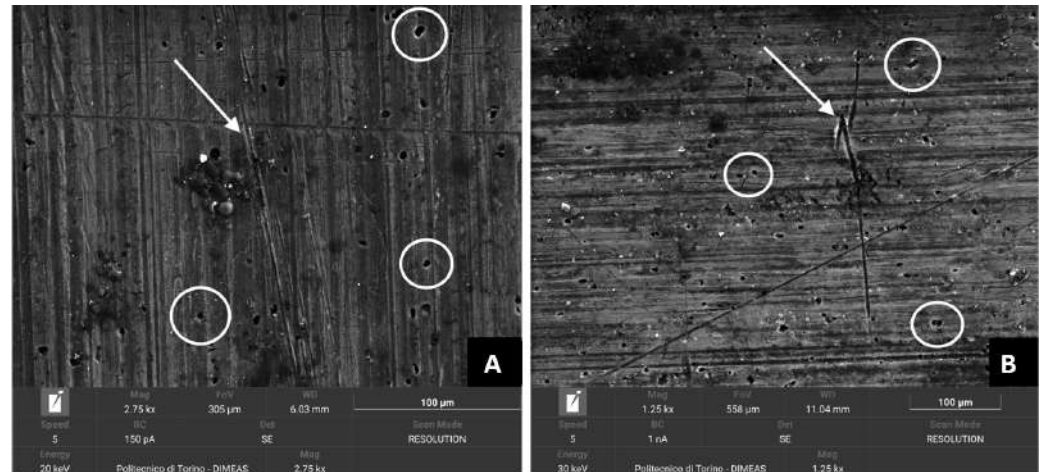
Considering the limited number of specimens considered in this study and observing Figure 11, it can be cautiously stated that at the same magnification, the corroded specimen, MCF 008, had the same number of holes and imperfections as the uncorroded one, MCS 012, both treated with nanotechnology, and only increased in size. The raw aluminum samples showed notable differences: an increase in the number of imperfections in the corroded sample, MCF 002, compared to its uncorroded counterpart, MF 000. This aspect shows a general improvement in the ability to resist corrosion for the nanotechnology-treated specimens.

Figure 11. Specimen surfaces MCF 008 (A) and specimen MCF 012 (B).

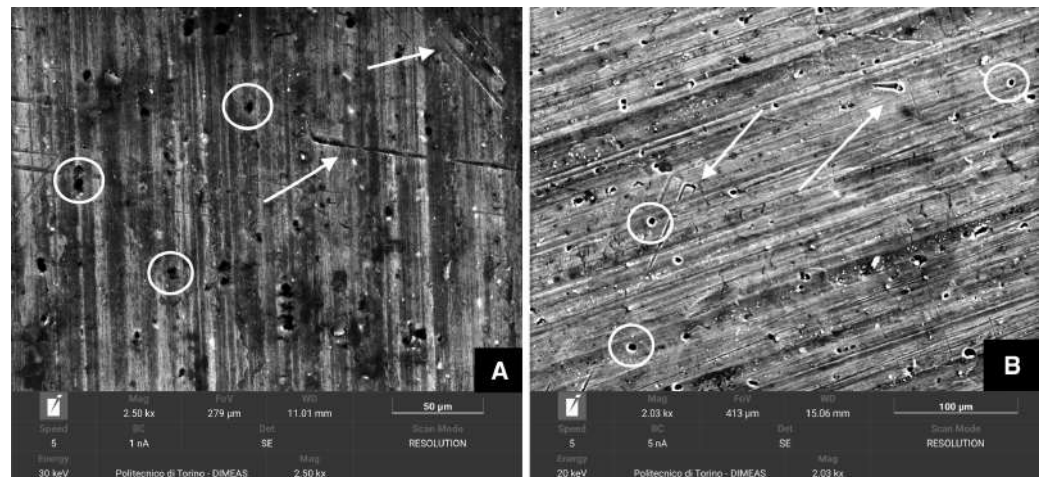
The analysis conducted by an SEM microscope provided better evidence of how corrosion affected the surface finish of the metal: to observe the same type of damage related to the machining and fabrication of the metal specimens, the corroded raw aluminum specimen, MCF 002, was analyzed at a lower magnification, compared to the uncorroded raw aluminum specimen, MF 000, see Figure 12.

Figure 12. Specimen surfaces MF 000 (A) and specimen MCF 002 (B).

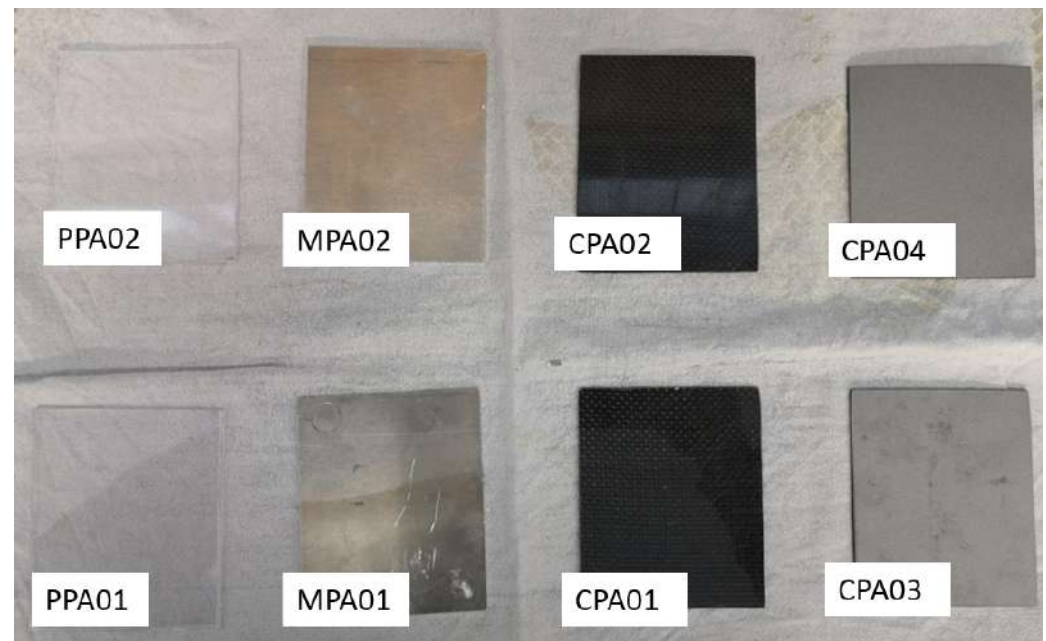
Table 4 and Figure 13 show the specimens subjected to cleaning tests.

Figure 13. Specimens under cleaning tests, see Table 4 for label definitions.

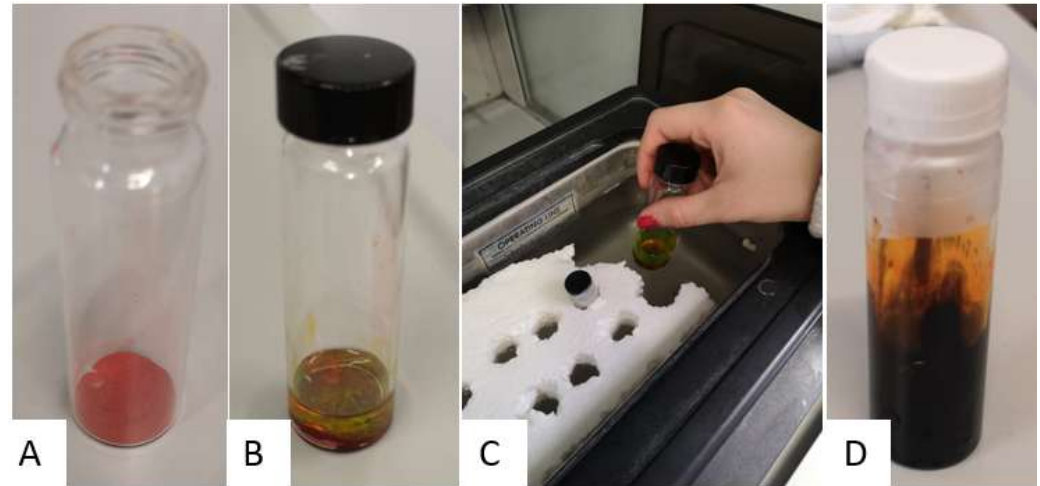
The fouling agent was a mixture consisting of 98% polyethylene glycol (PEG 400), 1% black dye, and 1% sodium fluorescein (Figure 14A). Sodium fluorescein was combined

with polyethylene glycol inside a small container (Figure 14B) and the mixture was made homogeneous by means of an ultrasound sonicator alternating mixing periods with stop periods (Figure 14C). Last, the black dye was added. The mixture thus produced had to be stored in the sealed container for at least one night before use (Figure 14D).

Figure 14. Fouling solution preparation: (A) sodium fluorescein (B) mixture of 1% sodium fluorescein and 98% of PEG400 (C) ultrasound sonicator (D) final mixture with addition of 1% black dye.

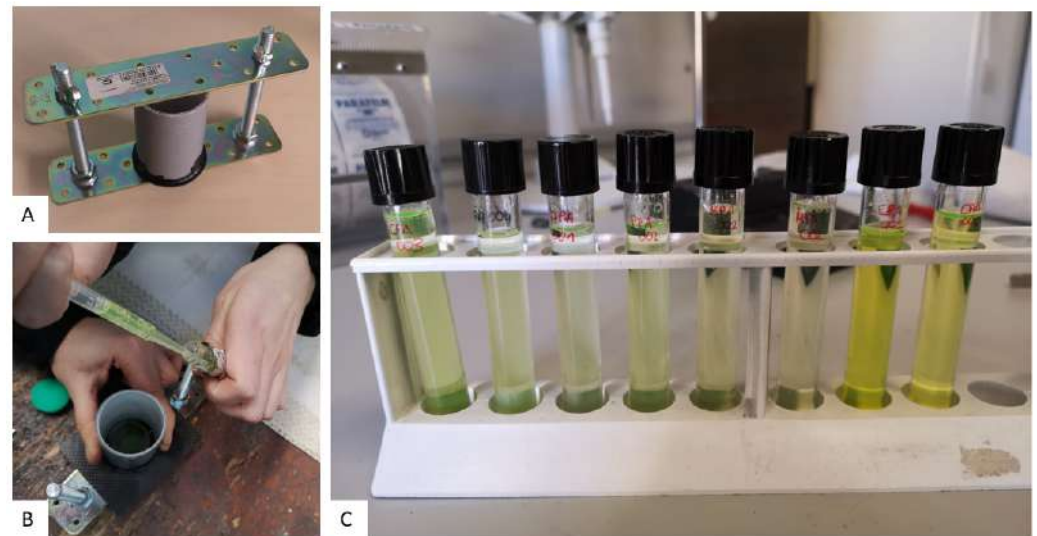
The procedure for removing the residual dirt, often barely visible, from the central portion of the specimen on which the fouling/cleaning procedure was carried out was then started. To do this, 10 mL of distilled water was introduced into the extraction device within 30 min of the fouling procedure, respecting some indications given by the regulation. The first specimen was placed face up within the clamp frame of the extraction fixture. The sealed tube was then placed in the center of the specimen, so that the seal defined the solution extraction area. Once the tube had been locked in the frame with a slight pressure generated by the screwing of the wing nuts, 10 mL of distilled water was added, stirred, and left to rest for 3 min. Finally, with a Pasteur pipette, a portion of the solution obtained was inserted into the test tube, correctly labeled, and placed on the rack, while the subsequent samples were extracted.

Figure 16. Extraction of residual dirt: (A,B) extraction fixture; (C) test rack with solution samples.

With the same amount of time to carry out the cleaning procedure, it can be noted that the Al2024 sample treated with nanotechnologies had a 16% increase in dirt removed, and the raw carbon treated with nanotechnologies had a 7% increase in dirt removed. The painted carbon treated with nanotechnologies had a 15% increase in dirt removed. Finally, the plexiglass treated with nanotechnologies had a decrease in dirt eliminated of 23%. Despite the apparently negative result obtained on the plexiglass, the results obtained on the composite and on the metal are promising in terms of efficacy of nanotechnology in terms of cleaning improvement. Likely, the ability of surfaces treated with nanotechnologies to be easier to clean (at least for CFC and Al2024) is due to the hydrophobicity characteristic that silicon nanoparticles are capable of attributing to the substrate on which they are applied. This property is also observable in Figure 15 where a visual comparison is made on the distribution of dirt in one treated and one untreated specimen. Extraction of the residual dirt and solution samples preparation is shown in Figure 16.
