Recovering the heritage and building traditions of the village of Tacora, Chile

Recovering the heritage and building traditions of the village of Tacora, Chile / Bocci, Martina; Yuste, Beatriz. - In: JOURNAL OF TRADITIONAL BUILDING, ARCHITECTURE AND URBANISM. - ISSN 2660-5821. - STAMPA. - 1:1(2020), pp. 235-240. [10.51303/jtbau.vi1.343]

Martina Bocci, Beatriz Yuste

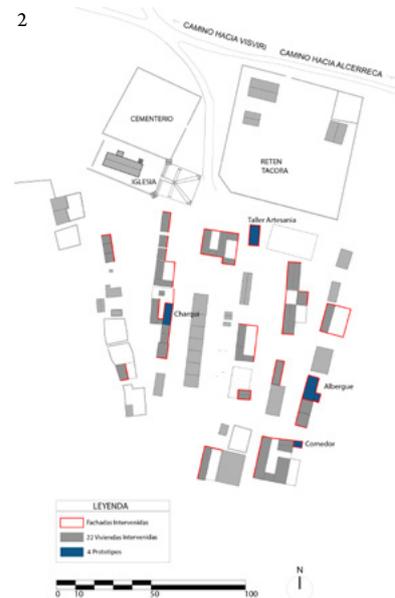
- 1: View of the village and the Tacora volcano
- 2: Site Map. The restored houses are highlighted in grey and the restored buildings for different services in blue

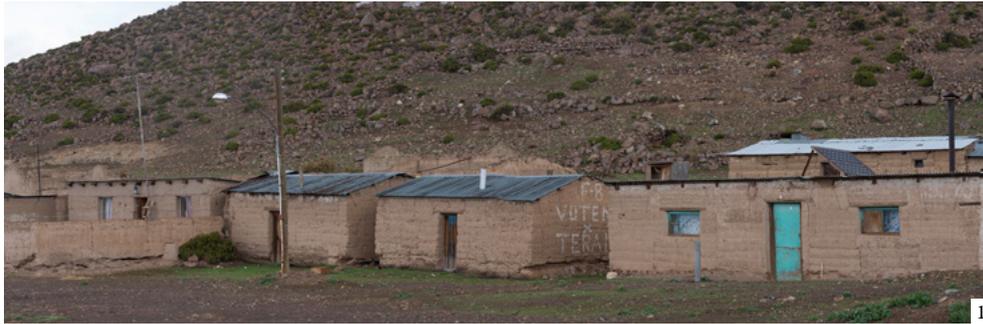
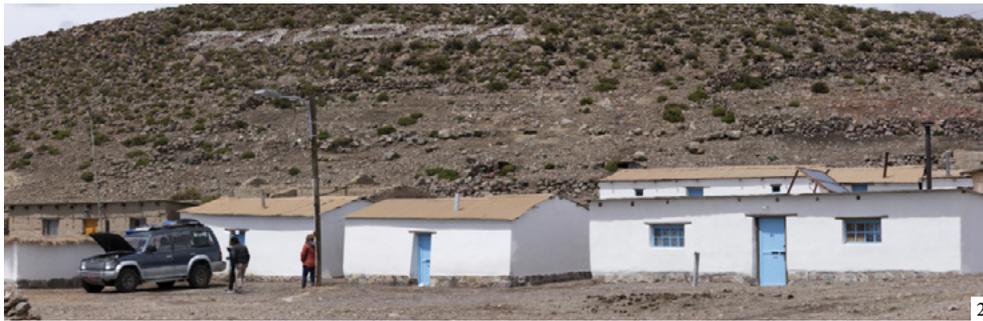
1 and 2: The houses of the village before and after their restoration

The interventions employed local techniques and solutions, without altering the architectural character of the place. Missing or eroded stone basements were restored; collapsed or detached portions of walls were rebuilt; cracks and fissures were repaired with earthen mortar injections, filled with adobe bricks or with volcanic stones and earthen mortars. In some gables, masonry was replaced by lightweight *quincha*: a local traditional structure made of wood and reeds which is filled with a mixture of earth and straw.

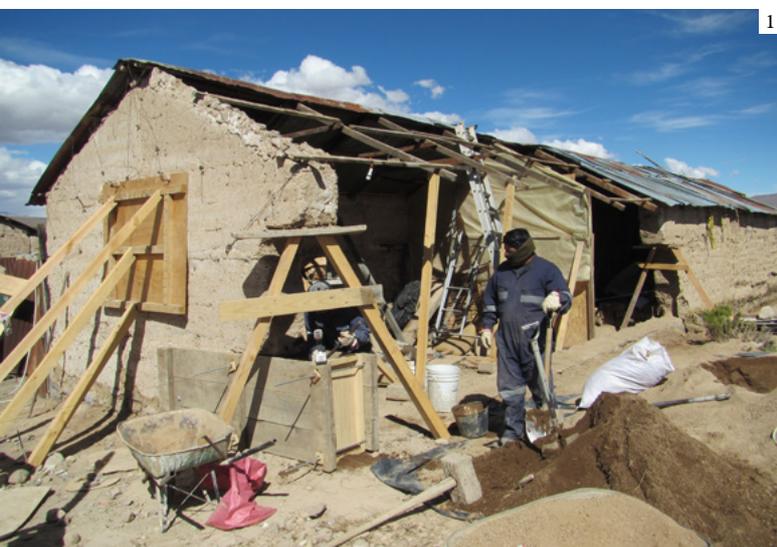
1

1: Process of reconstruction of a rammed-earth wall  
2: Wooden reinforcement of a rammed-earth wall

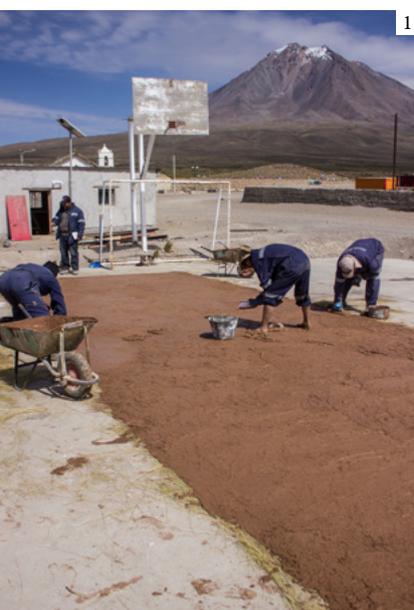
1: Making of a *caruna*

In the weaving workshop and the shop an oral tradition, which was still remembered by one of the workers, was recovered: *caruna* was laid on cowhide laces, braided to the rafters. *Caruna* is an insulation mat obtained by first placing some straw randomly on a flat surface, then pouring earth and *baba de tuna*, and finally treading on the mix. Once it is almost dry, it is cut and rolled (Bocci 2019).

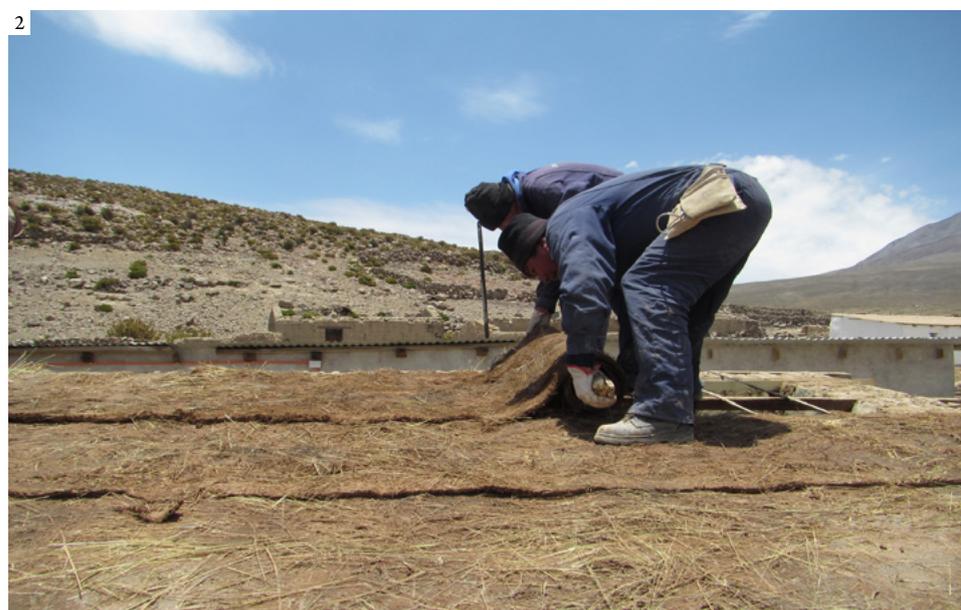
2: A *caruna* being placed on a roof
