Dust Generation in Tokamaks: Overview of Beryllium and Tungsten Dust Characterisation in JET with the ITER-Like Wall

Abstract

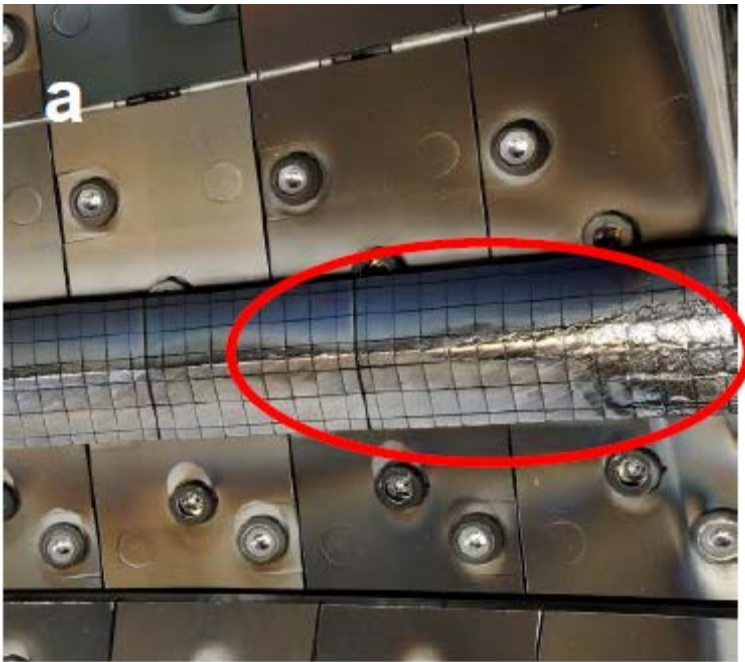
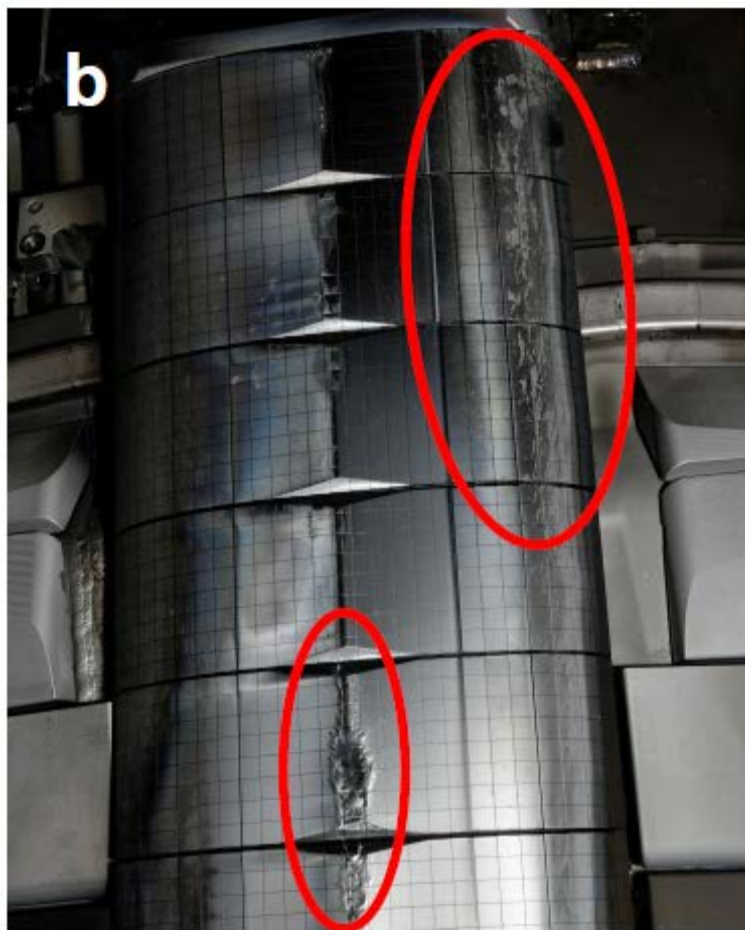
Figure 1

Melt zones on beryllium plasma-facing components: (a) upper dup plates; (b) inner wall guard limiters.

Generation of dust particles in a reactor-class thermonuclear reactor is considered as a potential hazard which would create serious issues regarding safety and economy of operation. In the worst case of a massive water leak onto hot dust a pressure build-up and an explosion of the released hydrogen could occur. Air ingress may lead to ignition. Tritium-contaminated and neutron-activated dust is also a radiological hazard. Detailed knowledge of dust generation is important for licensing and future operation of ITER (International Thermonuclear Experimental Reactor). For that reason collection of loose matter and the determination of particle properties have been carried out since late nineties in most controlled fusion devices. A comprehensive list of references to studies performed until the end of year 2011 has been compiled by Braams [1]. It should be stressed, however, that most of those works originated from machines with plasma-facing components (PFC) made of carbon. The only exception was connected with dust studies at ASDEX Upgrade where the tokamak performance with the tungsten-coated wall has been tested [2,3]. Metal particles have been a target of studies also at other devices [4], but a new chapter in plasma-wall interactions has been open when the JET tokamak with tungsten and beryllium wall components came to the scene [5-7]. Operation of JET with the ITER-Like Wall (JET-ILW) composed of beryllium (Be) in the main chamber and tungsten (W) divertor provides unique opportunity to determine material migration and fuel retention under the ITER-relevant environment. This also includes detailed studies of dust generation: quantity, morphology, location in vessel, etc. The program carried out in response to the ITER needs for safety assessment comprises: (i) remotely controlled vacuum cleaning of the divertor; (ii) local sampling of loosely bound matter from PFC; (iii) collection of mobilized dust on various erosion-deposition probes located in the divertor and in the main chamber [8-11]. Until now, three ILW campaigns have been completed: ILW-1 (2011-2012); ILW-2 (2013-2014); ILW-3 (2015-2016). An important outcome of the surveys is related to a small amount of loose matter collected by vacuum cleaning: of the order of 1 g after each campaign, despite the fact that the total energy input per campaign was increasing: 150 GJ, 201 GJ and 245 GJ, respectively. The other findings are related to the identification of several categories of particles, both ITER-relevant and only JET-specific, and to the identification of several places from where metal droplets (mainly Be) were released.

Melt zones on beryllium plasma-facing components: (a) upper dup plates; (b) inner wall guard limiters.

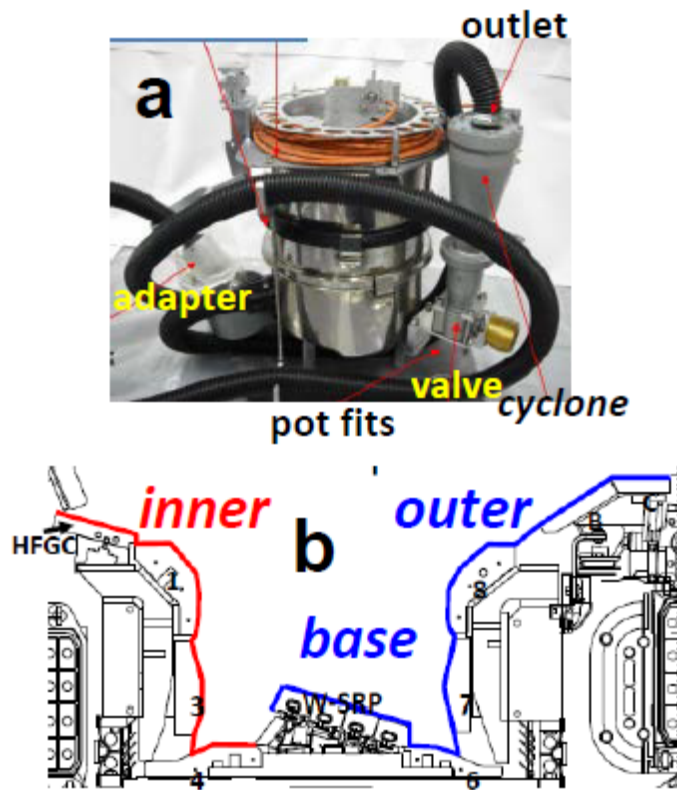
Figure 2

(a) Cyclone-type vacuum cleaner used in JET and (b) a poloidal cross-section of the divertor with areas of cleaning in the inner and outer leg.

After each ILW campaign a very detailed high-resolution photographic survey of all in-vessel components is carried out to determine the impact of plasma-wall interactions, especially off-normal events, on the state of PFC and possible damage to their structure. This facilitates the search for flaking (peeling-off) co-deposited layers and for splashes or droplets originated from melting of wall components. Images in Fig. 1(a) and (b) show examples of Be limiter melting and splashes of the ejected material. The photographic search is followed by vacuum cleaning of the divertor tiles. Dust is removed by a cyclone-type system from the divertor; surfaces of 22 out of 24 divertor modules are cleaned. Loose matter from the inner and outer legs is collected into separate pots. An image in Fig. 2(a) shows the equipment, while in Fig. 2(b) one finds the poloidal cross-section of the divertor with marked regions of cleaning. Further steps in dust sampling and preparation for analyses take place in the Beryllium Handling Facility (BeHF), where all materials retrieved from the torus are received. This comprises two remaining complete divertor modules equipped with erosion-deposition probes [12], selected limiter tiles, probes from the main chamber wall and also containers with the vacuumed dust. The latter is decanted into pots. Localised sampling of particles from the divertor and limiter components is carried out using carbon sticky pads, thus providing samples ready for analyses with electron and ion beam techniques. Sampling was done in over 120 locations on limiters and divertor tiles. In the following (in Section 3.2) only results for samples collected in the divertor will be reported.

(a) Cyclone-type vacuum cleaner used in JET and (b) a poloidal cross-section of the divertor with areas of cleaning in the inner and outer leg.

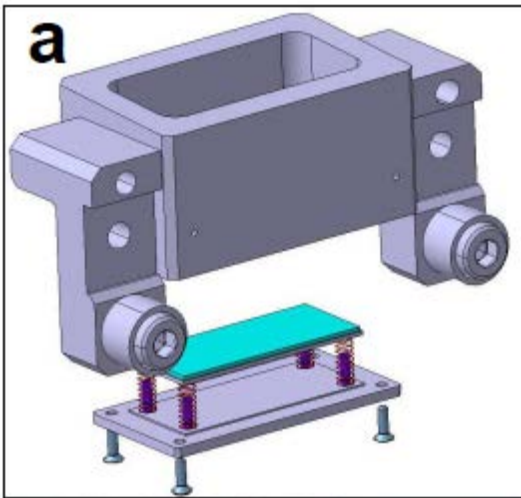
Figure 3

Dust monitors in JET-ILW: (a) a schematic drawing of the monitor for the outer divertor; (b) silicon plate, i.e. the actual dust collector after exposure in JET.

Dust collection and sampling from the divertor carriers is also performed once the tiles have been removed. Monitors with silicon plates installed above the outer and inner divertor as well as various wall probes belong to a separate class of dust collectors. Images in Fig. 3 (a) and (b) show respectively a dust monitor and the silicon collector plate retrieved from JET. This type of monitors was developed and first tested in ASDEX Upgrade [3]. They enable studies of as-deposited particles, e.g. those mobilized, in a way undisturbed by the collection itself. The same applies to several other wall probes, such as test mirrors [12,13].

Dust monitors in JET-ILW: (a) a schematic drawing of the monitor for the outer divertor; (b) silicon plate, i.e. the actual dust collector after exposure in JET.

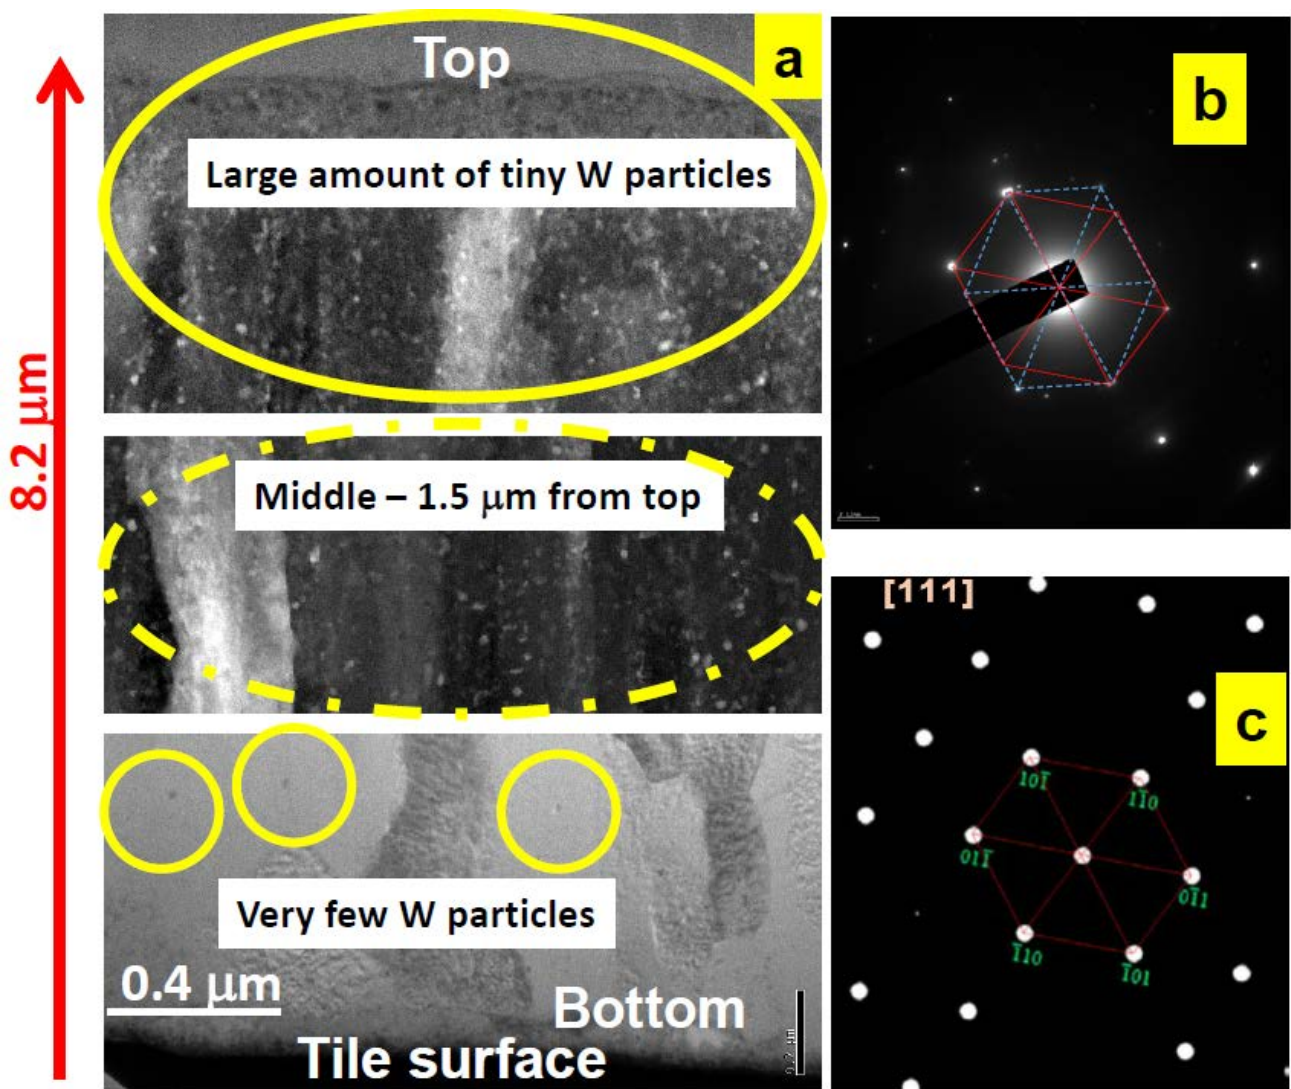
Figure 4

TEM examination of the Be flaking co-deposit retrieved from JET by vacuum cleaning. (a) details of the deposit structure and content of tungsten particles at different depth corresponding to consecutive phases of operation during ILW-1. (b) electron diffraction recorded at the lower region of the deposits; (c) diffractogram for reference beryllium.

Images and graphs in Fig. 4a-c are related to TEM studies of a FIB-sectioned 8 μm thick beryllium flake of a deposit. It most probably originates from the inner divertor: either from the high field gap closure plate (HFGC, i.e. Tile 0) or from the apron of Tile 1, because during the ILW-1

campaign deposits of that thickness had been formed only on those tiles, as reported in [20-22]. One perceives the fairly uniform bottom part of the deposit thus suggesting a quiescent columnar growth during the initial phase of the JET-ILW plasma operation with the L-mode. In that layer, the presence of only very few tungsten particles (encircled) has been identified with EDS. Their origin is related to the erosion of tiny flakes from the tungsten coatings on carbon fibre composite tiles (W-CFC). The number of tiny particles (5-15 nm), seen as white inclusions, has been increasing during the campaign due the increased power of auxiliary heating by neutral beam injection (NBI). From the electron diffraction pattern (Fig. 4b) recorded for the bottom part of the deposit one determines the lattice constant of $a = 2.4 \text{ \AA}$, i.e. close to the reference data for metallic beryllium, $a = 2.264 \text{ \AA}$; the reference pattern is in Fig. 4(c).

The results presented respectively in Figures 4(a) and 7(e-g) clearly demonstrate a significant structural differences and diversity of deposits: low porosity related to quiescent growth in the L-mode operation at the beginning of ILW-1 and highly porous structure following high-power operation in ILW-2. It is not possible to determine (even to speculate) the place where exactly the porous deposit was formed in the tokamak.

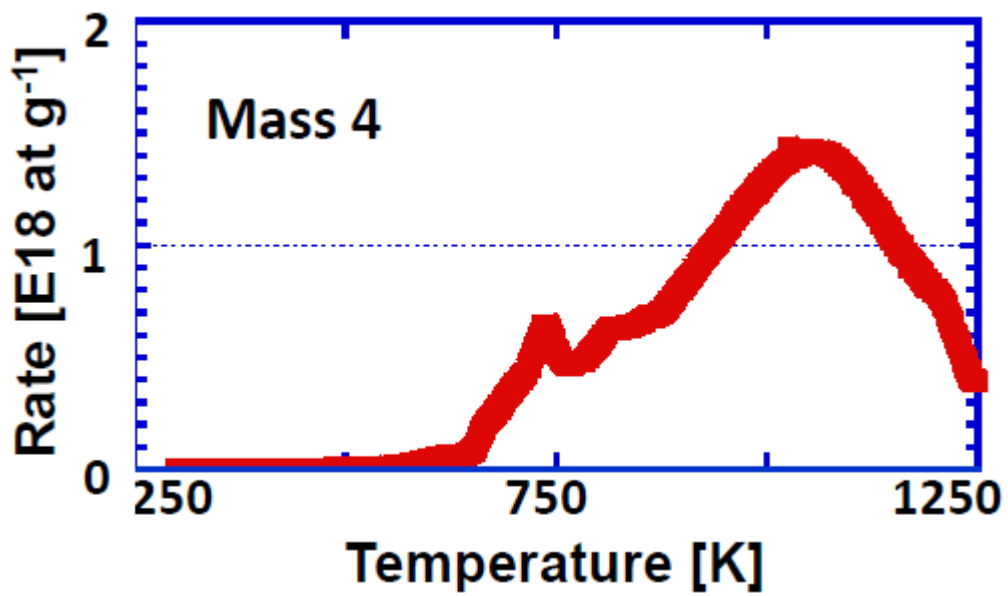
Figure 5.

Thermal desorption spectrum of deuterium from a sample of dust retrieved by vacuum cleaning from the inner divertor.

A thermal desorption spectrum for deuterium in dust particles (4.4 mg sample) is shown in Fig.5. The total deuterium retention determined mainly from the mass 4 signal of D_2 is 5.2×10^{18} D atoms, while the average retention in dust particles from the inner divertor has been estimated at the level of 1.2×10^{21} atoms/g. In the 2011-2012 JET campaign approximately 1.7×10^{26} D atoms were puffed and 3.7×10^{23} D atoms were retained (0.2 %) mainly in the Be deposition layers at the inner divertor [23]. Total retained D in dust particles is estimated to be 8.2×10^{20} D atoms in the inner divertor (only around 0.4 % of the retention in the divertor tile surface) which may indicate that the retention in metal dust is relatively small. It should be noted that D desorption is increased at the high temperature ($> 800 \text{ K}$) and peaked at 1050 K, which does not appear in the standard beryllium deuteride powder [24]. It indicates the necessity to investigate further of relationship between hydrogen isotope retention, and surface morphologies and oxidations on JET-ILW dust particles. Tritium activity determined with liquid scintillography in a sample of 2.3 mg has been on the level of 0.1 GBq/g, equivalent to $2.8 \times 10^{-7} \text{ g(T)/g}$ or $56 \times 10^{15} \text{ T atoms/g}$. , It should be stressed that some particles placed in the cocktails remained after the LSC analysis thus indicating the presence of insoluble fraction in the dust.

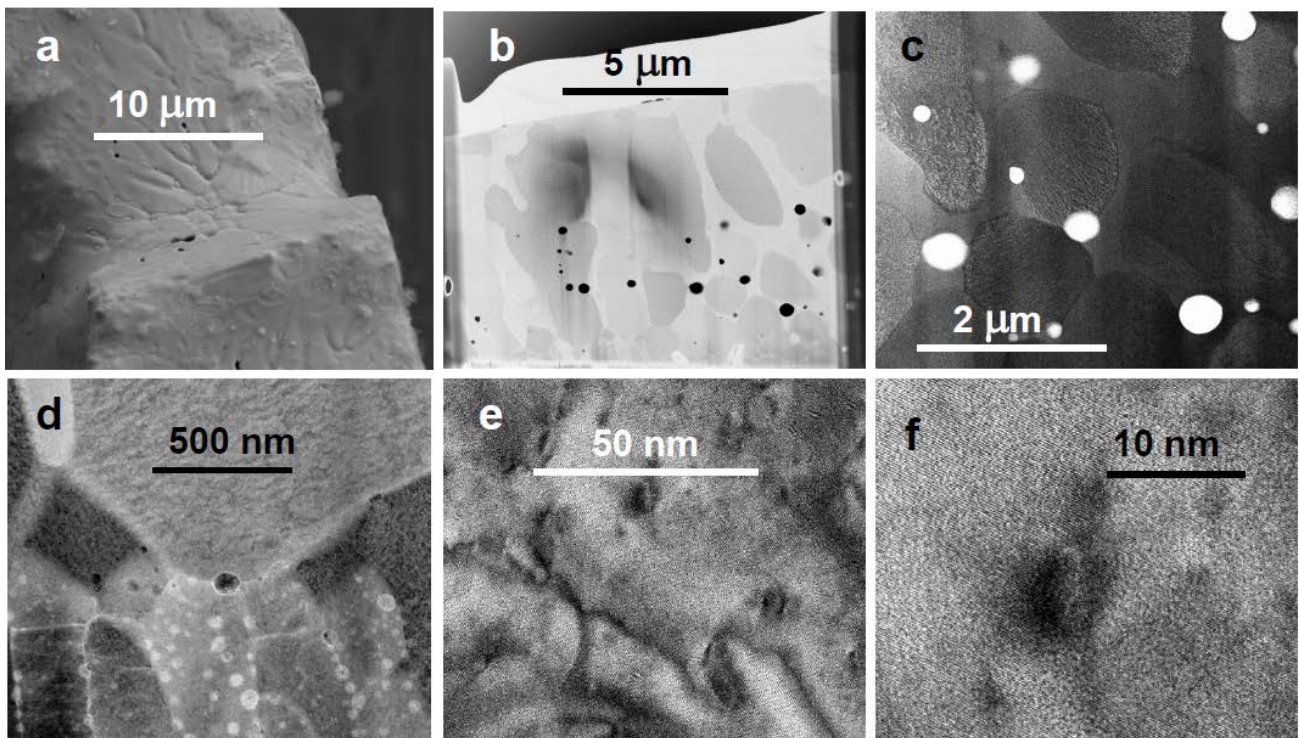
Figure 6

Surface topography and internal structure of tungsten dust sampled by sticky pads from the outer divertor tile recorded by SEM and STEM: (a) SEM image of surface features; (b) - (d) STEM images revealing details of the crystalline structure and porosity, (e) and (f) high resolution STEM revealing defects: dislocations and dislocation loops.

The appearance and internal structure of tungsten dust is shown in Fig. 6 (a-f) for a flake of the W coating on CFC tiles. One perceives a recrystallized melt zone (Fig. 6a) and the structure of grains

inside the material (Fig. 6b-d). Bright and dark spots (dependent on the STEM operating mode) visible in the images indicate holes in the structure. Defects such as dislocations and dislocation loops are shown in high-resolution images (Fig. 6e,f). It should be stressed that tungsten dust originated mostly (or even only) from the erosion W coatings. There has been no evidence of droplets or splashes.

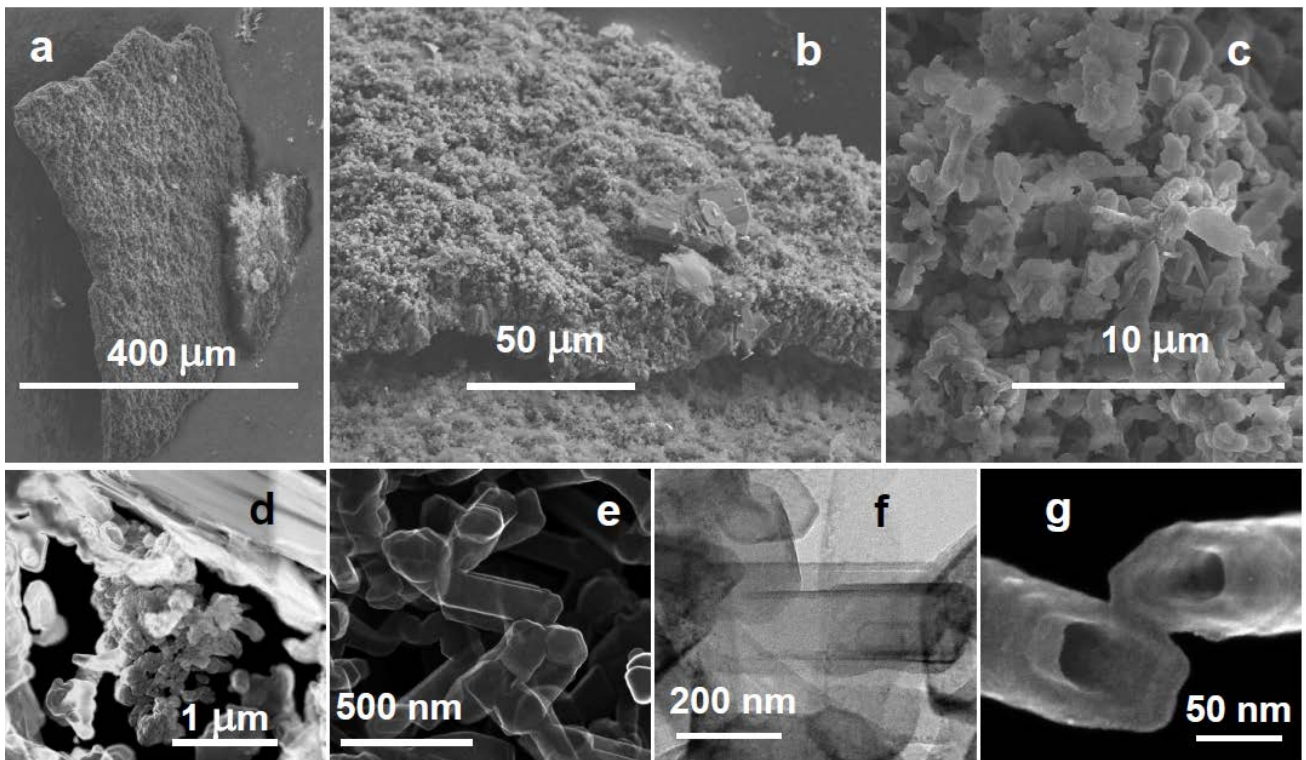
Figure 7

Thick beryllium deposits retrieved from the divertor carriers: (a) – (c) surface topography recorded by SEM and (d)-(g) internal structure recorded by STEM from the FIB-produced lamellae. Images (e) and (g) recorded in secondary electron mode, while (d) is high angle annular dark field image and (f) is a bright field image.

Images in Fig. 7 (a-g) shows general appearance and very fine features of a beryllium-based co-deposit found after the second ILW campaign on the divertor carriers thus indicating that it was originally detached from the deposition zone on the tiles. Its composition was determined by EDS: Be as the main component with some carbon, oxygen, nitrogen and small quantities of Ni, Fe and W. The collection of images is a result of examination performed using SEM (Fig. 7 a-c) and STEM operated in different modes (Fig. 7 d-g). The sample for STEM was prepared using FIB technique. There are two main features: (i) relatively large size (over 350 μm) of a flake thicker than 30 μm and (ii) very porous structure visible both in the surface layer and inside the material. From STEM images one may conclude that the internal porosity exceeds 50%. It may be even greater taking into account that there are hollow elements in the structure. They resemble nano-tubes, as shown in Fig. 7(g). Based on that and assuming 65% porosity one may tentatively estimate the density of such Be-rich matter at the level of about 0.6 g cm^{-3} . High porosity of co-deposits on the divertor tiles can also be inferred from FIB-TEM analysis reported in [25,26]. These findings of low-density materials may partly explain very low weight of the matter collected by vacuum cleaning.

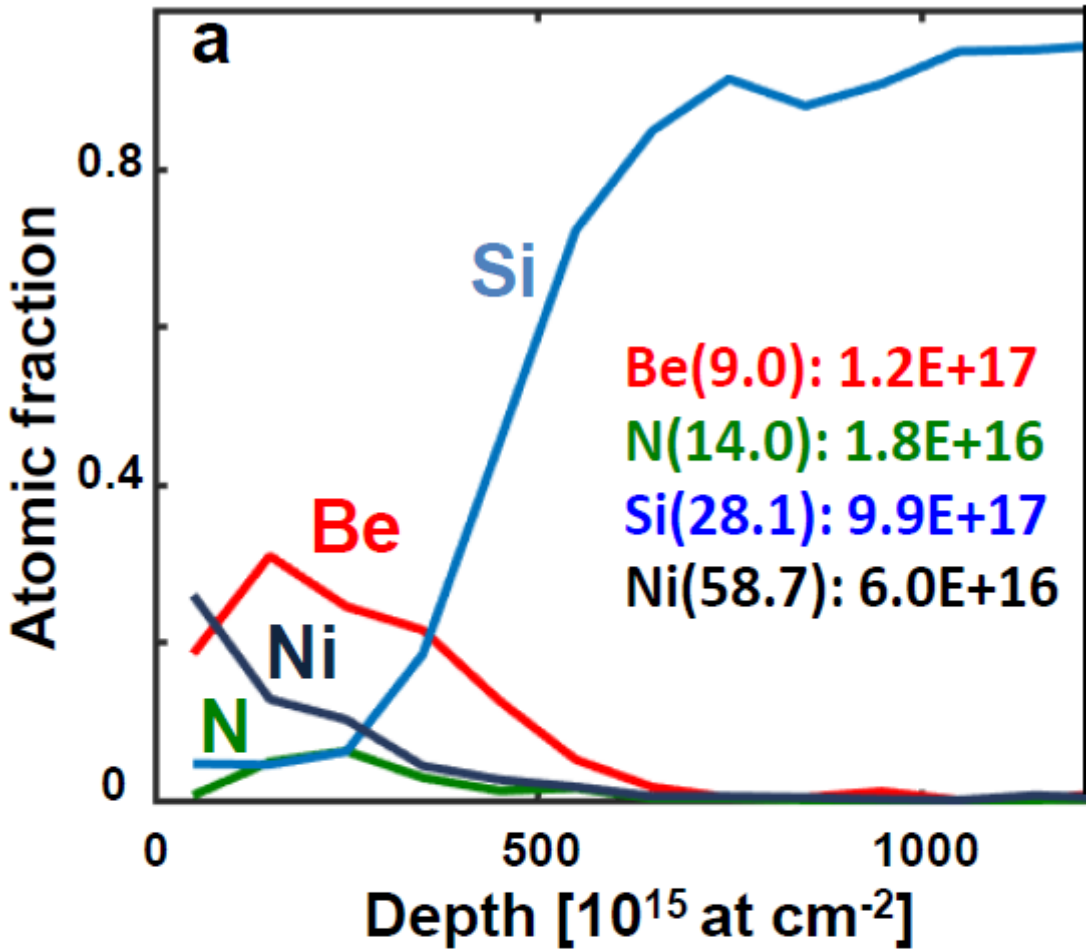
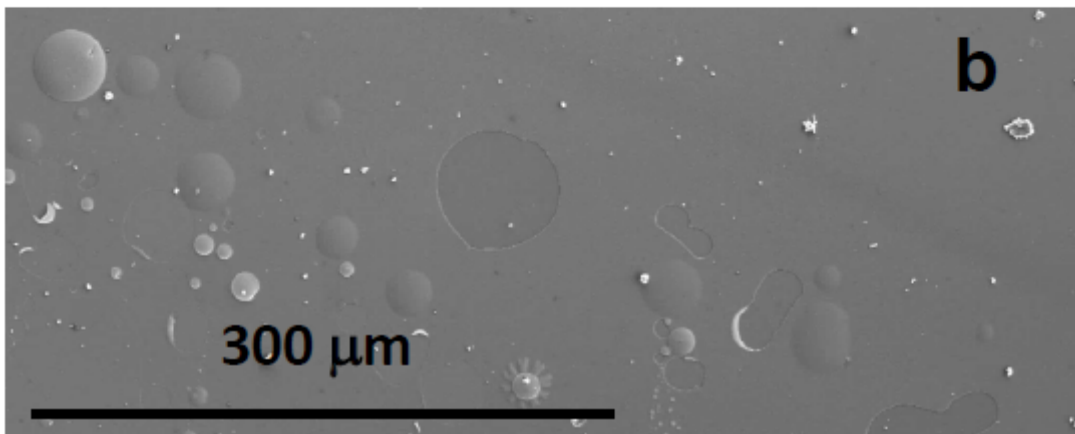
Figure 8.

Analysis of silicon plate of the dust monitor from the inner divertor: (a) HIERDA-based depth profiles of co-deposit constituents on the plate; (b) overview SEM image of the Si plate with deposited dust particles and the peeling-off layer the co-deposit.

Two main types of stuff have been found on the monitors: co-deposit resulting from material migration in JET and a variety of dust particles. Plots in Fig. 8 (a) are depth profiles determined by HIERDA for species deposited on the silicon substrate located above the inner divertor. The main constituents of the deposit are: Be, C, N, Ni+Fe and fuel atoms. There are only traces of tungsten. For clarity of the graph not all species are plotted. The layer thickness is around 300-350 nm. Its appearance is shown in Fig. 8(b), which clearly demonstrates the presence of fine dust particles (areal density approx. 400-500 cm^{-2}) and flaking of that layer. The latter is caused by an internal stress in the co-deposit most probably related to thermo-mechanical incompatibility between the

substrate and the layer. This statement is based on the fact that there are numerous blisters, 4 – 60 μm in diameter, which break. This observation proves that there is no critical thickness at which co-deposits start peeling-off. It shows that even very thin layers can detach thus generating brittle flakes of dust which may disintegrate further. It also should be mentioned that remnants of such flakes have not been detected on the plate by high-resolution SEM. Similar situation had been noticed on surfaces of test mirrors from JET where stratified carbon-rich [27,28] or beryllium-rich [11] co-deposits were peeling-off. In the latter case only few fragments of the broken layers remained on the mirror surface. This indicates that this type of dust does not adhere to surfaces on the contrary to other particles found on dust monitors and other wall probes, reported in [12,14]. In the following only a brief account on such objects will be given.

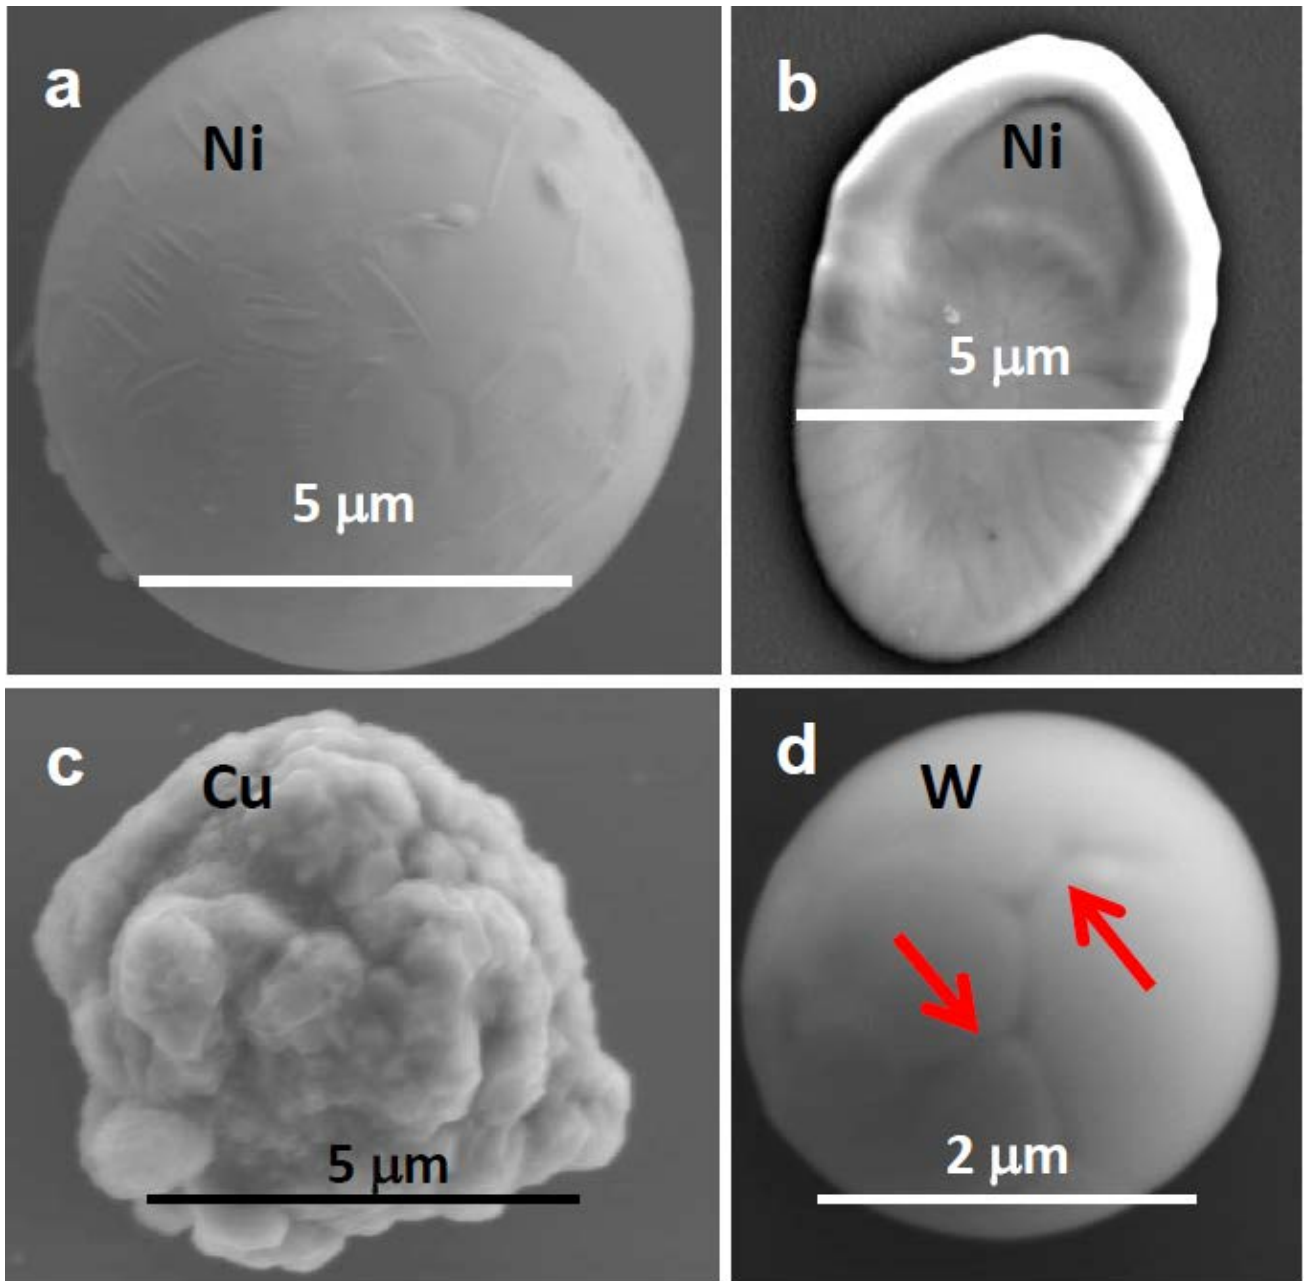
Figure 9.

SEM images of medium-Z and high-Z metal particles on the dust monitor: (a) and (b) nickel (Inconel) droplet and splash; (c) copper particle and (d) tungsten spherical particle formed the agglomeration of flakes from W-coated CFC tiles.

Images in Fig. 9 show examples of droplets, splashes and also irregular pieces of medium-Z and high-Z metals on the dust monitors and test mirrors: Ni, Cu, W. Nickel, the main component of Inconel alloy, originates most probably from the grills of antennas for auxiliary plasma heating and also possibly from damaged tie rods in Tile 7 from the outer divertor. Micrographs (Fig. 9 a and b) indicate that the material was molten before reaching the surface of the dust collector. The presence of small chunks of copper (Fig. 9 c) can be related to the erosion from grids of the neutral beam injection system. Spherical tungsten particle is not a droplet, but an agglomerate of tiny flakes (200 nm - 1 μm) detached from the W-coated tiles. It has a form of a ball with empty interior, as it was proven using FIB [10]. One can perceive seam-like features, indicated by arrows, between respective elements of the structure. This type of dust is quite common in JET, while the study has not provided any evidence of solid W droplets ejected as a result of material melting. The presence of spherical tungsten agglomerates has been identified on the monitors and also on mirrors located in the divertor. A possible pathway of formation has been discussed in [14]. Such objects have been found in JET and also in ASDEX Upgrade [3], i.e. in machines with W-coated tiles. In this sense, they may be considered not ITER-relevant, as no coated tiles will be placed in that machine. However, in ITER one may expect W-rich co-deposits. The question is whether flaking of such layers would lead to their coagulation in the plasma edge and, eventually, to the formation of ball-type dust or even small droplets. As a remark on W droplets in JET-ILW one should mention that the only exception is related to their formation on protruding components as seen during the dedicated melt experiment on intentionally misaligned lamellae in bulk tungsten tile at the divertor base, i.e. Tile 5 [29].

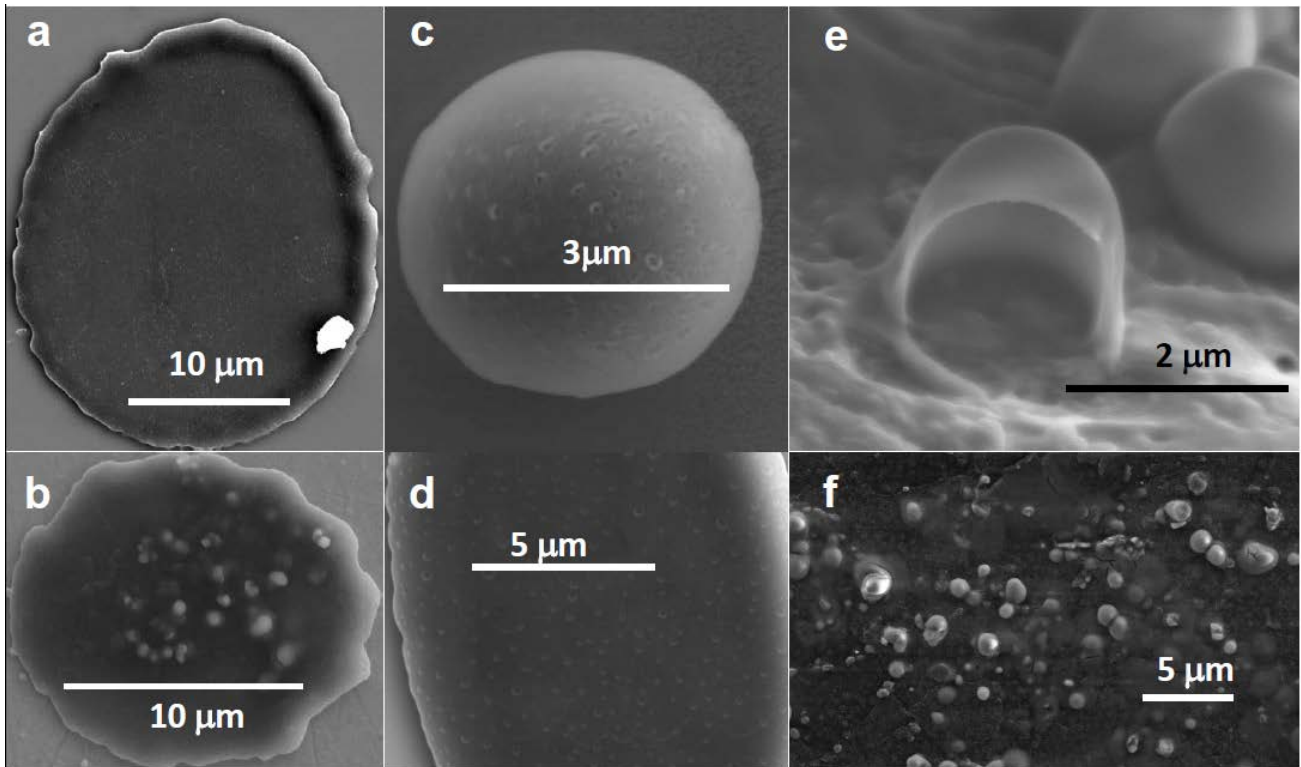
Figure 10.

SEM images of beryllium droplets and splashes: (a) splash on the dust monitor from the inner divertor (a); splash on the test mirror from the main chamber (b); droplets with surface features indicating the presence of cavities (c) and (d) small bubbles; (e) FIB-produced cross-section revealing the structure of thin-wall bubbles in a Be-rich deposit from the inner divertor; (f) bubble-like structure on the Be splash on the test mirror.

Beryllium on dust monitors and other wall probes occurs in the form of circular flat splashes (Fig. 10 a and b) and droplets regular of regular spherical or oval shape (Fig. 10 c and d). Their formation most probably occurred in the very last stage of operation in ILW-2, when experiments on

run-away electron generation were carried out. This resulted in melting of the upper dump plates and, as a consequence, ejection of molten matter. Surfaces of droplets are not smooth, but they reveal additional features, like cavities (100-200 nm in diameter, Fig. 10 c) or bubbles/blisters, 100-250 nm in diameter, as shown in Fig. 10 (d). In the latter case one also perceives regular and directional forms like fish scale (or wavy-like) suggesting the flow of material during the cooling phase. The fact is certainly not surprising, but this the first so clear documentation of such structures on Be dust. In Fig. 10 (e) there is FIB-produced cross-section which reveals the structure of thin-wall (45-50 nm) bubbles in a Be-rich deposit from the inner divertor, while the image in Fig. 10 (f) shows a large number of bubbles on the surface of a Be splashed on the test mirror from the main chamber wall. The results strongly suggest boiling state and partial evaporation of beryllium released from the limiters.
