Improvement of foundation soil behavior for Gründerzeit buildings in Austria using polyurethane resin injections

ABSTRACT: The second half of the XIX century signed a period of comprehensive industrial and cultural development in Austria known as Gründerzeit. The architecture was deeply influenced during this epoch by the construction of large masonry buildings, called “Gründerzeit Häuser”, which represent today the historical heritage of the most important Austrian cities. Due to the increasing demand for apartments in the centre of these cities, renovations and adaptations of existing buildings has been performed in the last decades. These modifications of the buildings structure represent, besides a business opportunity for the real estate economy, an increase/variation of the load for the foundations. Hence, the renovation and preservation of this architectural heritage often involve the improvement of the foundation soil. This article illustrates how the soil treatment with expanding polyurethane resin represents an efficient solution to achieve this goal. A case study of a historic building in the city of Salzburg is presented.

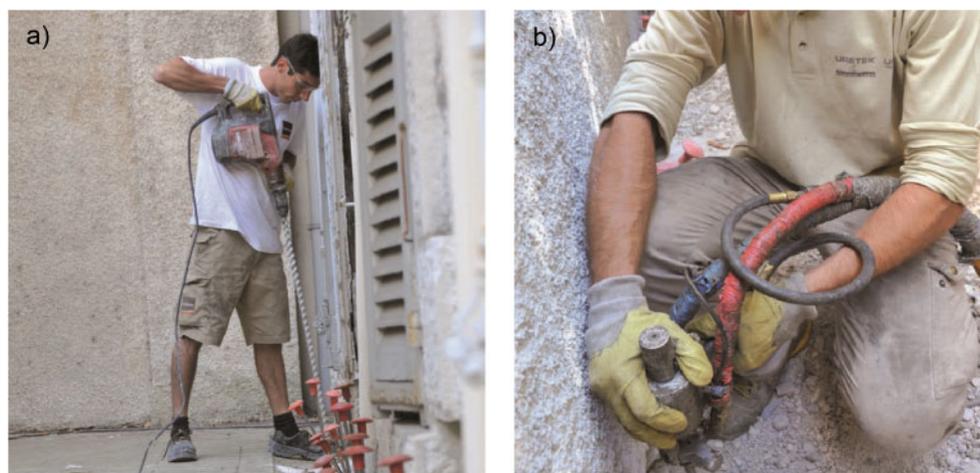
Figure 1. Example of operations: a) Drilling of the borehole; b) Equipment for the injection of the expanding polyurethane resin.

volume increase under unconfined conditions (null mechanical stress) of about thirty times (Buzzi et al. 2008; Dei Svaldi et al. 2005). When the resins are injected underground, the expansion process occurs in confined conditions leading to a compaction of the soil surrounding the injection point until a mechanical equilibrium is achieved between the resin and the soil (Dominijanni & Manassero 2014). The injection can be performed at different depths using either several injection tubes with single-point injection at the bottom end of the tube or a single tube with several lateral injection points (multi-point). In both cases, the injections are performed with small tubes (external diameter of about 10–15 mm) and equipment, reducing the treatment impact on the existing structure as much as possible. Figure 1 shows an example of the drilling operations carried out with a portable drill, and the equipment adopted to perform the injection of the resin in the installed tube from the ground surface.

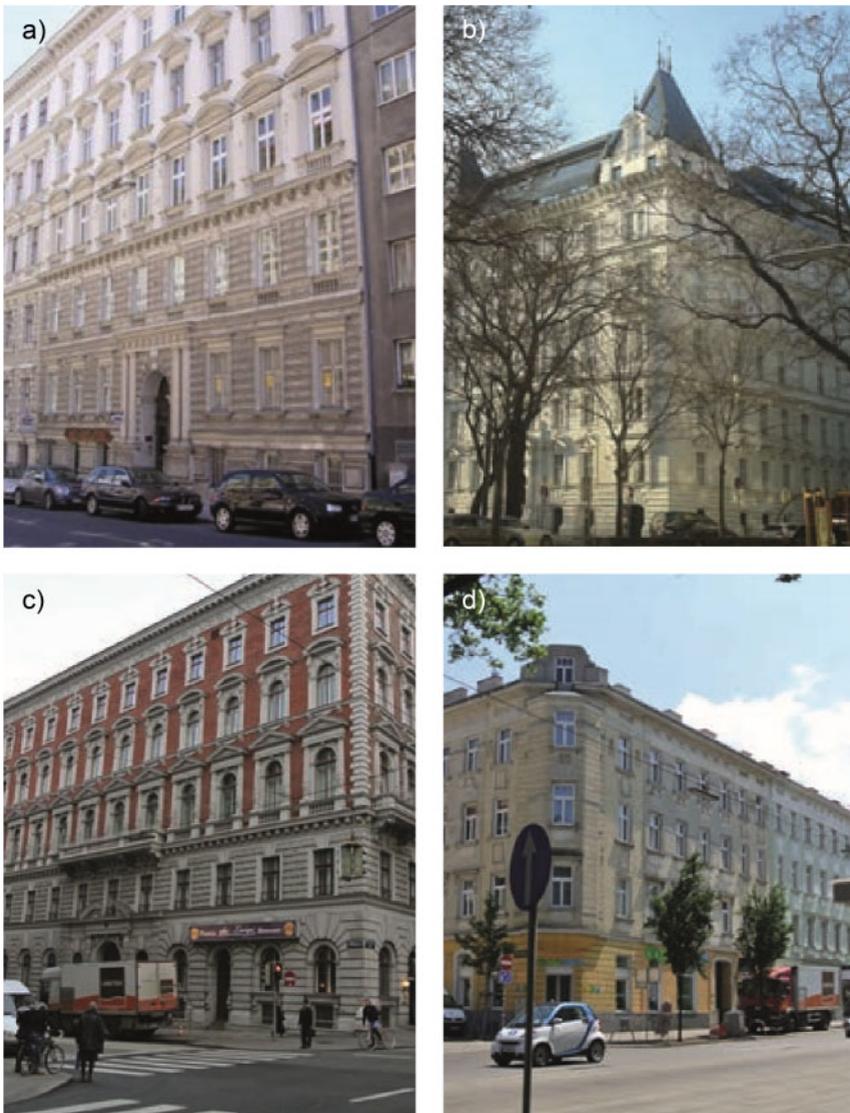
Figure 3. Overview of Gründerzeit buildings in the city of Vienna that undergone foundation soil treatment with expanding polyurethane resins.

An example of four historical buildings in Vienna, constructed during the Gründerzeit period, which have been subjected to soil foundation treatment with polyurethane resins for the construction of attics and/or renovation works, is illustrated in Figure 3. In all of the four cases, the buildings have shallow foundations at a depth in the interval 0.6–2.0 m below the ground surface. In this framework, the injections have been performed underneath the foundation beams. For the building in the image a) (Figure 3), about 260 m linear of strip foundations at a depth interval of 1.3–1.5 m were treated in 20 days of work. For the building in the image b), about 350 m linear of strip foundations at a depth

of 2.0 m were treated in 25 days of work. These two works were performed for the construction of an additional attic floor. For the buildings in the images c) and d) (Figure 3), about 200 m linear and 50 m linear of strip foundations were treated in 18 and 5 days, respectively; in these two last cases, the treatment aimed at the improvement of the foundation soil for settlements mitigation occurred during and after renovation works of the structures. In all the illustrated examples, the foundation soil was mainly composed of a silty sand/gravel. This feature has made the treatment of polyurethane resins extremely attractive. The performed works allowed the stabilization and improvement of the foundation soil, which is usually assessed through settlements monitoring system.

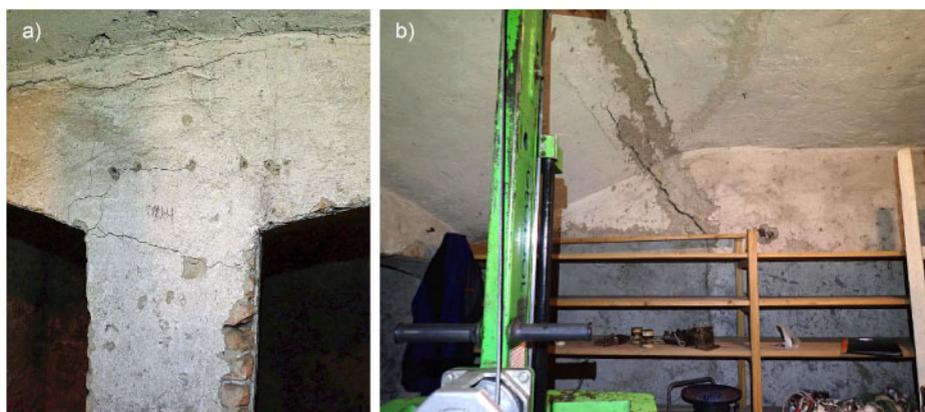
Figure 6. Examples of fissures in the masonry walls and pillar of the building structure in the basement.

Direct measurements of settlements have not been performed, neither in the past nor in recent time. However, evidence of these settlements has been given by the fissure network observed in the masonry walls and pillars of the basement level of the building, with openings in the order of several millimetres to centimetres (Figure 6). Some of these fissures have been filled in the past with cement, although most of them have been subjected to reopening. This aspect has suggested the progressive occurrence of settlements of the building during years, probably starting after the renovation works performed in 1961. A further contribution to the settlements of the building has been given by the deepening of the Salzach riverbed of about 3 m, which has been induced by the increase of the river flow starting from 1959. This factor has been responsible for a progressive lowering of the water table in the surrounding soil and the consequent consolidation settlements of the fine soil layers. Currently, the water table has been monitored with a piezometer installed in the performed geotechnical survey and its level, highly influenced by the Salzach river located about 100 m away from the building, has been found to oscillate in the interval -5 to -6 m from the ground surface.
