Improvement of foundation soil behavior for Gründerzeit buildings in Austria using polyurethane resin injections

3 CASE STUDY OF A BUILDING IN SALZBURG

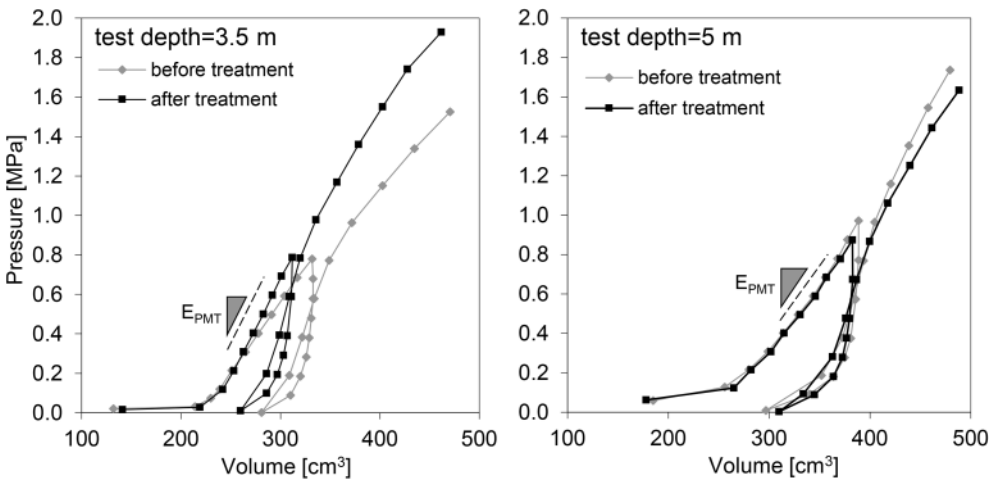
Figure 10. Results of the pressuremeter tests performed before and after the treatment with expanding polyurethane resins at depths of 3.5 m and 5.0 m.

The increase of the penetration resistance (expressed in terms of N_{10} and N_{SPT}) is related to the increase of both the relative density and the mean stress in the ground. These factors are responsible for an increase in soil stiffness, which has been also evaluated with the pressuremeter tests. The results of the pressuremeter tests performed at a depth of 3.5 m are illustrated in the in Figure 10. The comparison of the two curves highlights an overall stiffer mechanical response of the soil after the treatment with polyurethane resins. In particular, the difference between the two tests can be

observed during the first loading of the curves (up to a pressure of about 0.8 MPa), as well as during the unloading phases of the stress cycle. During the first loading, the deformation modulus (E_{PMT}) has increased from 18 MPa to 26 MPa, while during the unloading phase the modulus has increased from 44 MPa to 66 MPa. Similar results have been observed for the pressuremeter tests carried out at a depth equal to 5 m below the ground surface (Figure 10). In this case, the deformation modulus has increased from 22 MPa to 24 MPa during the first loading, and from 46 MPa to 70 MPa during the unloading phase. With respect to the tests performed at a depth of 3.5 m, the lower increase of stiffness during the first loading is related to the higher stiffness of the natural soil at a depth of 5 m. In addition, it has to be considered that, in the area C the injections have achieved a depth equal to 5 m, therefore the influence of the treatment is expected to be less pronounced with respect to the shallow injection performed at a depth of 3.5 m.
