Raw Earth Construction Perspectives in Italy: An Overview Through the Rehabilitations of Casa Fenu in Villamassargia, Sardinia, and Casa di Teresa in Casalincontrada, Abruzzo

Martina Bocci

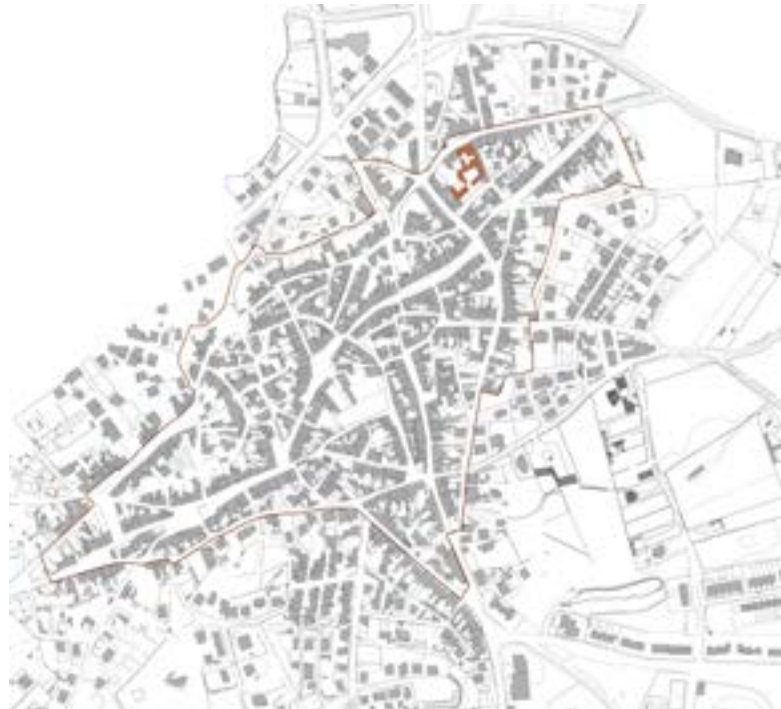
Figure 1: Historic centre of the medieval town of Villamassargia, in which 79% of the buildings are in *ladiri*. The Casa Fenu complex is marked in red.

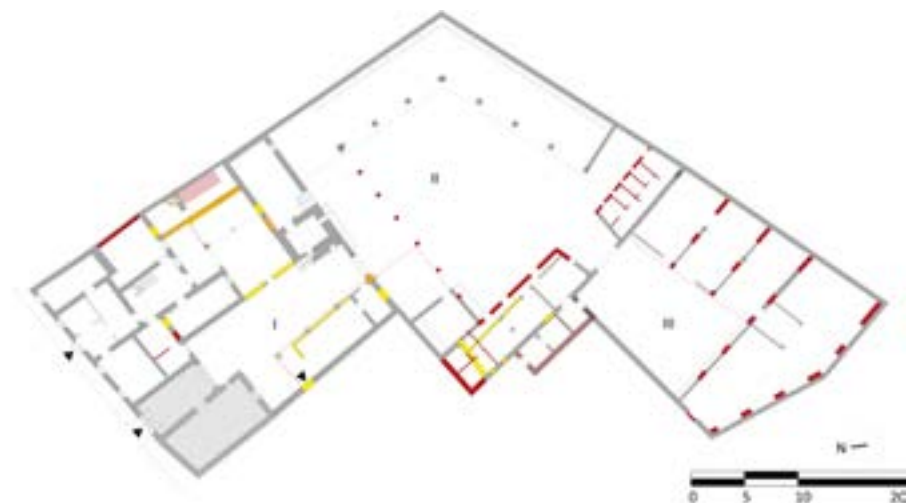
Figure 5: Demolition and reconstruction plan. The demolition is marked in yellow and the new construction in red

The restoration was based on different approaches in each part of the complex (Figs. 5 and 6); raw earth was used even in partially or completely rebuilt parts.

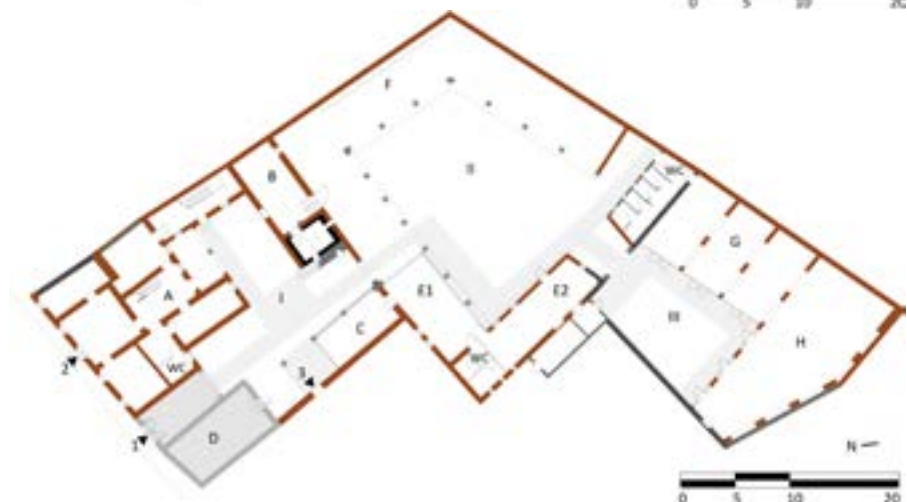
Figure 6: Project plan, ground floor.

Courtyard I: A) exhibition rooms and tourist agency; B) storerooms; C) tasting rooms; D) Villa Fenu; 1) portal and entrance hall to the courtyard; 2) main entrance; 3) connection to Villa Fenu.

Courtyard II: E1) cafeteria and E2) kitchens; F) exhibition area. Courtyard III: G) workshop and laboratories; H) conference room. Red: *ladiri* masonry; black: concrete; dark grey: stone masonry; grey: fired bricks and hollow bricks

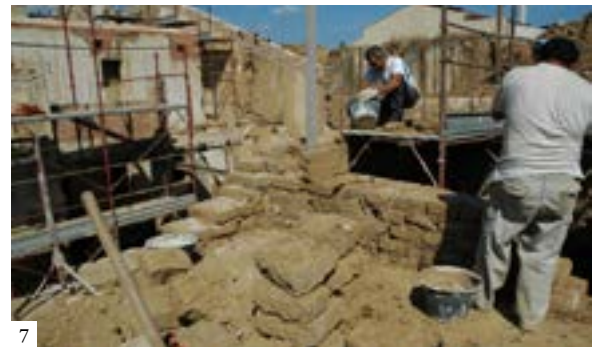
Figure 7: In the reconstruction work of building B, the reuse of original *ladiri* in good condition was frequent. The earth derived from the demolition, heterogeneous and with spurious materials, was not reused within the construction site, but was instead reused to fill the land where the earth used for the new bricks was extracted from. (Ignazio Garau)

between opposite walls. Damaged wall portions were demolished and rebuilt with new *ladiri* (Fig. 7) measuring 10x20x40 cm, made by hand with a mix of earth and fibers and laid on an earth, lime, and sand mortar bed. Minimum requirements for *ladiri* were established, such as dimensional stability and compressive strength. Deteriorated masonry surfaces were restored by removing loose parts, reinforcing with wooden sticks or filling with brick flakes and a mixed mortar of natural hydraulic lime, slaked lime, and sand, as well as by applying a mixture of earth and natural fibers in thin layers. The most delicate parts, such as plinths, cornerstones, doorposts, jambs, lintels, and roof-beam bearings, were strengthened with fired bricks (Fig. 8).

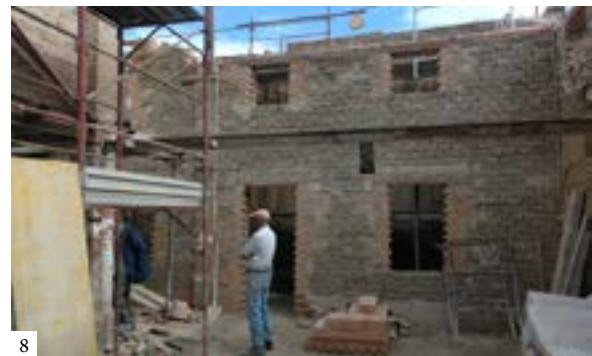
Figure 8: The openings were consolidated: reveals and lintels were installed, sometimes with a new element on the inner side, or fired brick platbands, replacing the eroded or fractured bricks (Ignazio Garau)

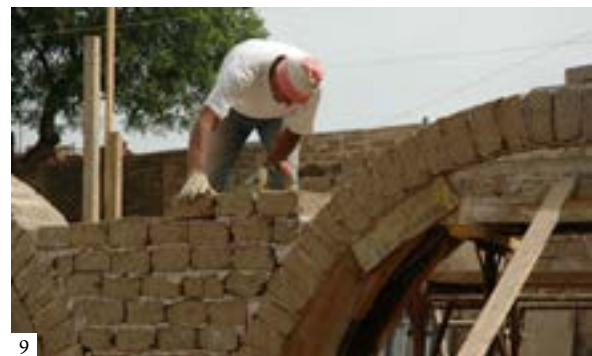
Figure 9: Laying of *ladiri* in the construction of the portion of the wall between two arches (Ignazio Garau)

Given their advanced state of decay, the remaining structures around courtyard III were demolished and reconstructed using *ladiri*. Fourteen arches (spanning about 2.5 m) in four parallel walls were built with unfired bricks (Fig. 9). Fired bricks were also used at certain points to counteract the thrust and to support the roof trusses (Fig. 10)

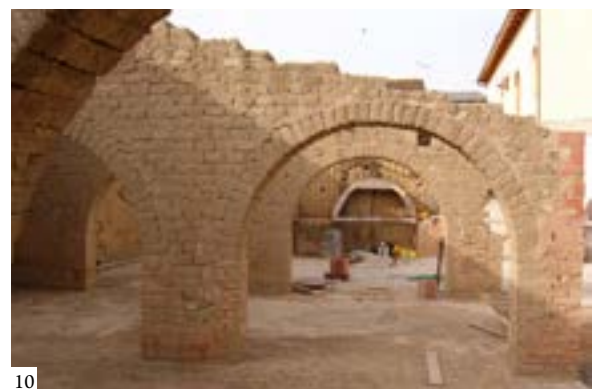
Figure 10: View through the arches of courtyard III (Ignazio Garau)

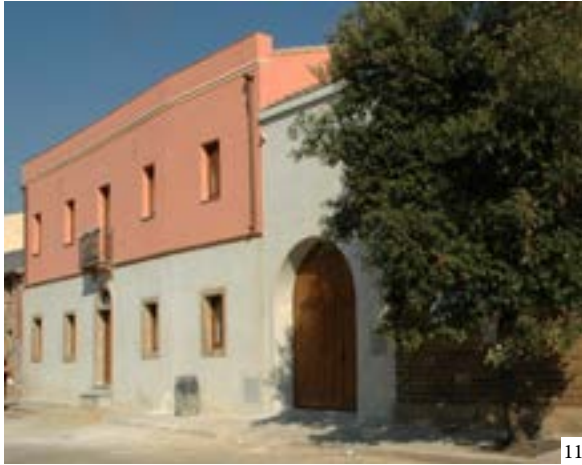
11

Figure 11: The colour of the main façade was chosen to match the shades found in other buildings in Via Santa Maria (Ignazio Garau)

A plaster made of earth, sand, and lime, plus natural fibers such as hay and straw, was applied on all walls. This was rendered with slaked lime and sand and finished with a smooth coat of long-aged slaked lime. The interior walls were limewashed, with color from natural earth pigments. The exterior walls were finished with two coats of a breathable, weather-resistant mixture of slaked lime, mineral additives, natural earths and oxides (Fig. 11).

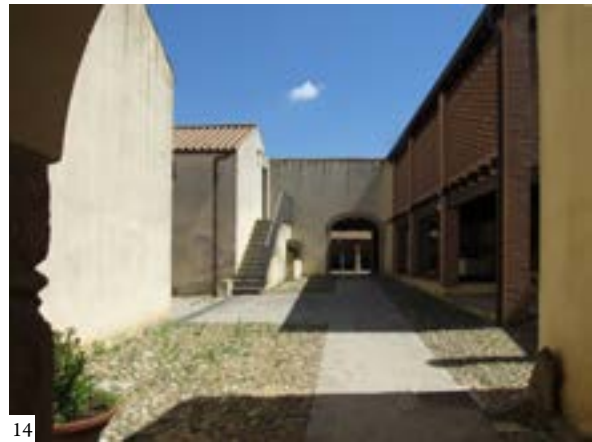
14

Figure 14: Courtyard I as seen from the entrance hall (1): on the left the staircase leading to building B, on the right building C made of fired bricks on the second floor, while glass curtain walls enclose the rooms on the ground floor (Ignazio Garau)

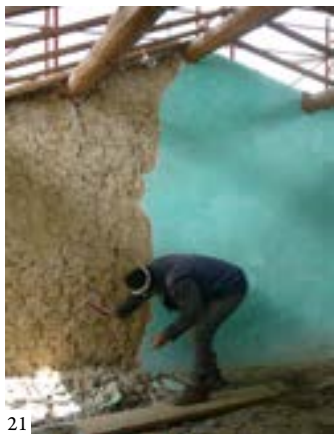
21

Figure 21: Removal of plaster in the west first floor room (CEDTerra)

The inner surfaces of the walls were in good condition but loose parts had to be removed from the outer walls (Fig. 21). Cracks and gaps were consolidated and new *massoni* were laid, made from a mixture of earth, sand, water, straw, and pure gypsum. For every 5 kg of mud mixed with straw, one 20x12 cm loaf-like brick was obtained. The bricks were left to cure overnight wrapped in straw and then laid (Figs. 22 and 23). A structural framework of twigs facilitated bonding with the existing masonry. The connection between the west and east blocks and the repair of the damaged chimney were executed using wooden frames filled with the *massoni* mixture, with wooden formwork. A wood bar was used to level the surface. Two tie-rods were fitted along the long side of the house.

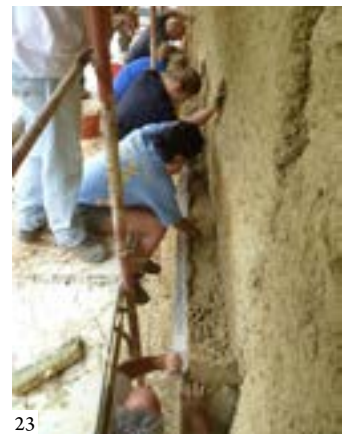
23

Figure 23: Laying of *massoni* by workshop participants: they can be thrown with force, to allow the release of excess water, or laid on beds of dry straw and pressed to adhere and penetrate each pore (CEDTerra)

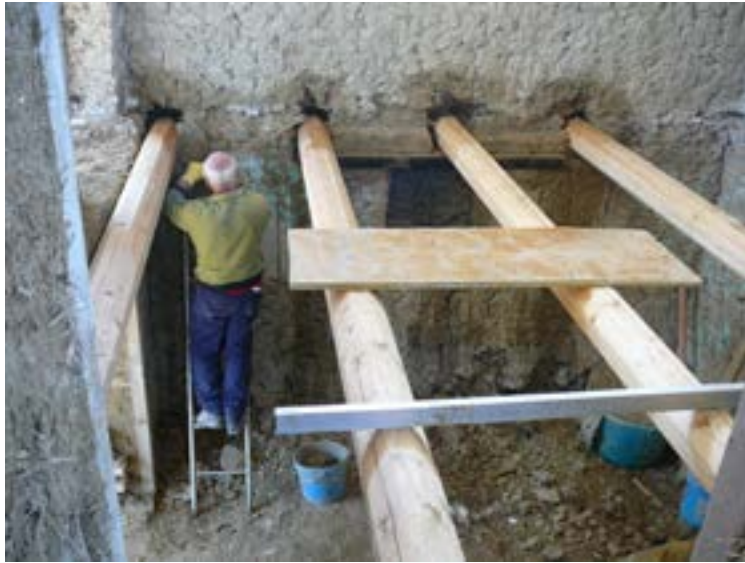
Figure 24: Laying the new beams in the west room (CEDTerra)

better distribute the loads (Fig. 24). Joists placed above the beams support the brick flooring.

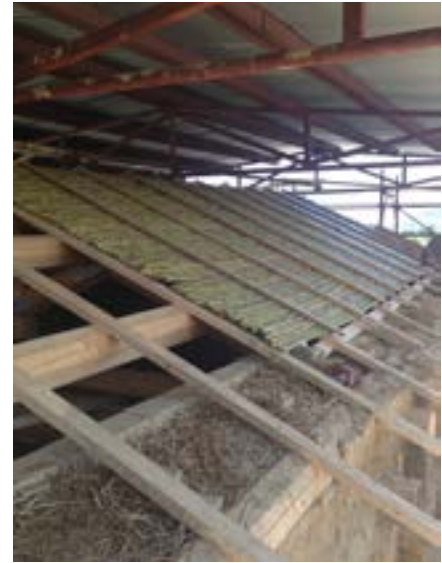
Figure 25: Laying of the laths made during the 2015 workshop (CEDTerra)

Ring beams at the top of the walls distribute the loads of three trusses supporting the main beams and rafters. On the east half of the roof, laths covered with 10 cm of straw and earth were laid, and on the west half, wooden boards waterproofed with a membrane (Fig. 26). A layer of pressed

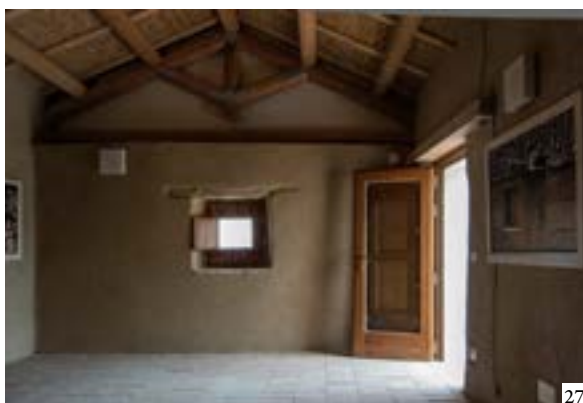
27

Figure 27: New internal staircase in the west portion. The tie-rod added during the renovation runs along the wall

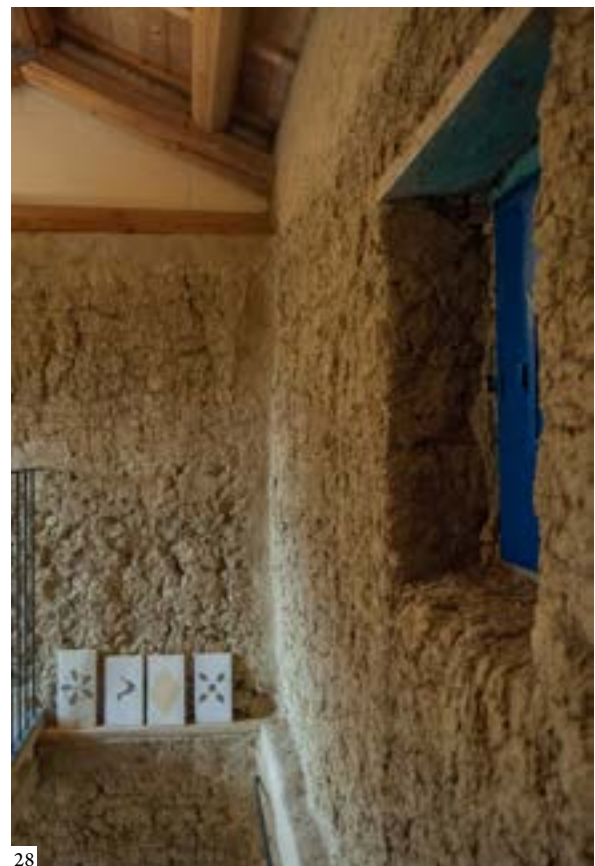
28

Figure 28: *Massoni* walls left without plaster on first floor to the west
