Plasma enhanced chemical vapor deposition (PECVD) of SiO_x thin films on Portuguese limestone: An experimental study

Plasma enhanced chemical vapor deposition (PECVD) of SiO_x thin films on Portuguese limestone: An experimental study / Ding, Yufan; Grassini, Sabrina; Angelini, Emma; Schiavon, Nick. - In: JOURNAL OF CULTURAL HERITAGE. - ISSN 1296-2074. - ELETTRONICO. - 70:(2024), pp. 281-292. [10.1016/j.culher.2024.10.001]

Journal of Cultural Heritage

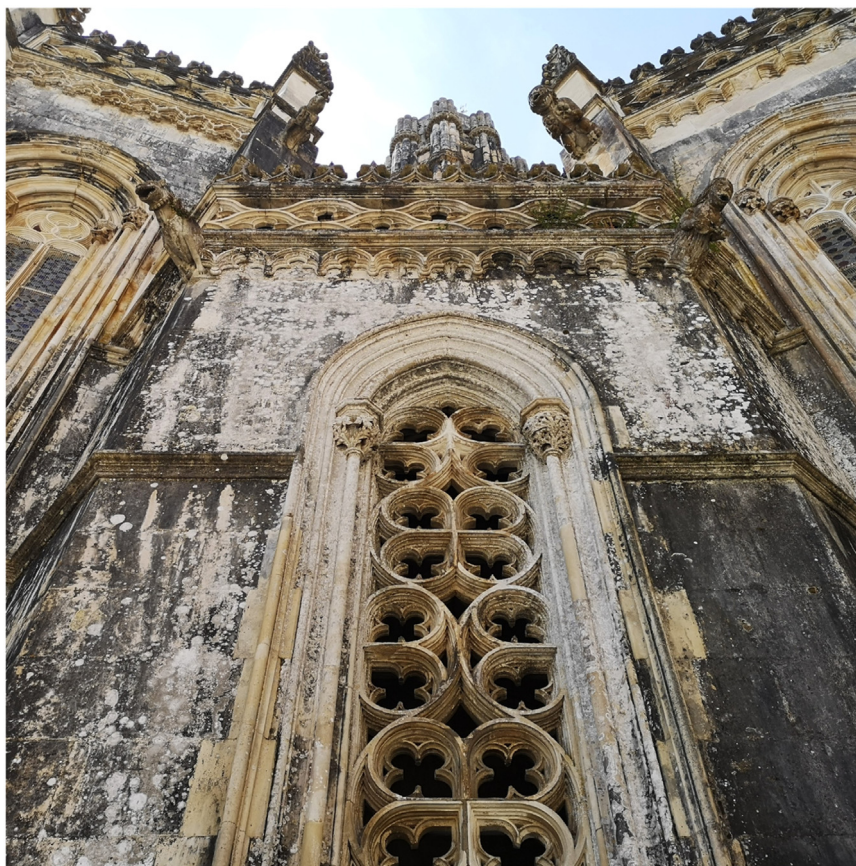
Fig. 1. Batalha Monastery, Portugal. Limestone heavily affected by microbial deterioration and lichenous patinas.

Ornamental Stones in buildings and monuments in urban environments are exposed to the risk of significant decay as a consequence of anthropically and naturally produced agents [1–6]. The Batalha Monastery (also officially known as the “Mosteiro de Santa Maria da Vitoria”) located in central Portugal near the city of Leira, has been included in the list of UNESCO World Heritage sites since 1983. Several local quarries provided the oolitic limestones for the construction of the monastery in 1386 and as well for the restoration programme in 1834 [7,8]. Over a century after the last large-scale restoration intervention, the Batalha Monastery is today showing a high degree of stone decay (Fig. 1), due not only to atmospheric pollutants from vehicular traffic sources (the Portuguese national highway IC2 - N1 runs around 50 m west to the building [9]) but also to bio-deterioration processes, which are

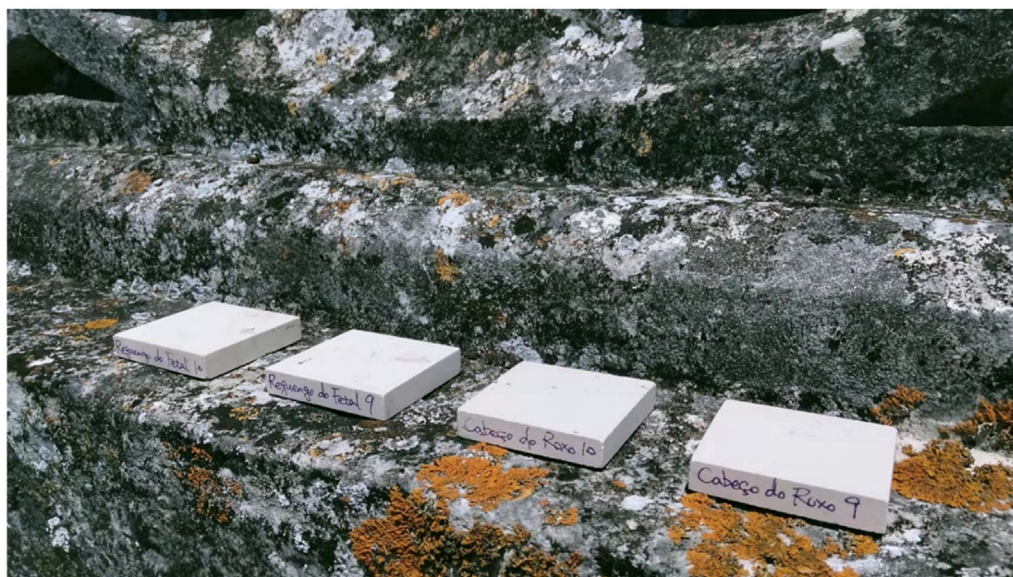
Fig. 2. Uncoated and SiO_x deposited stone samples placed on the roof of Batalha Monastery (from left to right, 1st and 3rd covered with SiO_x thin film, 2nd and 4th uncoated).

Stone tablets, 5 × 5 × 1 cm in size, uncoated and coated with SiO_x thin film were exposed on the roof of the Batalha Monastery facing south from 9th June to 10th October 2021 (Fig. 2). The tablets were collected after three months' exposure and observed under optical microscope. By means of the Datacolour CHECK II PLUS Spectrophotometer, the colour change of sample surfaces before and after outdoor exposure was evaluated. The result was illustrated using the CIE Lab Colour Space system.
