# Unmanned Aerial Vehicles (UAV) Photogrammetry in the Conservation of Historic Places: Carleton Immersive Media Studio Case Studies

**Abstract:** The increasing commercialization of unmanned aerial vehicles (UAVs) has opened the possibility of performing low-cost aerial image acquisition for the documentation of cultural heritage sites through UAV photogrammetry. This paper presents two case studies that illustrate the use of the DJI Phantom 4 normal UAV for aerial image acquisition, and the results that can be achieved using those images. A general workflow procedure of oblique image capturing and data processing of large data sets has been illustrated in the Prince of Wales Fort case study to create photogrammetric models and to generate orthophotos for condition assessment applications. The second case study provides insight on the possibility of using UAVs for post-disaster documentation when the accessibility and the availability of high cost equipment is of major concern. The results that were obtained from UAV photogrammetry of Nyatapola Temple and Bhairabnath Temple in Taumadhi Square in Nepal, which were damaged by the 2015 Gorkha earthquake, are presented and discussed.

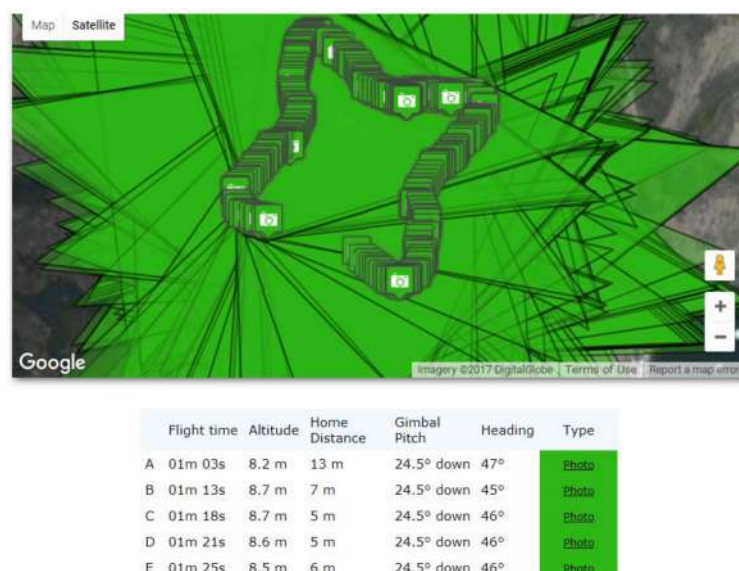
Figure 5. UAV Photograph locations at Prince of Wales Fort—Screenshot from airdata.com [23].
