3D Data Fusion for Historical Analyses of Heritage Buildings Using Thermal Images: The Palacio de Colomina as a Case Study

# 3D Data Fusion for Historical Analyses of Heritage Buildings Using Thermal Images: The Palacio de Colomina as a Case Study

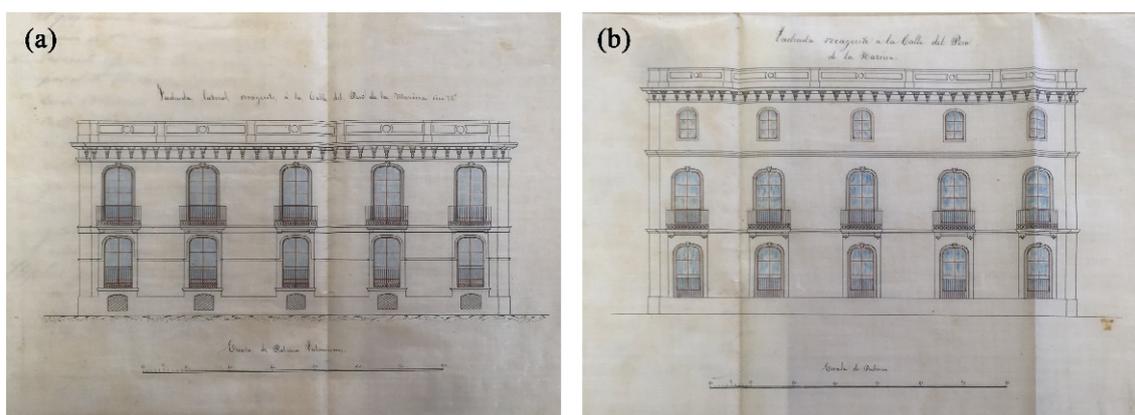
**Figure 2.** (a) First proposal for the western façade, dated June 1863. Semi-basement, ground floor and main floor (this solution was not built); (b) Second project proposal for the western façade, dated December 1863. Ground floor and two floors. Architect Manuel Ferrando. Municipal Historical Archive of Valencia, Urban Police box No. 97, year 1863.

The current appearance of the building, obviously, is not what it was in its medieval origins and is the result of its architectural evolution as a “house of the weight of flour”. In the 19th century, the building passed into private hands. Therefore, it had to adapt to its new use and the new fashion. The only existing documentation on the palace of the Marquesa de Colomina consists of two façade proposals, one of them not carried out (dated June 1863) (Figure 2a) and the one finally carried out (dated December 1863) (Figure 2b). Both were the work of the architect Manuel Ferrando, and their main difference is that the one in June has two floors and a semi-basement, while the one in December has a ground floor and two upper floors.

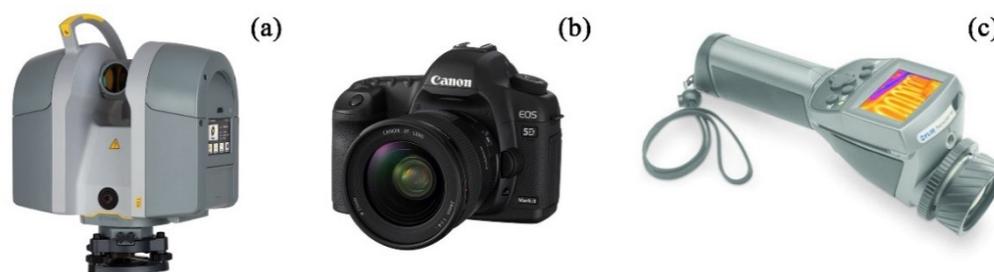
**Figure 3.** (a) Trimble TX6 laser scanner; (b) Canon EOS 5D Mark II; (c) FLIR ThermaCAM™ B4.

- 8 LiDAR scans, using a Trimble TX6 laser scanner (Figure 3a) in order to provide high-resolution point clouds to accurately describe the external geometries of the Palacio;
- 455 colour digital images, using a DSLR camera (model: Canon EOS 5D Mark II) (Figure 3b) to document the visible range of the electromagnetic spectrum;
- 308 TIR images, using a terrestrial thermal camera (model: FLIR ThermaCAM™ B4) (Figure 3c) to detect anomalies or phenomena that are not visible to the human eye, but noticeable in long wave infrared (LWIR—8–14.000 nm).

The LiDAR survey was carried out to acquire the data of the external surfaces of the building in its current state (acquisition date: 9 May 2022). The main specifications of the laser scanner employed during the acquisition of the point clouds—a Trimble TX6—are reported in Table 1.

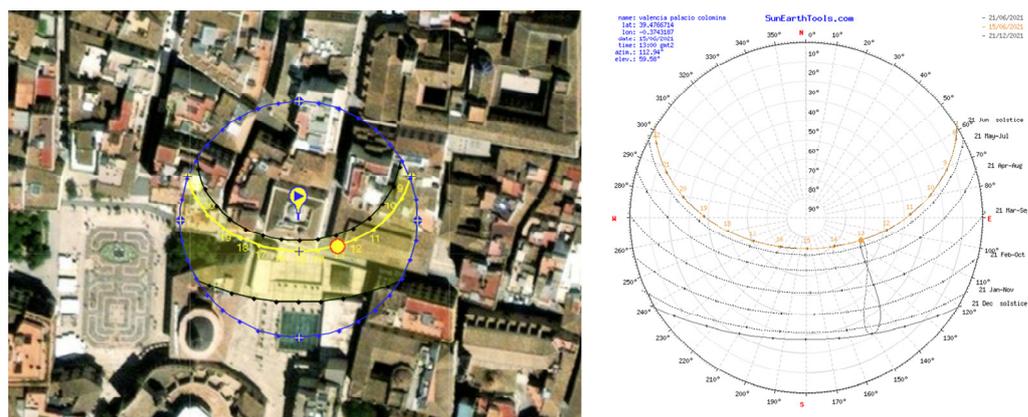
**Figure 4.** Solar path scheme from one of the days on which the TIR images were collected.

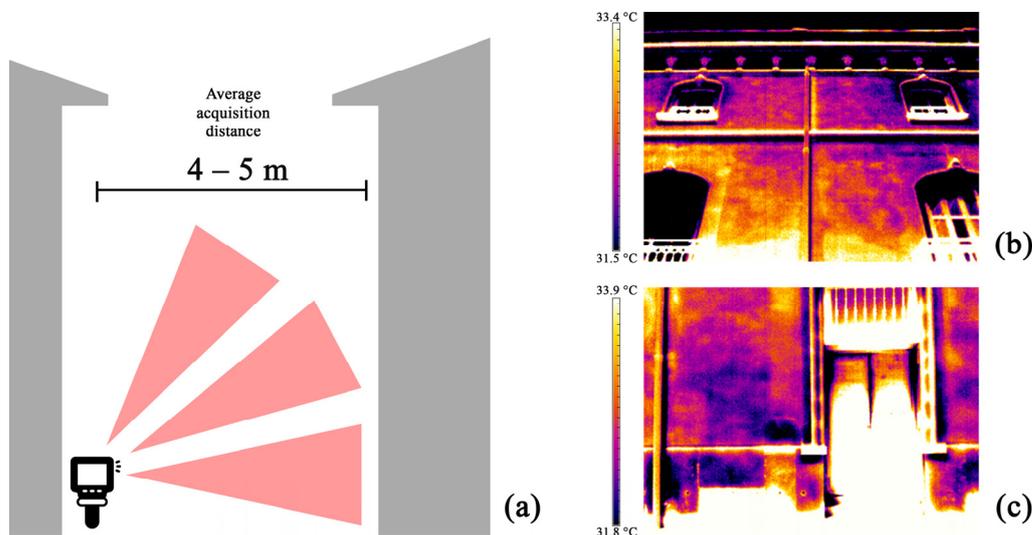
**Figure 5.** (a) TIR image acquisition scheme; (b) example of a thermal image acquired, of the upper area of the façade, and, therefore, characterised by a high perspective distortion; (c) example of a thermal image acquired, corresponding to the first floor of the building, covering only a limited portion of the façade.

As well as the acquisition of the visible images, the presence of neighbouring buildings represented one of the crucial problems encountered during the TIR image acquisition operation. As mentioned above, the criticality is related to the reduced acquisition distance (4–5 m) (Figure 5a) due to the proximity of other buildings (concerning three out of four sides of the surveyed monument). Additionally, this difficulty was further accentuated by the camera's limited FoV, considering the relatively long focal length (45 mm, significantly higher compared with the 24 mm focal length of the lens equipped on the DSLR camera). As a result of the described acquisition conditions, each image covered only a restricted and very limited portion of the considered façade (Figure 5c). Additionally, as well as the previous photogrammetric acquisition, the images of the higher part of the building were considerably foreshortened and characterised by a high perspective distortion (Figure 5b).

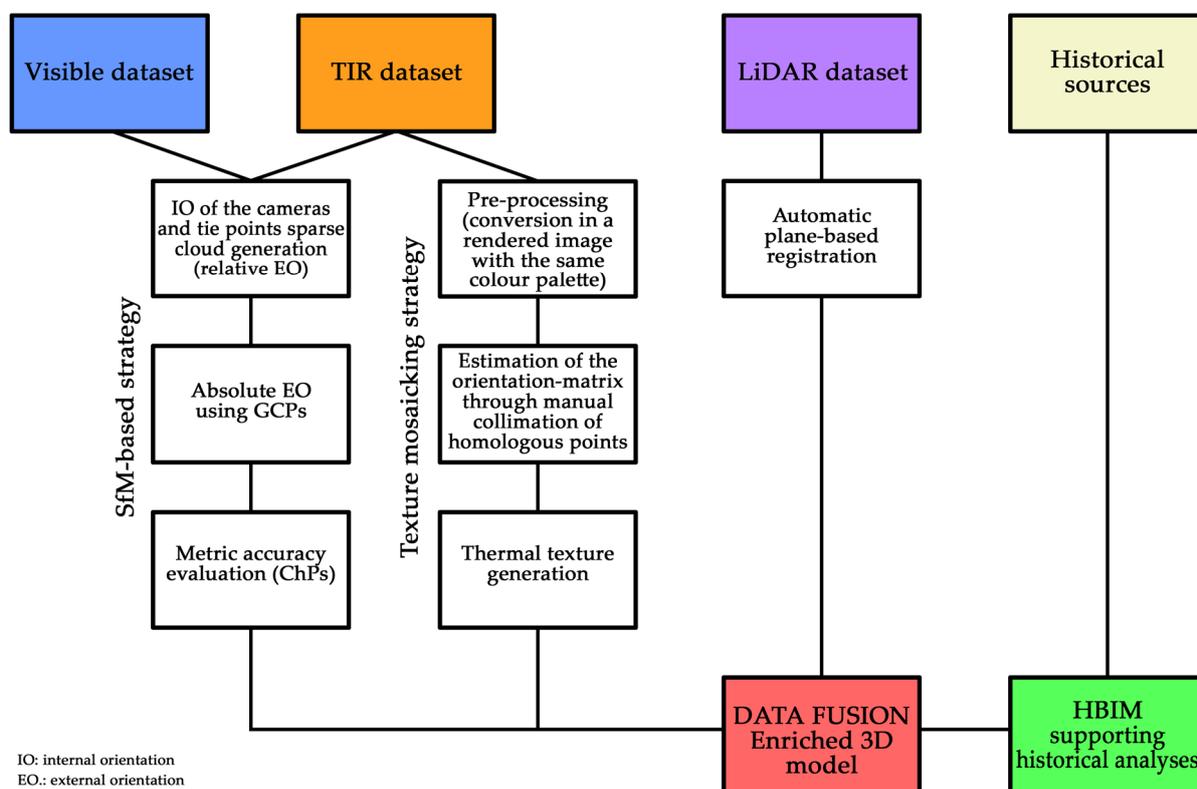
**Figure 6.** Flowchart of the followed workflows.

- The LiDAR scans were registered using an automatic plane-based registration;
- The colour digital images were processed following a photogrammetric SfM-based procedure;
- The TIR images were processed following two different pipelines: when possible (i.e., when the thermograms were acquired following photogrammetric criteria), a standard photogrammetric SfM-based workflow was followed, similar to colour processing; the second workflow consisted of projecting the thermal images on the 3D mesh derived from LiDAR—characterised by a very high spatial resolution—to generate a thermal texture;
- These procedures will be further described in the following sections. The workflows carried out in this study can be observed in Figure 6.

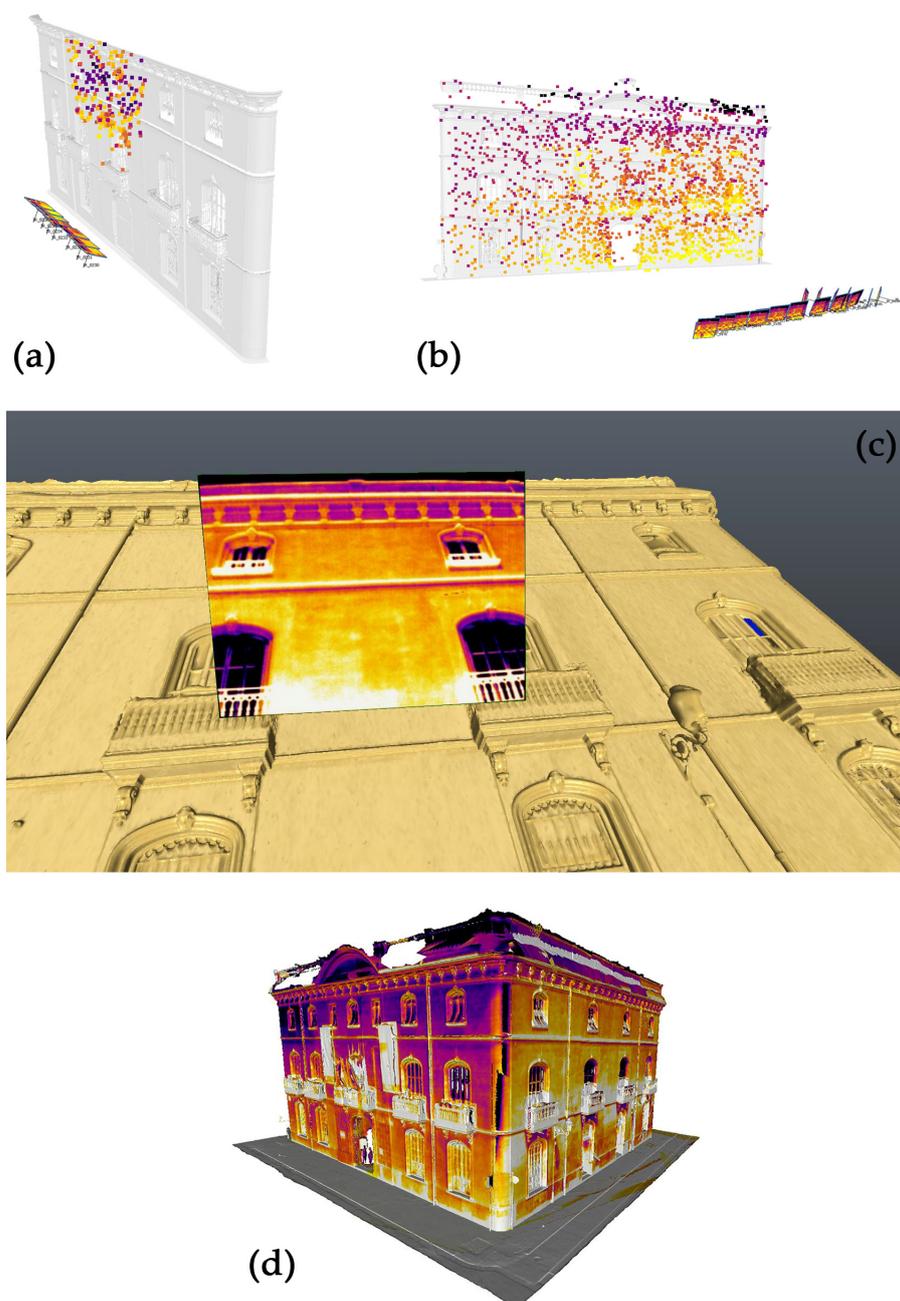
**Figure 7.** (a) Oriented block of thermal images following an SfM-based pipeline (upper area of the central modules of the northern façade); (b) oriented block of thermal images following an SfM-

based pipeline (southern façade); (c) example of oriented TIR image projected of the three-dimensional surface; (d) 3D mesh after the first phase of the texturisation.

- Manual collimation of the homologous points. A set of points was manually identified on each thermogram and the corresponding area of the 3D mesh, to estimate the orientation matrix of each image [33] (Figure 7c);

- Generation of a thermal texture. From the previous mosaicking procedure, where all the TIR images were oriented, a thermal texture was generated and projected onto the 3D mesh (Figure 7d);

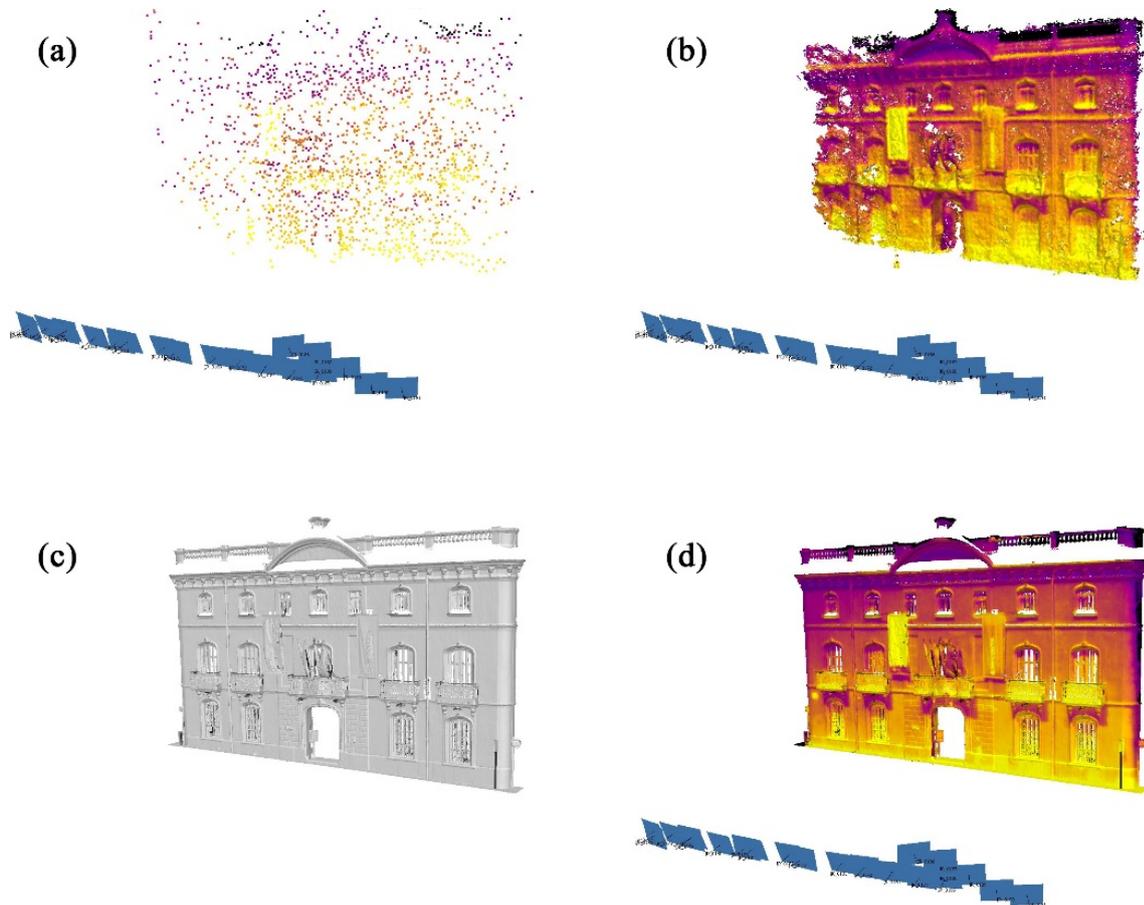
**Figure 8.** (a) Oriented thermal images and sparse cloud of tie points; (b) dense point cloud derived from thermal images, characterised by low resolution and topological errors; (c) high-resolution point cloud derived from LiDAR; (d) integration between the LiDAR point cloud (high-resolution geometry) and thermal data (information connected to the radiometry).

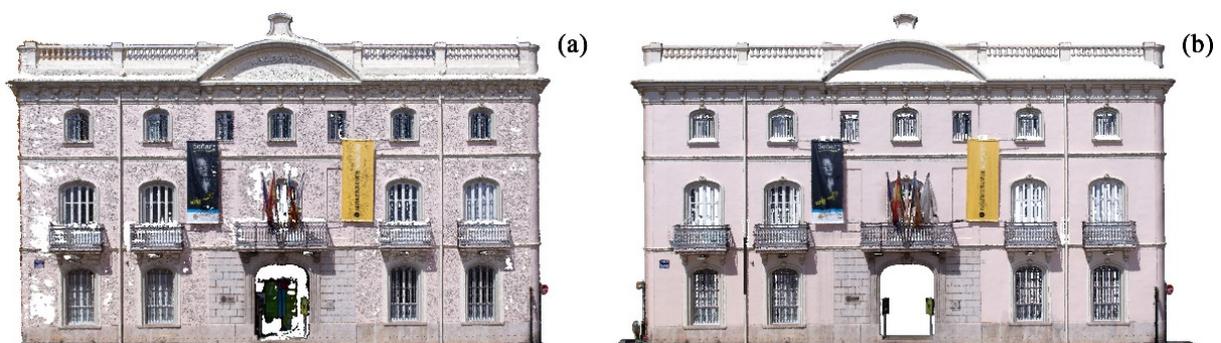
**Figure 9.** (a) Photogrammetric point cloud; (b) LiDAR point cloud coloured from the digital images oriented during the photogrammetric process.

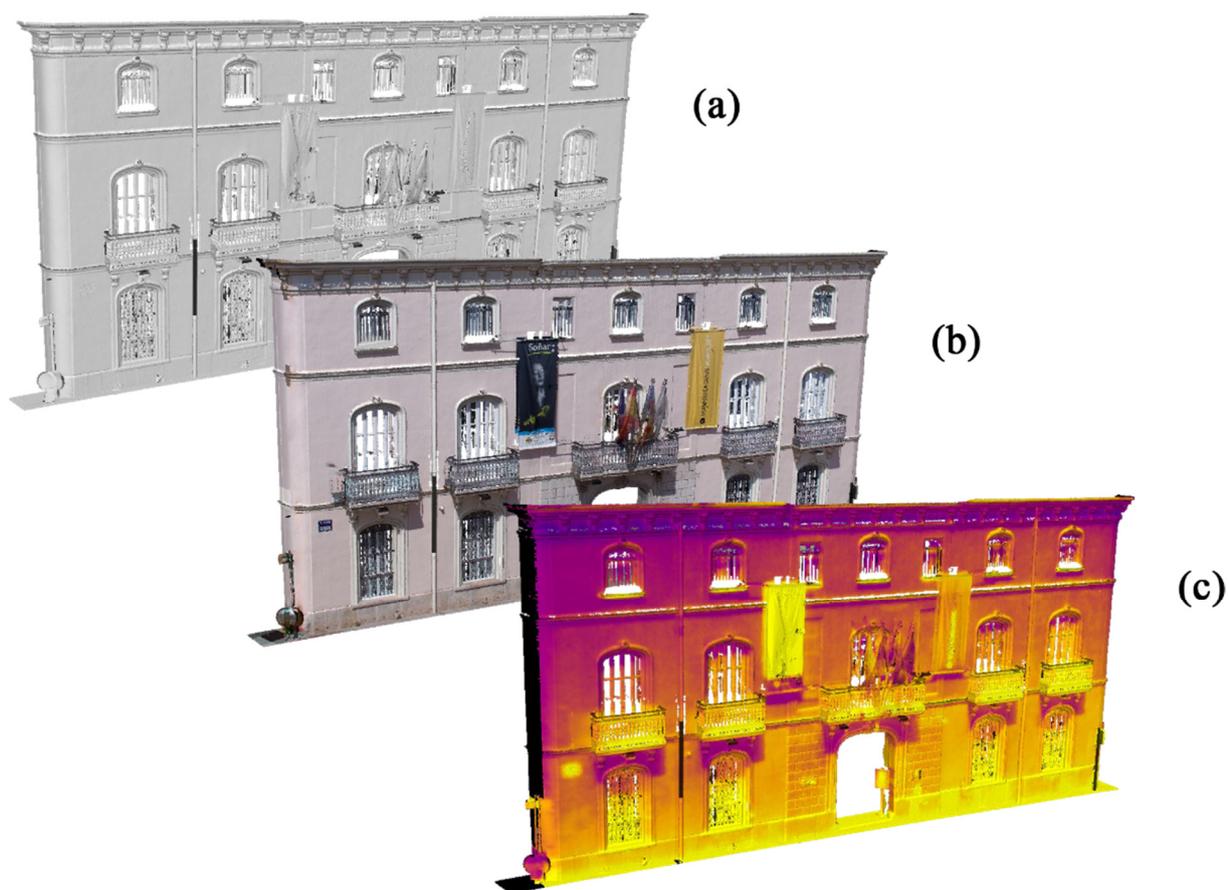
**Figure 10.** (a) LiDAR point cloud; (b) LiDAR point cloud (photogrammetric integration with colour images); (c) LiDAR point cloud (photogrammetric integration with TIR images).

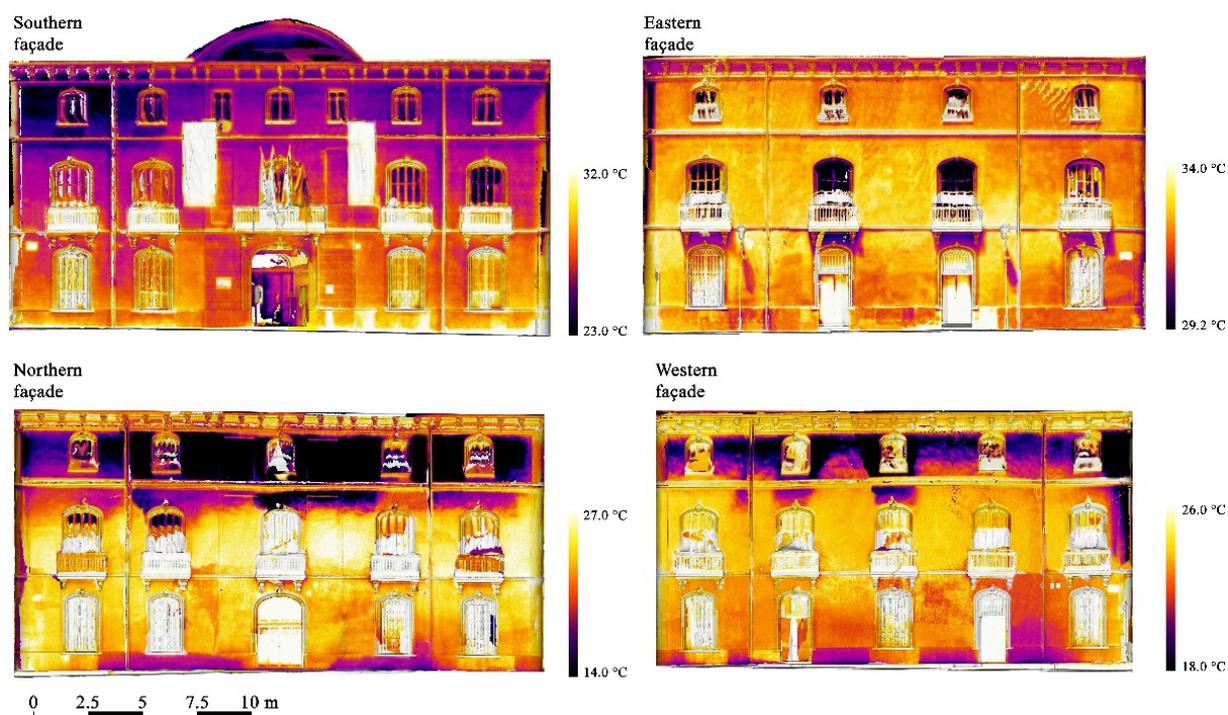
**Figure 11.** Orthophotos achieved from the integration of the 3D mesh derived from the LiDAR point cloud and projected TIR images after the mosaicking process, aimed at the generation of a thermal texture.

However, it should be noted how the second workflow was more flexible, and how it was possible to be applied to the building in its entirety, allowing the generation of high-resolution orthoimagery of all the four façades of the Palacio de Colomina (Figure 11), while the photogrammetric pipeline allowed the achievement of good results for only some portions of the surveyed façades.

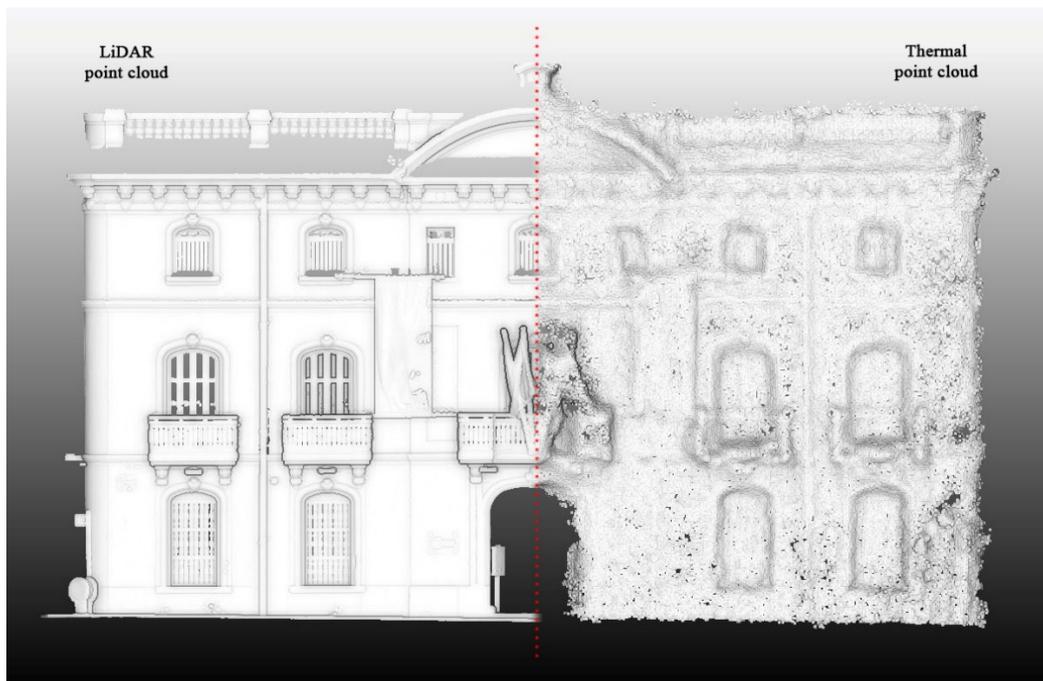
Figure 12. On the left, LiDAR point cloud of the southern façade. On the right, photogrammetric dense point cloud derived from TIR images.

Concerning the photogrammetric data derived from the SfM-based processing of the TIR images, from a preliminary visual inspection, it appears evident that the thermal point cloud was characterised by a lower level of detail and a high level of noise, coherently with the limited spatial resolution of the TIR images. This aspect becomes even more evident by comparison with the LiDAR point cloud, which can be observed in Figure 12. Moreover, as it is possible to follow in Figure 13c, the thermal point cloud was significantly less dense than the others.

It should also be noted that in both the colour point cloud and the thermal point cloud, the left side was more poorly reconstructed (presenting holes, gaps, and lack of information). This was due to the fact that, as previously mentioned, the left side of the Palacio was partially covered by a small building that prevented, in that area, increasing the image acquisition distance. For this reason, the images on the left side of the 3D model were less convergent, leading to a noisier and less complete 3D reconstruction.

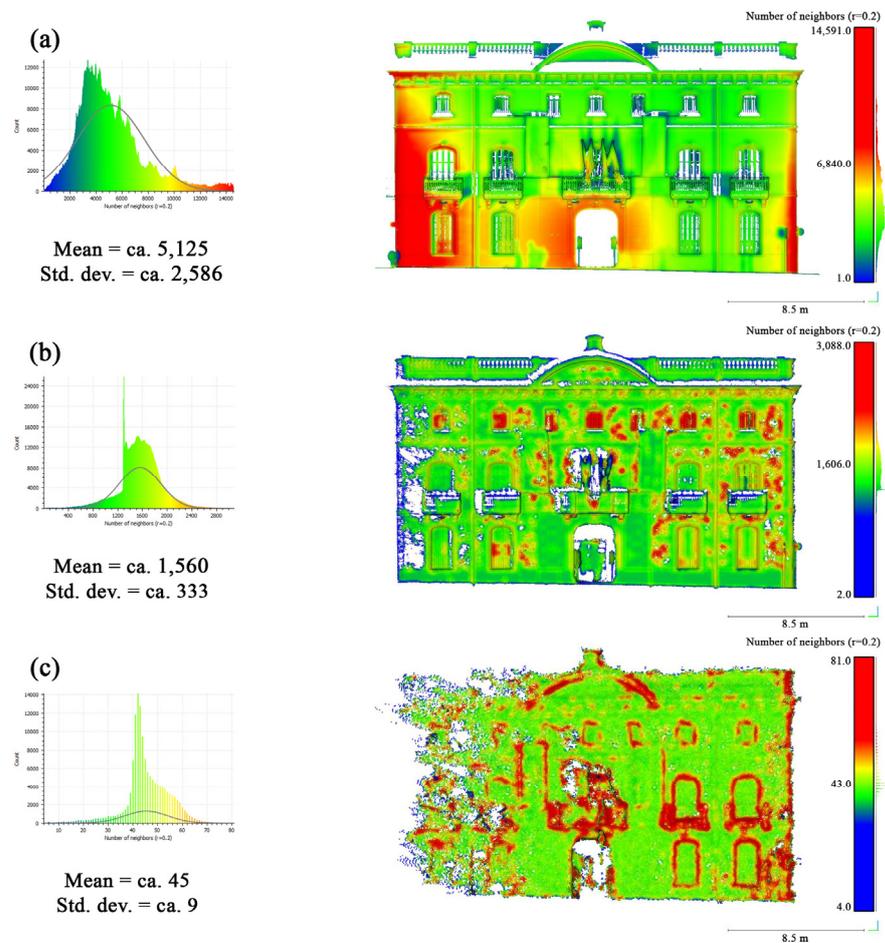
Figure 13. Density analysis. (a) LiDAR point cloud; (b) dense point cloud derived from colour images; (c) dense point cloud derived from TIR images.

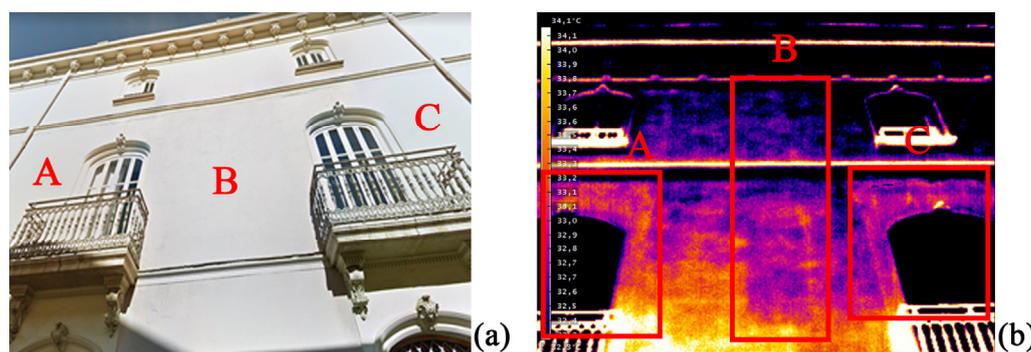
**Figure 14.** (a) Colour image of a section of the eastern façade of the Palacio; (b) thermal image of the same area. It is possible to observe some anomalies not visible in the colour image but clearly detectable in the thermal image (highlighted in red as A, B and C).

- Traces that are consistent with the presence of architectural elements obliterated by subsequent building interventions (Figure 14);
- Possible clues of drastic modifications regarding the volume of the building.

In the first case, by way of example, we report some discrepancies detected in the central part of the eastern façade. Hereby, radiometric contrasts coherent with the presence of (a) façade decorations, niches, or obliterated windows, and (b) remains of the decorated frames of the central windows, appear more massive and thicker, compared with the current ones (Figure 14, areas A and C).

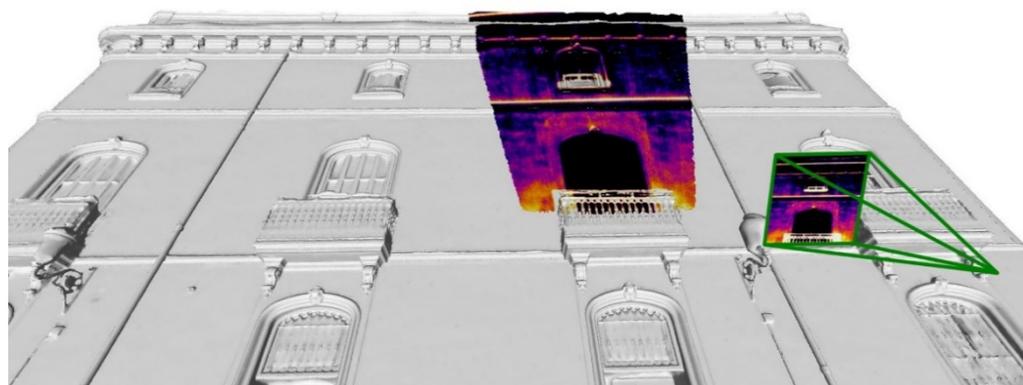
**Figure 15.** Projection of the TIR image evidencing a thermal discrepancy in the eastern façade, coherent with the presence of the remains of a previous frame of one of the main floor windows.

In this case, both the adopted strategies aimed at integration of LiDAR data and TIR images (SfM photogrammetry and texture projection, Figure 15) enabled us to spatialise the hidden elements on the 3D surface, representing a significant advantage during the 3D modelling phases.

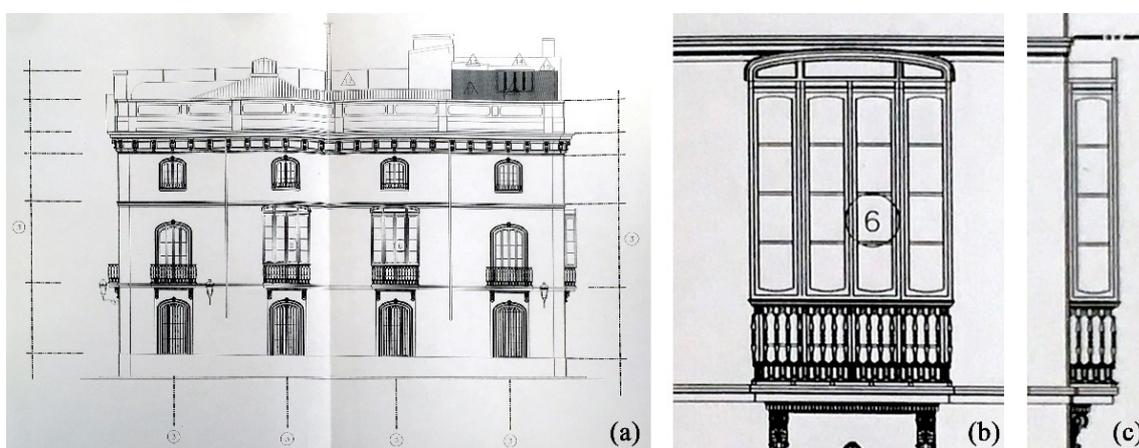
**Figure 16.** (a) CAD drawing of the eastern façade in 1995 before renovation. The two central windows of the second floor are shown with a glass housing, which was later removed; (b) front view of the housing; (c) side view. Architect Francisco Esquembre Casañ. Intermediate Municipal Archive of the Valencia City Council. Urban Police, file number 608, year 1995.

However, for a correct interpretation of the anomalies to distinguish between niches and obliterated windows, a comparison with archive data helps. To initialise modifications and renovations of the Palace, CAD plans with condition mapping were created in 1995. On the eastern façade, two glass housings of the central balconies are shown (Figure 16). Such housings were typical in Valencia during the first half of the 20th-century and are still preserved in many other buildings. They were used to enlarge the room by including the balcony. Therefore, the wall was opened to the entire width of the balcony. The shape of anomalies A and C detected in the TIR data (Figure 14) well fits the frame of the wooden housing shown in the plans. Two more pieces of information were given in the plan. First was the reason why the housings were removed during the renovation, as their construction was indicated as being in poor condition “*agrietamiento carpinteria*”. Second was the former opening of the wall to the entire width of the balcony, mentioned by a horizontal cutout of the wall “*Degüello horizontal muro*”. This means the housings were removed during the renovation, and the openings in the wall were closed to fit the window frames. Therefore, other materials were used, causing the thermal differences.

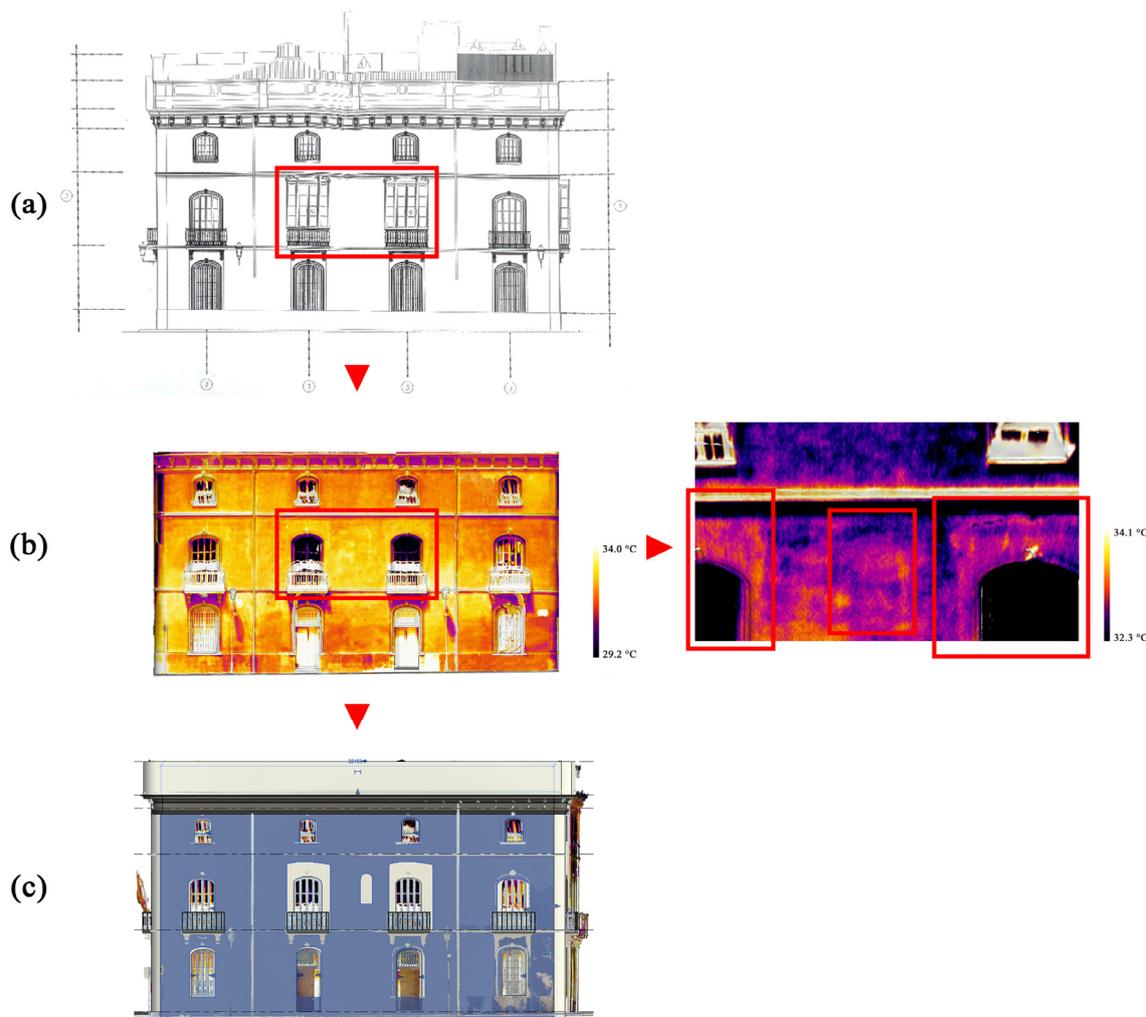
**Figure 17.** Eastern façade. Superimposition of different data in the HBIM environment: (a) condition mapping from 1995; (b) TIR orthoimagery showing the thermal anomalies (different temperature scales); (c) virtual reconstruction of the “A” and “C” anomalies according to the historical plan and further reconstruction of the central “B” anomaly.

In order to stress the effectiveness of the possibility of matching historical documents in a BIM environment, an example is proposed regarding the thermal anomalies detected on the east façade. While overlaying the thermal information and the historical plans, a direct comparison was much easier, and the location of the thermal discrepancies “A” and “C” could be analysed in connection with the condition mapping of 1995 (Figure 17).

The cause of the thermal anomaly “B” remains unclear. The discrepancy shape is coherent with a horizontal line ending in an arch. Within the HBIM, it is possible to model virtual reconstructions. In this way, the thermal anomaly was reconstructed together with the changes in the central windows (Figure 17c). Based on this virtual reconstruction, the anomaly can be better discussed. There are two possible interpretations: in the first, the anomaly could be interpreted as a niche in the façade, which is common in similar examples in Valencia (Figure 18). However,, as observed in the virtual reconstruction, the niche would not fit symmetrically into the façade, shifting out of the central axis. Therefore, a connection to the visible façade representing the construction of 1863 with perfect symmetries is unlikely. This leads to the second interpretation. The anomaly may have been caused by an occluded window of an earlier construction of the building. This would be an indication that structures of previous buildings are still preserved underneath the shape of the 1863 façades.

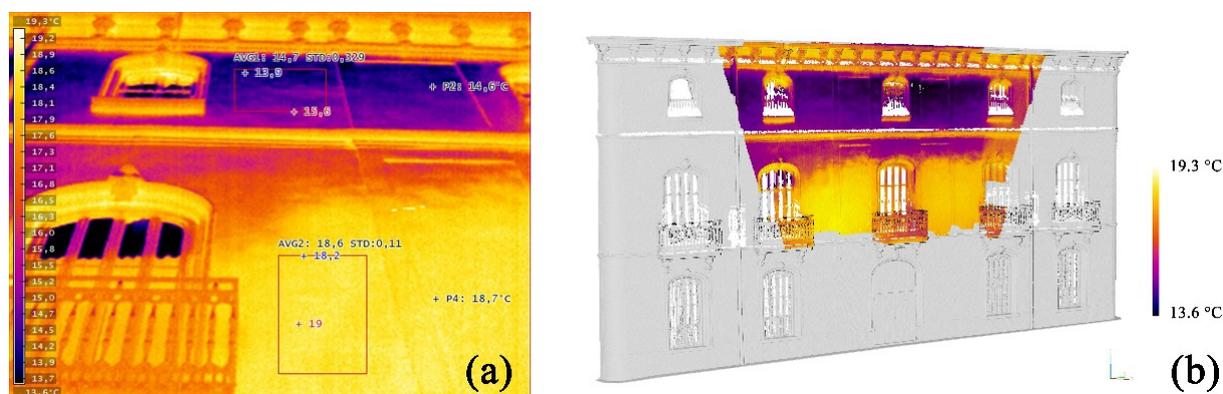
**Figure 19.** (a) TIR image of the northern façade upper area, evidencing a remarkable thermal discrepancy between the second and the third floor (approximately 5–6 °C); (b) 3D data integration between the LiDAR point cloud and TIR images through SfM photogrammetric processes, evidencing a thermal discrepancy between the second floor and third floor.

Additionally, another thermal discrepancy was detected, suggesting a modification of the building volume, as observable in Figure 19. In this case, a significant difference in temperature (ca. 5–6 °C) was observed between the second and the third floors of the northern and the western façades (Figures 13 and 19). The phenomenon appears consistent with an enlargement of the Palacio with an additional floor using different materials, characterised by a significant emissivity difference. Together with the detection of the hidden arch (Figure 17), this observation proves the existence of two levels of a preliminary building, preserved under the actual façades. This is coherent with the information derivable from the 18th-century plan from Tomás Vicente Tosca in 1704 and the *Valentia Edetanorum vulgo del Cid* from J. Fortea in 1738 [27] where the building was shown with only two floors and a smaller volume. Furthermore, the integration of former constructions could be the reason why the first proposal for the renovation in 1863 (Figure 2a) was rejected. The first draft from June 1863 was characterised by only two floors, but it included a basement. If the preliminary building did not have a basement, completely new construction would have caused much higher effort and costs, especially compared with the re-use of existing constructions that were enlarged with a third floor on top.
