After the earthquake. Design processes for intervention on vernacular heritage in Central Italy

Gianluca Loffredo¹, Federica Recla², Nicolò Suraci³, Cristiano Tosco⁴

Topic: T4.1. Conservation and restoration projects of vernacular architecture

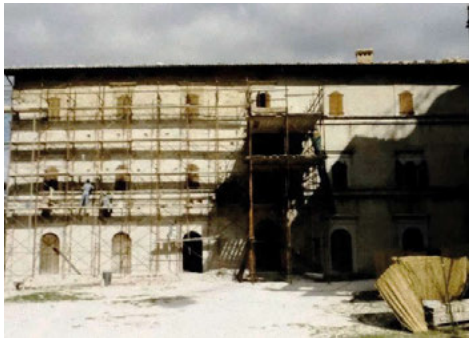
One of the main topics is the potential reintroduction of the plaster on the natural stone façade of *Palazzo delle Guaita*. Historic research, historical pictures (Fig. 3), and an accurate survey of the masonry stone suggest that the exterior aspect of that building was historically characterized by the presence of plaster. The reintroduction of plaster, in addition to FRCM (Fabric Reinforced Cementitious Matrix), would nowadays be a proper method to increase the mechanical resistance of the masonry and, concurrently, restore the historical appearance of the building.

Fig. 3. Photography from 1988 testifying the presence of plaster on the Shrine façades (Source: Archivio Impresa Alessandrini, 2019)

The historical accuracy of this solution could be proved by the documents conserved in the historical archive of the complex, which was, however, preserved inside another monumental complex severely damaged during the earthquake: the church complex of *Collegiata di Santa Maria*. Its content was transferred to a temporary location, inside the *Archivio di Stato* in Ancona. Today, the consultation of this material is unfortunately not possible, even though there are arrangements in progress with UNIVPM (*Università Politecnica delle Marche*).

Furthermore, the reintroduction of the plaster on the façade must be discussed and approved by *Soprintendenza* and Municipality, since the architectural complex is in an area characterized by particular landscape interest. Therefore, an intervention that changes the exterior aspect of the buildings must be accurately motivated⁷.
