After the earthquake. Design processes for intervention on vernacular heritage in Central Italy

Gianluca Loffredo¹, Federica Recla², Niccolò Suraci³, Cristiano Tosco⁴

Topic: T4.1. Conservation and restoration projects of vernacular architecture

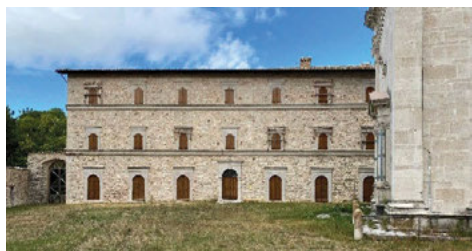
Fig.1. View of “Palazzo delle Guaite” (Source: Cristiano Tosco, 2021)

Besides the central plan church, characterized by square honed stones (ashlar masonry), the complex consists of four main buildings: *Palazzo delle Guaite* (Guardhouse) (Fig. 1), *Casa dei Pellegrini* (Pilgrims' house), *Casa dell'Armata* (Army house) and *Fontanile* (Fountain building).

All the buildings are nowadays characterized by natural cleft stone facades, even though some plaster traces are visible. Thanks to the absence of plaster, it is possible to read different textures in the natural stone, which suggest transformations and additions in the construction history.

The quality of the masonry is adequate since the walls are not built with sack masonry, nevertheless, the mortar has a poor quality.⁶ These characteristics, combined with other factors (volumes, heights, seismic intensity, etc.), have led to several cracks and some localized collapses.
