A Machine Vision—Based Pipe Leakage Detection System for Automated Power Plant Maintenance

A Machine Vision—Based Pipe Leakage Detection System for Automated Power Plant Maintenance / Bao, Nengsheng; Fan, Yuchen; Ye, Zihao; Simeone, Alessandro. - In: SENSORS. - ISSN 1424-8220. - 22:4(2022), p. 1588. [10.3390/s22041588]

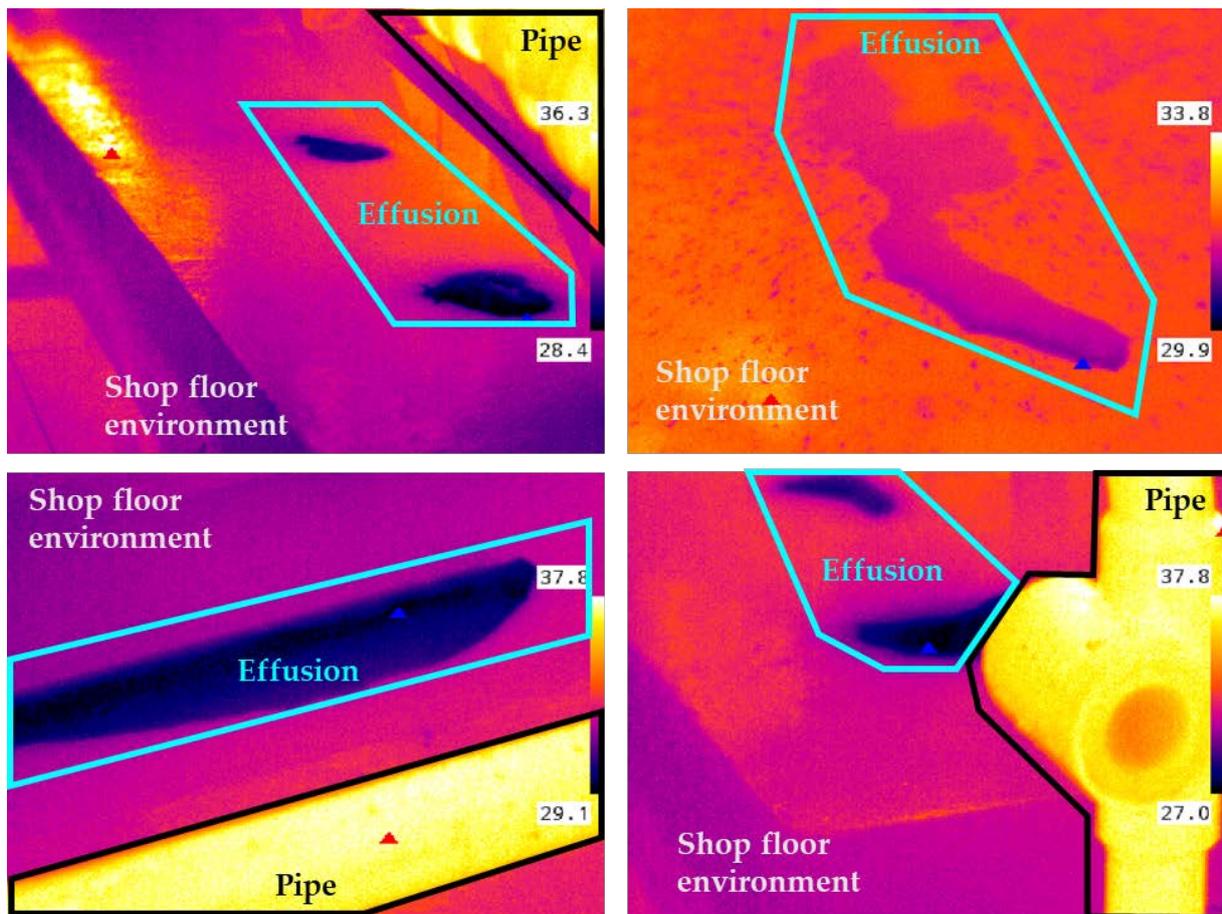
Figure 1. Infrared measurements (in °C) carried out at HUANENG thermal power plant. The variability range in effusion temperature is due to ambient temperature, different pieces of equipment and distance from pipe to the effusion.

In order to characterize the operating conditions, an industrial survey of temperature measurements was carried out at HUANENG power plant, Shantou, China, with the aim of defining the temperature ranges of the equipment to be inspected. Figure 1 shows four survey image instances in which the temperature of the working pipe ranges between 33 and 37.8 °C, the effusion on the ground ranges between 28 and 30 °C, and the ambient temperature is between 31 and 33 °C. The temperature survey was carried out for a large amount of equipment within the HUANENG facilities throughout a long period of time, showing that such temperature ranges are consistent in space and time with a very limited variability range (as shown in Figure 1).

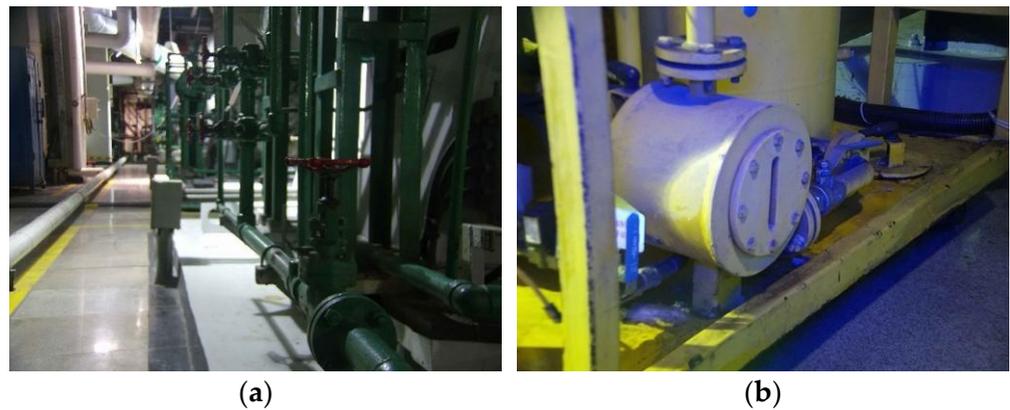
Figure 2. Significant difficulties in the actual factory environment: (a) Complex pipework layout; (b) diverse illumination conditions and non-uniform light distribution result in highly variable detection area background.

The visual detection technology survey suggests that the two major characteristics of colorless effusion, namely the reflective characteristic under full lighting and the low temperature characteristics in the environment, can be deployed by existing technology for detection purposes. However, the design and implementation of a comprehensive detection system results difficult in complex industrial environments. With reference to a generic thermal power plant, on the one hand, the site environment is complex and characterized by crisscrossing pipelines, with significant environmental interference problems occurring during maintenance inspection such as humidity and cold areas (as shown in Figure 2a). On the other hand, the areas affected by fluid effusion are usually poorly illuminated, making the colorless effusion detection hard to be directly performed (as shown in Figure 2b).

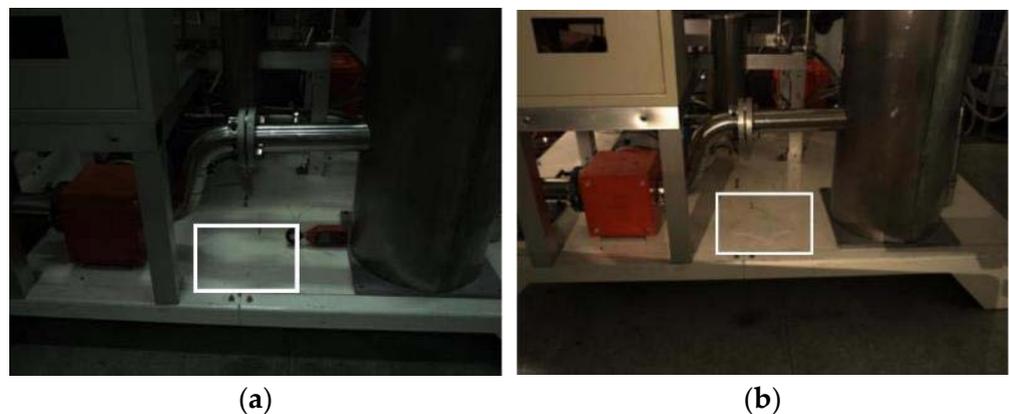
Figure 3. Difficult to detect colorless effusion (in the white box): (a) effusion feature in natural light; (b) effusion feature under LED flash light.

In general, the illumination conditions of the overall environment can be enhanced through a flash light, but visual characteristics of the leakage would still tend to appear as colorless, as shown in the white box mark in Figure 3a. The use of additional LED lights could enhance the water leakage edge features visualization, but the overall edge contour would look still fuzzy and hard to detect (as shown in Figure 3b).

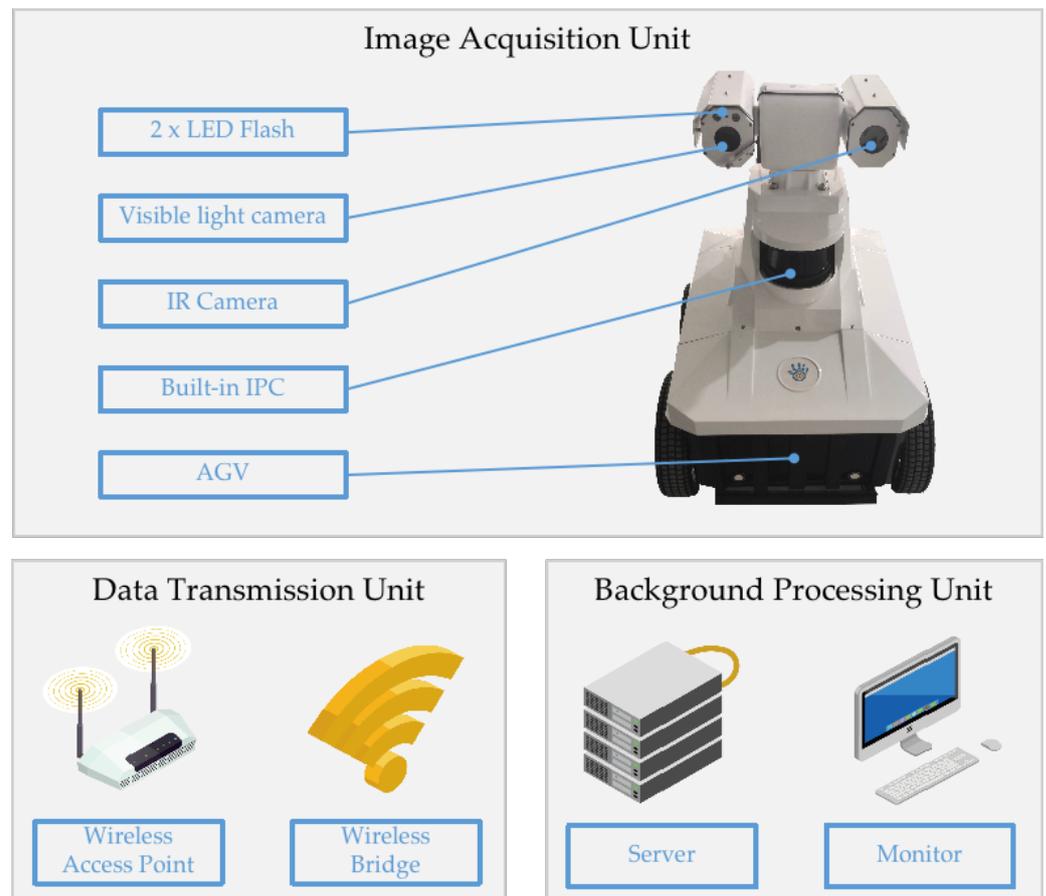
Figure 4. Inspection system hardware structure: the images acquired by the acquisition unit are sent to the processing unit through a wireless network endowed with an access point and a number of wireless bridges to cover the entire area. Images are then processed and stored in a dedicated server. A GUI visible on a monitor allows for interactive monitoring.

Taking into account the characteristics of weak illumination and complex environment in an actual industrial scene, this paper proposes a machine vision-based pipe leakage detection system. Such a system consists of three units: an image acquisition unit, wireless transmission unit, and background processing unit (as shown in Figure 4).

The image acquisition unit is composed of an automatic guided vehicle AGV (738 × 864 × 592 mm), visible light camera, two flash lights, an infrared camera, and an industrial personal computer (IPC). The visible light camera and infrared camera can capture high-definition images in two different light spectra at the same time [34]. In order to solve the problems of uneven light in the industrial environment and the consequent difficulty in identifying the features of colorless effusion, a pair of flash lights is designed for the image acquisition unit to expose the contour of different shapes of effusions more clearly.

The wireless transmission unit, made of an access point and a wireless network bridge, is responsible for establishing the wireless transmission channel from image acquisition unit to the data processing unit. The background processing unit includes hardware devices such as computing servers, computer monitor, and intelligent algorithms contained therein. The unit is used for image processing, data storage, and decision-making.

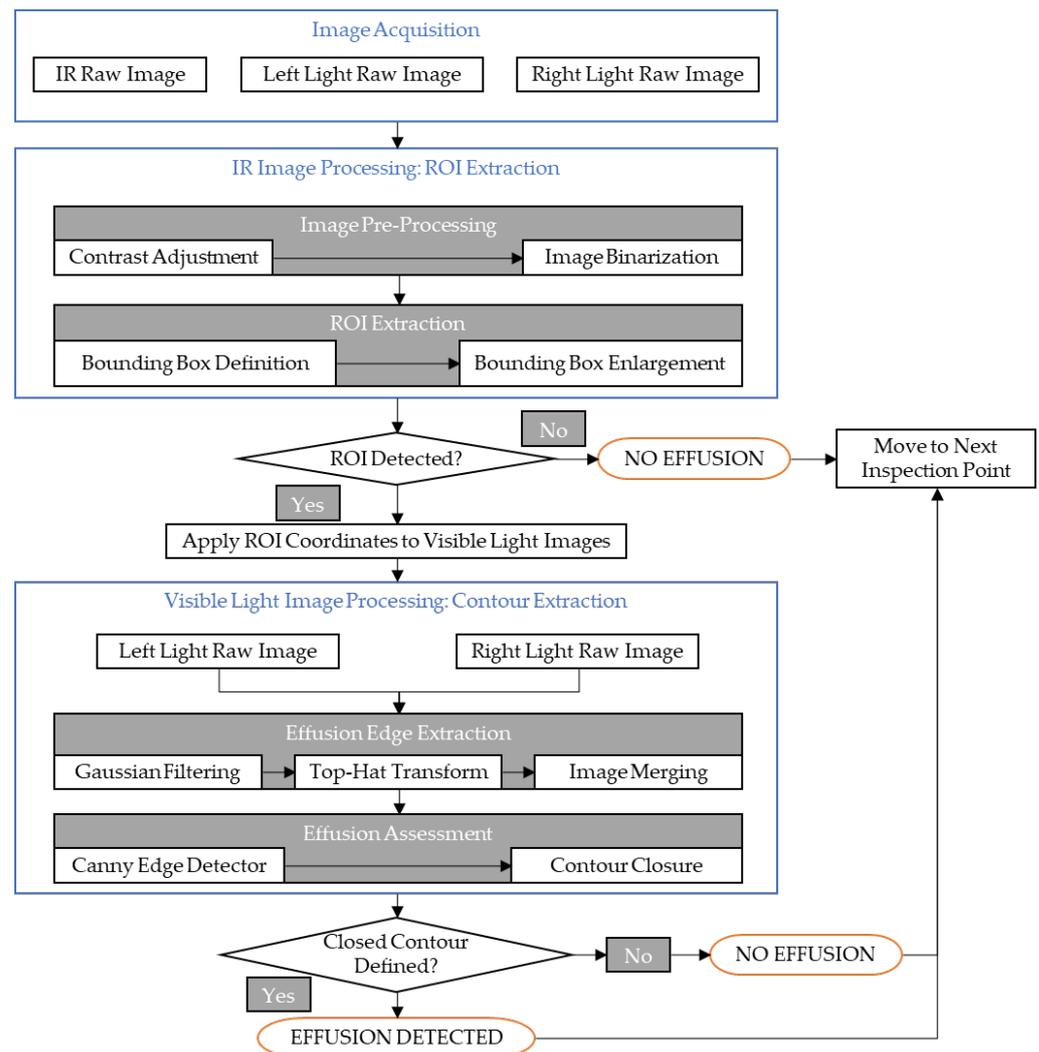
Figure 5. Detection system overall flowchart.

In order to overcome the interference and occlusions caused by complex background, this paper proposes an automatic inspection system for colorless effusion contour detection method based on the sequential analysis of multi-source images. The framework flow chart of the proposed system is reported in Figure 5.

The first step is the image acquisition, which consists in the simultaneous generation of three digital images, respectively consisting in an infrared image and two visible light images using a left and a right light source separately.

The second step involves the infrared image processing. In this respect, according to the low temperature characteristics of the effusion, the potential effusion is identified and its position is determined by the definition of a region of interest (ROI).

The third step is the visible light image processing in order to define the effusion contour. Then in the fourth step, the ‘top hat’ algorithm [35] is used to completely extract the effusion edge. The last step carries out a further image processing aimed at the effusion assessment enabled by the computation of the contour closure.

To summarize, the overall process first uses infrared imaging to locate a potential effusion and then conducts a secondary assessment for the final effusion characterization. In this way, the leakage identification efficiency can be improved, and environmental interference can be reduced at the same time, thus improving the recognition accuracy.

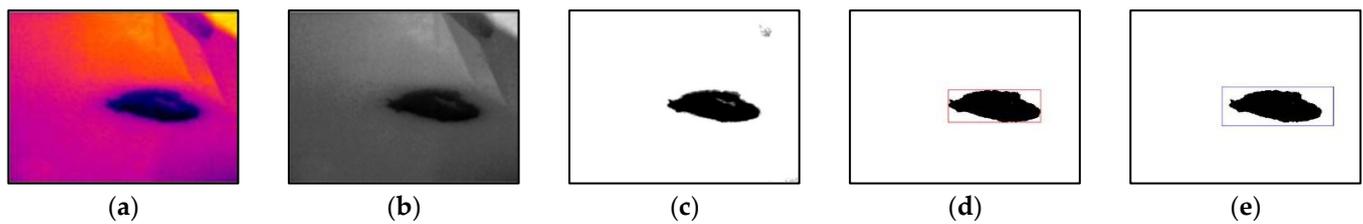
Figure 6. IR image processing procedure: (a) raw IR image in false colors, (b) infrared grayscale image, (c) enhanced contrast image, (d) bounding box, and (e) enlarged bounding box.

The temperature inside the power plant furnace reaches more than 1700 °C [36], requiring the use of side and wall air supply and other technologies to cool down the high temperature and avoid pipeline corrosion [37]. The temperature survey mentioned in Section 1 confirmed the temperature of effusion accumulation due to pipe water leakage is always lower than the ambient temperature, forming a temperature gradient in the pipeworks surrounding environment (as shown in Figure 1). Infrared thermal imaging technology allows for the surface temperature measurement of an object based on its thermal radiation energy [38]. In this respect, a potential leakage can be automatically identified by processing an infrared image, firstly performing a contrast enhancement, saturating the bottom 2% and the top 2% of all pixel values, and subsequently binarizing the image using Otsu's thresholding method [39]. Such a technique has been selected due to its good binarization results with reference to the images under examination, the short computation time, and high implementation flexibility. From the binarized image, a region of interest (ROI) of the leakage area is defined by computing the bounding box of the resulting image region. In order to ensure that the ROI fully contains the complete edge contour of the leakage area, the rectangular bounding box is enlarged by 20% (as shown in Figure 6).

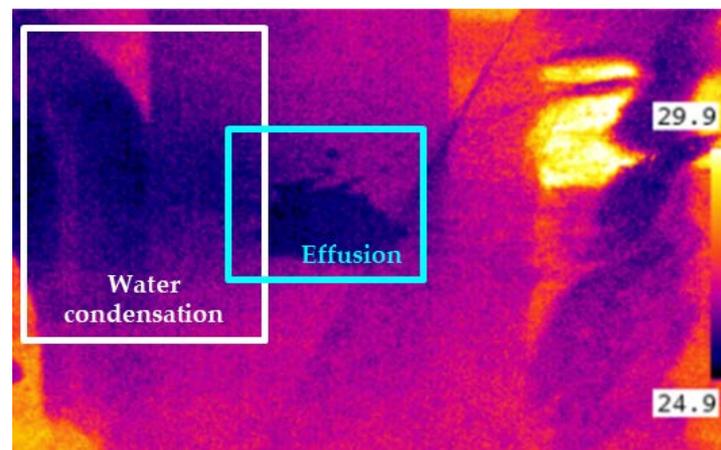
Figure 7. Infrared image of effusion in a humid environment, units in °C.

Although a colorless effusion has a lower temperature compared to the environment, the recognition of fluid accumulation within an infrared image could be potentially affected by water condensation phenomena on pipes, equipment, and floor. Figure 7 shows how, in a humid environment, water condensation and actual effusion could partially overlap, increasing the complexity of the classification task. This scenario indicates that, in the presence of humid environments, relying on the sole use of infrared imaging would produce a high false positive rate [30].

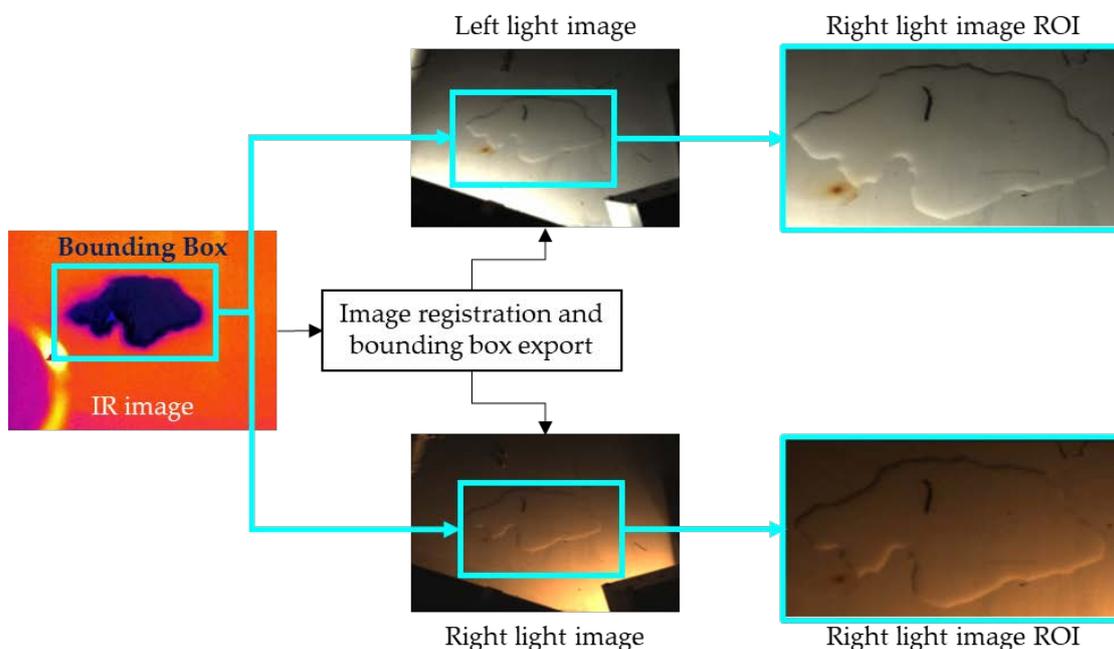
Figure 8. Visible light images ROI extraction process from the IR image. The ROI is firstly identified on the IR image, then the IR image and the visible light images are registered, and the ROI is exported and applied to the visible light images.

The specific process is as follows: for a single detection task, the system will acquire a set of three digital images (specifically an infrared image, a left light image, and a right light image). Initially the images need to be aligned to compensate the offset between the two cameras. Subsequently, an infrared image pre-processing is performed and aimed at the ROI extraction (as mentioned in Section 4.1). Then the computed ROI coordinates will be utilized on the left and right light source images, respectively (as shown in Figure 8).

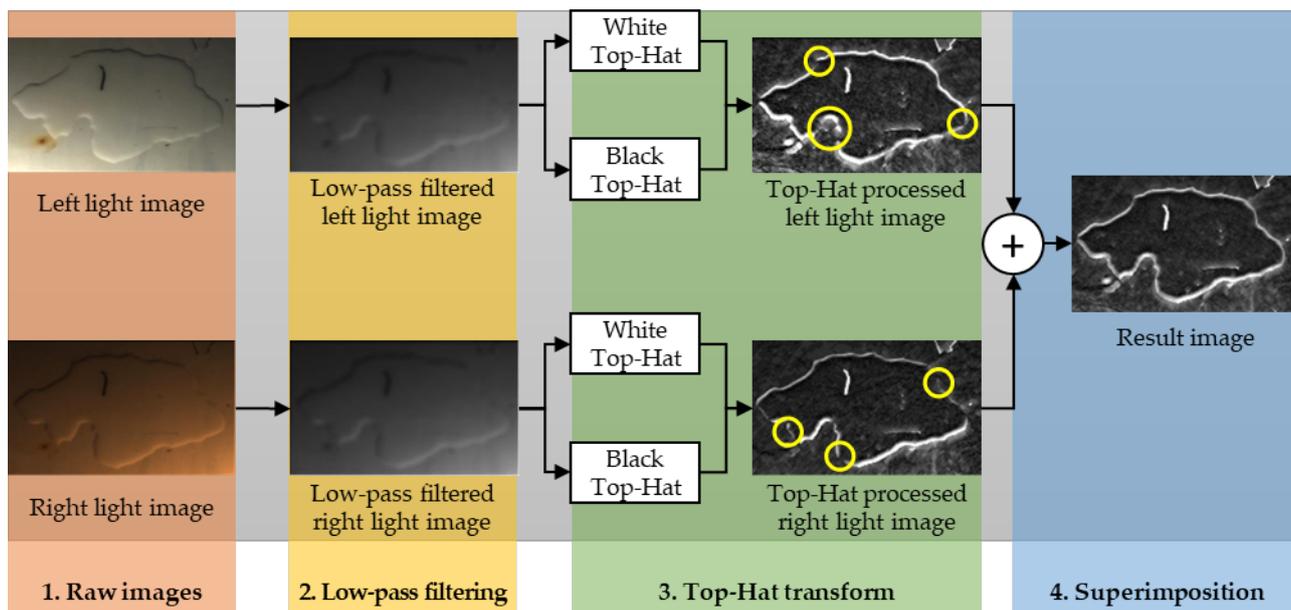
Figure 9. Visible image processing steps including gaussian denoising, top hat processing for contour extraction, and superimposition to remove contour discontinuities.

In this phase, the visible light raw images (Figure 9, step 1) are subject to a Wiener low-pass filtering [40] with a 5×5 pixel neighborhood size, with the aim of reducing the ambient noise. After filtering (as shown in Figure 9, step 2), the effusion contour presents a dark edge on the top (farther from the light source) and a bright edge on the bottom (closer to the light source). The effusion contour extraction is then carried out by applying a top-hat transform [35]. Specifically, a black top-hat and white top-hat transforms [35] were both applied to the input images and highlight the effusion contour.

In this paper, both WHat and BHat transforms have been configured with a 35×35 pixel neighborhood size and a diamond-shaped morphological structuring element [41] Following this twofold top-hat transform, both bright and dark edge features of the effusion are highlighted (as shown in Figure 9, step 3).

Due to the light sources' configuration and the water mass position, a single visible light source image can produce some discontinuities in the contour definition (see the yellow circles in Figure 9) leading to possible missing segments in the contour. To overcome this issue, the two top-hat processed images (i.e., left and right) were then superimposed to obtain the complete effusion contour characterization (Figure 9, step 4).

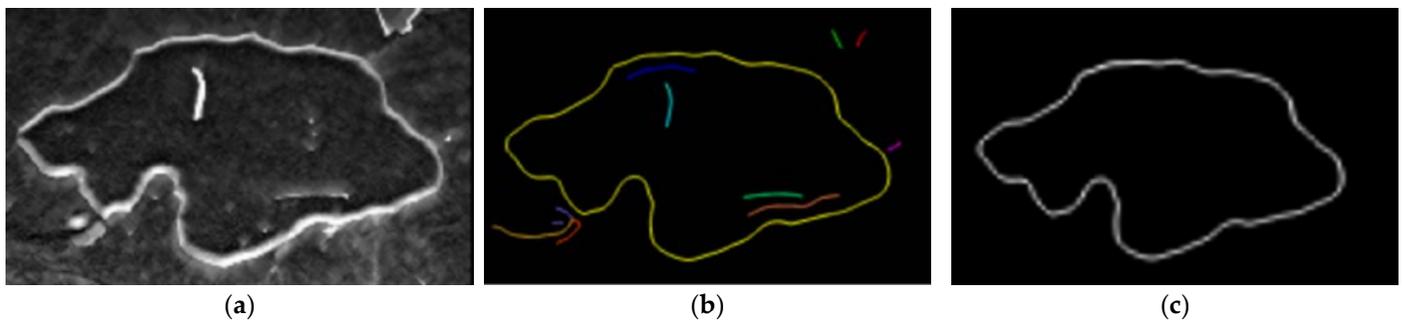
Figure 10. (a) Top hat processed image, (b) edge extraction results of effusion contour, and (c) result of effusion contour extraction.

The final stage of the effusion detection is carried out in this phase. The images resulting from the previous steps are subject to a Canny operator-based [42] procedure to determine the effusion edge. This algorithm uses two different thresholds to detect two types of edges, namely strong and weak edges. Strong edges are defined as the actual effusion edges while the weak edges are potential noise which needs to be further assessed. The advantage of this algorithm is that it can identify the real strong and weak edge information in the image more accurately, highlight the edge information, and reduce the interference of the environment. The process result is shown in Figure 10.

(1) The input image, shown in Figure 10a, is smoothed and denoised via Gaussian square filter, with a kernel size of 7×7 pixels.

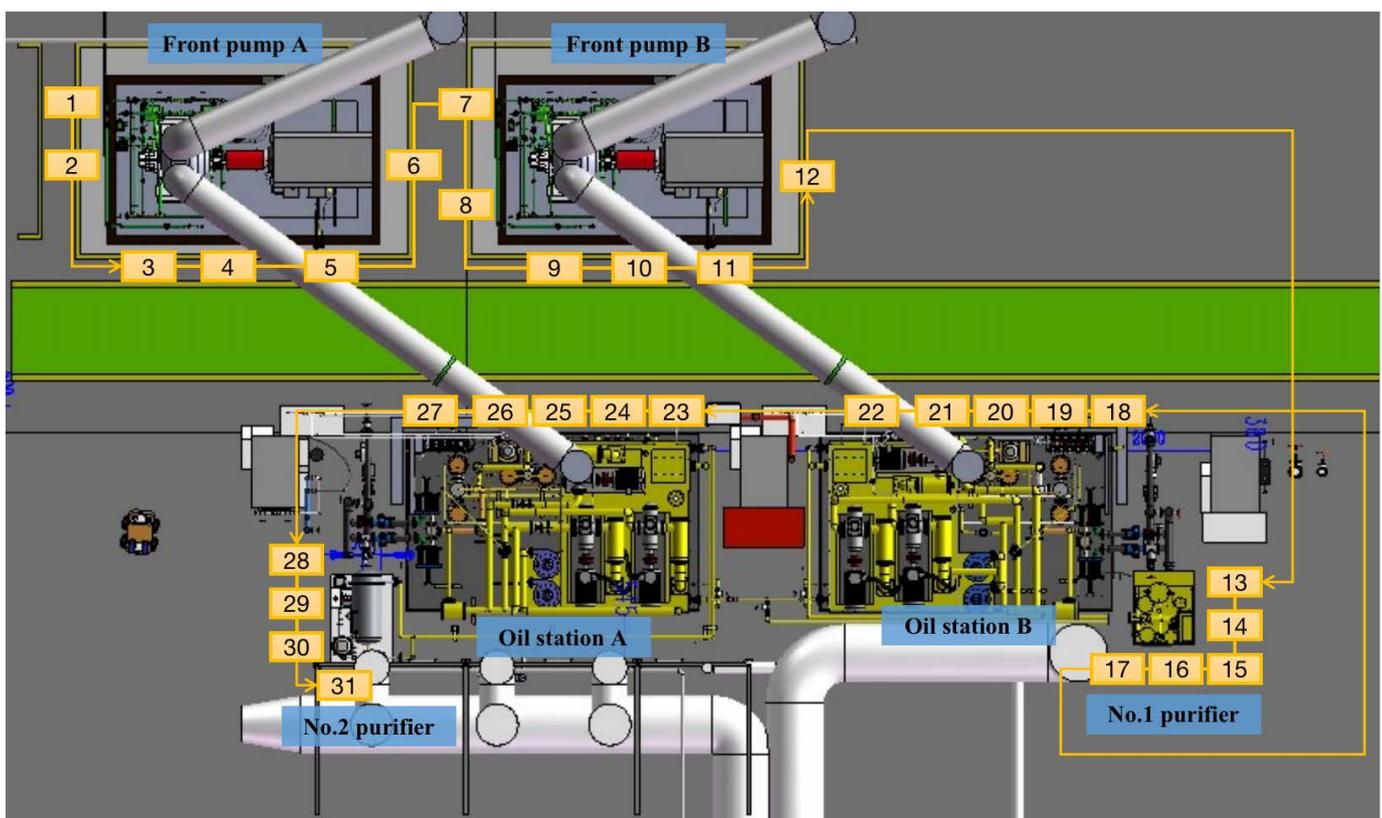
Figure 11. Top view of the overall inspection area including the equipment to be inspected, the 31 inspection points, and the inspection path.

With reference to Figure 11, the overall power plant floor is divided into six inspection areas based on the working equipment location: Area 1 (front pump A); Area 2 (front pump B); Area 3 (No.2 purifier device); Area 4 (oil station A); Area 5 (oil station B); and Area 6 (No.1 purifier device). Each inspection area includes a number of inspection points (i.e., critical points for equipment maintenance). There are 31 total inspection points distributed in 6 inspection areas. In this context, the AGV moves along a predefined inspection path covering the 31 inspection points, as illustrated in Figure 11. To each inspection point corresponds a specific AGV positioning location which is designed to provide for a clear view of the inspection point, minimizing the cluttering and shading.

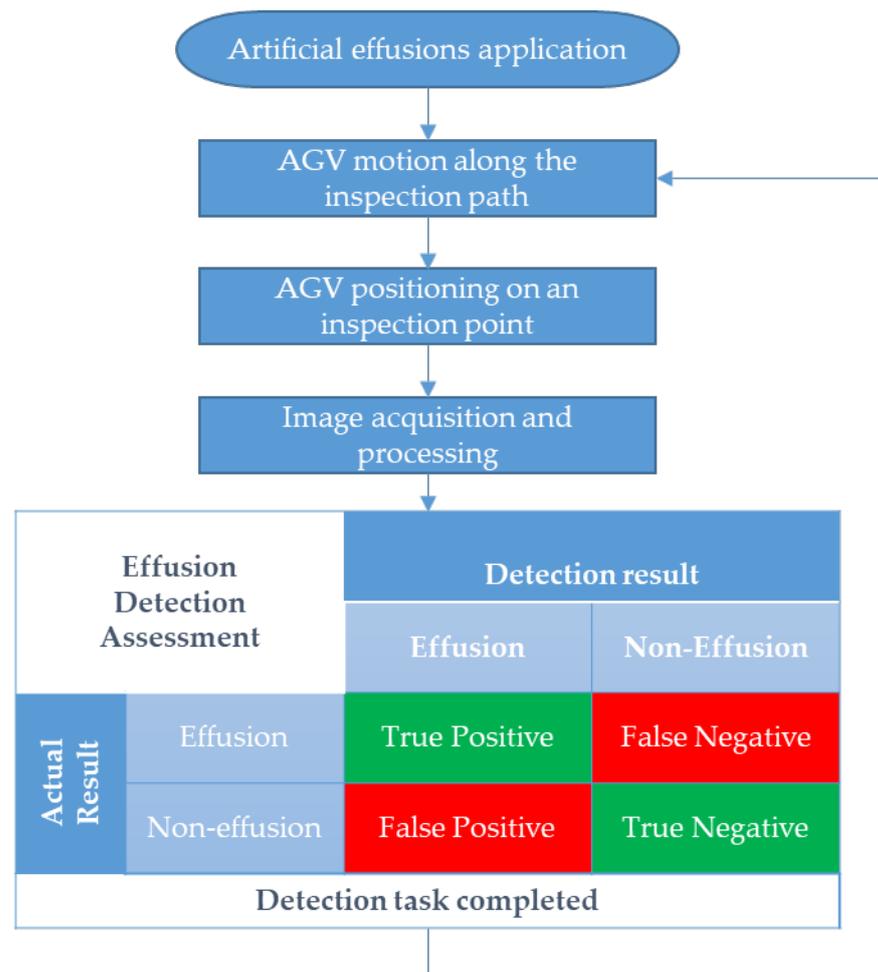
Figure 12. Flowchart of the experimental process including the effusion detection steps and assessment confusion matrix.

Figure 12 illustrates the experimental tests flow chart. Artificial effusions were placed manually by using 0.4 liters of tap water which, considering the floor material, generates an effusion surface of approximately 200 cm². A total number of 461 effusions were placed for the experimental program.
