The 'health record' of the church of Santa Maria Assunta in Pontecurone: contamination between historical knowledge and non-destructive testing results

Giulia Beltramo, Monica Naretto, Monica Volinia

Politecnico di Torino, Department of Architecture and Design, Italy

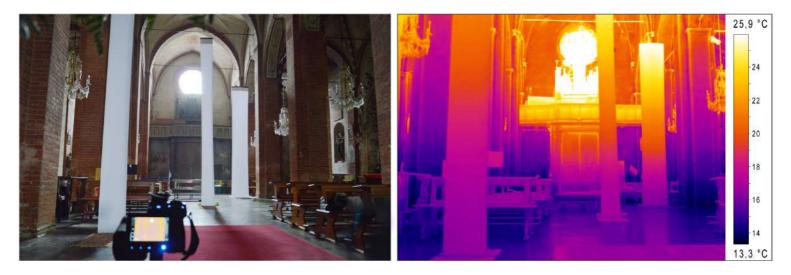
Thermographic acquisitions, conducted with protocols different (active or passive) depending on the objectives, made it possible to identify the textures of vaulted systems, locate cracks and plaster detachments (Fig. 3),

Fig. 3 Right side nave, 4th bay. Active IR scan: gaps and plaster detachments (February 24th, 2021).
