Fine metal dust particles on the wall probes from JET-ILW

E. Fortuna-Zalesna^{a*}, J. Grzonka^{a,b}, M. Rubel^c, Sunwoo Moon^c, P. Petersson^c,
A. Widdowson^d and JET Contributors**

EUROfusion Consortium, JET, Culham Science Centre, OX14 3DB, Abingdon, UK

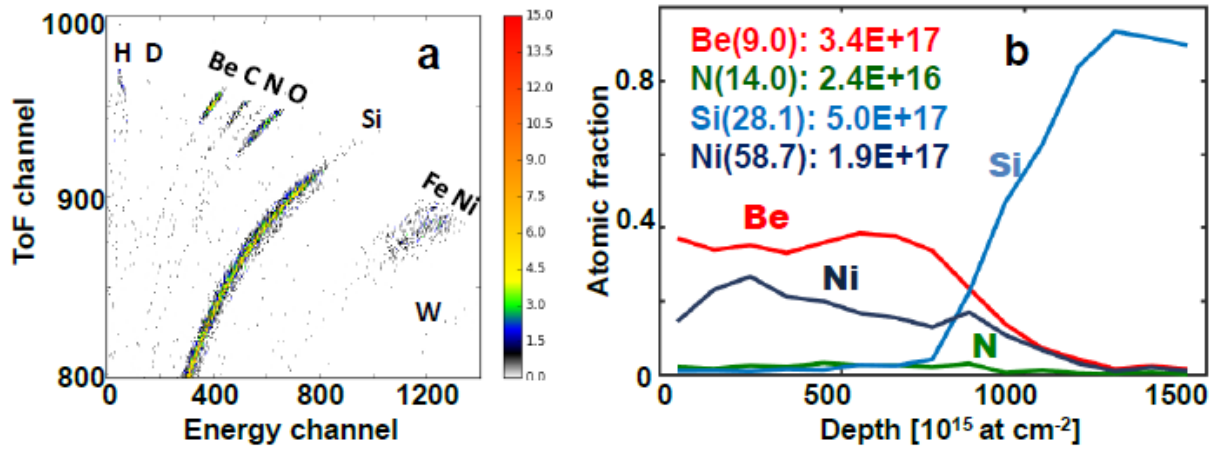
Figure 2

Fig. 2. Results of the silicon plate analysis with ToF HIERDA: (a) spectrum with described detected elements and (b) depth profiles for Be, Ni, N and Si.

Visual inspection of the monitors indicated the presence of thin deposited layers and only very few isolated particles which could be considered as dust. Results of the quantitative depth profiling with ToF HIERDA are in Fig. 2. Features of all co-deposited species are recorded: from hydrogen to Inconel wall components (Ni and Fe) and traces of tungsten. The hydrogen signal is significantly stronger than that of deuterium reflecting the fact that the

ILW-2 campaign was concluded with approximately 300 shots in hydrogen fuel which resulted in the depletion of the D content in deposits on limiters by 30% in comparison to the retention after ILW-1 [12,17,18]. The presence of nitrogen puffed for plasma edge cooling is clearly noticed. The strongest signal is related to silicon from the substrate, thus proving that the layer thickness does not exceed 1 μm , i.e. which is the reliable information depth with HIERDA in layers composed mainly of low-Z atoms. Depth profiles in Fig. 2 (b) for the outer divertor confirm small thickness of co-deposits. Beryllium is the major species (40%), but the contribution of Inconel constituents is remarkably high. Their origin on the outer wall monitor is most probably connected to: (a) the erosion at the Inconel ICRF grill and (b) the unfortunate damage and melting of tie rods in the vertical divertor tiles (Tile 7) and consecutive spreading of Ni and Fe onto the horizontal Tile 6. Erosion of the vacuum vessel wall also contributes to the generation of medium-Z impurities. For clarity of presentation the profiles of carbon and oxygen are not depicted: the concentration of these elements in the co-deposited layer amounts to about 10 and 30%, respectively.

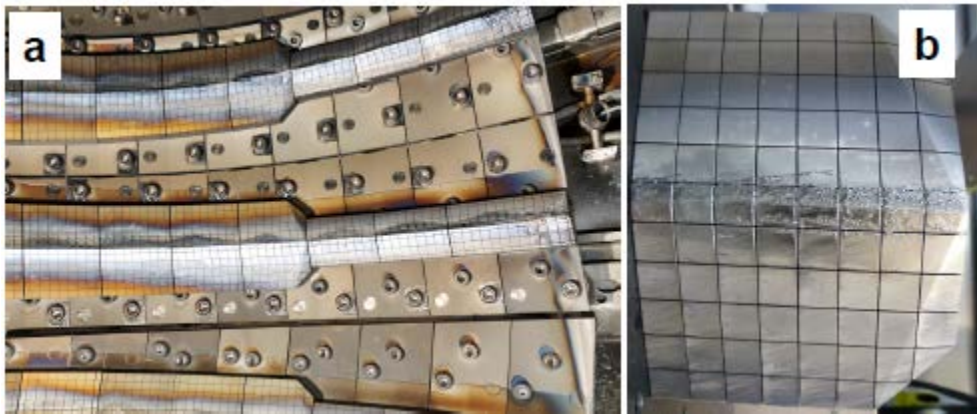
Figure 5

Fig. 5. Top part of the JET vacuum vessel with beryllium upper dump plates: (a) an overview image and (b) details of the molten region.

The fairly uniform internal structure without a split into thin strata clearly confirms that the “pancakes” were formed in a single event, not as a result of gradual deposition over a longer period. The lack of noticeable co-deposited layers provides a strong indication that splashing occurred at the final stages of the ILW-2 campaign. With very high probability it may be attributed to the experiment performed on the last operation day: generation of runaway electrons. High power loads at disruptions caused melting of the upper dump plates (UDP). As a consequence, there was a “rain” of droplets falling at right angle (straight down) from the molten layer of dump plates located just above the monitor on the high field side. Images showing the damage at UDP are in Fig. 5. This explains a circular shape of splashes on that collector. The shape makes these particles distinct in comparison to elongated, even comet-like, metal splashes recorded on earlier occasions when the $\mathbf{j} \times \mathbf{B}$ force played strong role [1,2]. Though the effect of UDP melting is clearly seen it is not possible to conclude whether (and *if*, then to which extent) the matter from the plates was lost or only displaced. High-resolution photographic survey of the entire vessel also enabled identification of

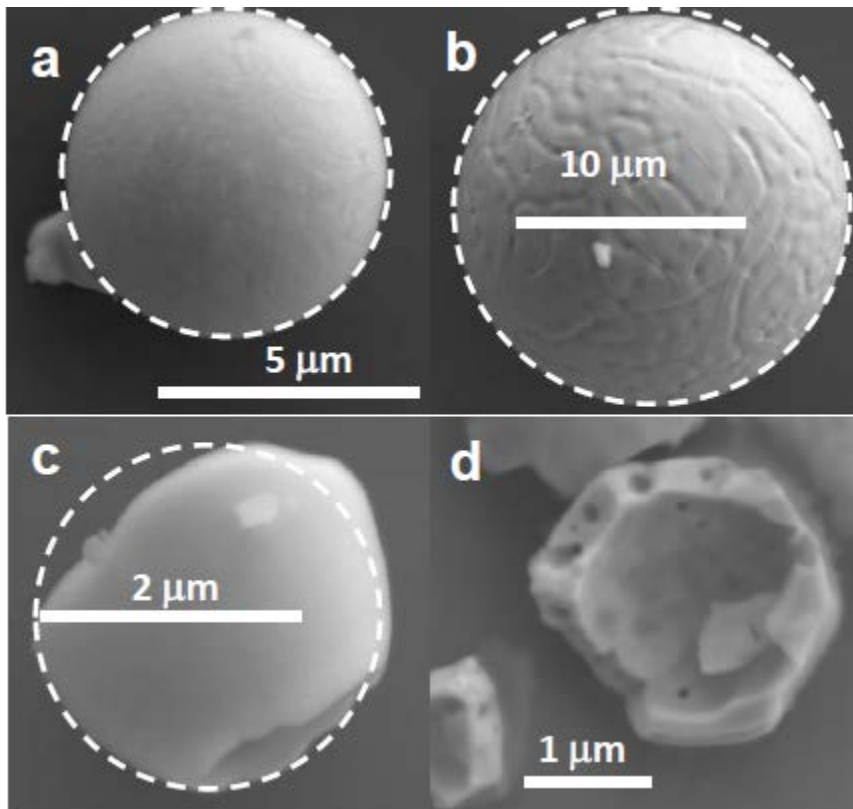
Figure 10

Fig. 10. Tungsten ball-like structures with a thin shell and empty interior: (a) and (b) closed spheres, (c) sphere in the phase of formation and (d) broken shell. Particles (a) – (c) are from the outer wall monitor while (d) is from the test mirror in the divertor.

Tungsten spheroids, i.e. ball-like objects with a thin shell and empty interior, have been detected after ILW-2 in significant quantities (observation after ILW-1 in [8]). They originate from tungsten flakes detached by whichever reason from the W coatings on carbon

fibre composite (W/CFC) tiles in the divertor or in the beam shine-through protection region of the JET wall. Some options regarding the nucleation and growth processes of such objects were proposed and discussed in [8]. After ILW-2 they have been found on the divertor tiles, on dust monitors and also on test mirrors located deep in the shadowed region of the divertor. A collection of pictures selected from a large catalogue is in Fig. 10. Images show closed spheres and also demonstrate objects *in statu nascendi*. In that phase, thin W flakes start forming round structures acting as “scaffolding” for next pieces in the scrape-off layer (SOL) to merge the precursor and coagulate. One may suggest that the process leads to the decrease of area in contact with plasma. A good insight into the internal structure is provided in Fig. 10(d) where a cross-section of the shell is visible. The outer diameter of the ball is around 2.2 μm , the shell thickness is 0.3-0.4 μm and the resulting volume of W in the shell is $3.8 \times 10^{-12} \text{ cm}^3$. Assuming porosity in the structure at about 20%, the mass of the “ball” would be around $56 \times 10^{-12} \text{ g}$ corresponding roughly to less than 2×10^{11} W atoms. Such objects, as derivatives of coatings, are not ITER-relevant. However, they are presented here for a single reason: without proper SEM/FIB studies they might mistakably be considered as W droplets and serve for reactor-directed predictions or modelling.
