Characterization of Tannic Acid-Coated AZ31 Mg Alloy for Biomedical Application and Comparison with AZ91

Article

Abstract: Magnesium alloys are promising materials for bioresorbable implants that will improve patient life and reduce healthcare costs. However, their clinical use is prevented by the rapid degradation and corrosion of magnesium, which leads to a fast loss of mechanical strength and the formation of by-products that can trigger tissue inflammation. Here, a tannic acid coating is proposed to control the degradation of AZ31 and AZ91 alloys, starting from a previous study by the authors on AZ91. The coatings on the two materials were characterized both by the chemical (EDS, FTIR, XPS) and the morphological (SEM, confocal profilometry) point of view. Static degradation tests in PBS and electrochemical measurements in different solutions showed that the protective performances of the tannic acid coatings are strongly affected by the presence of cracks. The presence of fractures in the protective layer generates galvanic couples between the coating scales and the metal, worsening the corrosion resistance. Although degradation control was not achieved, useful insights on th

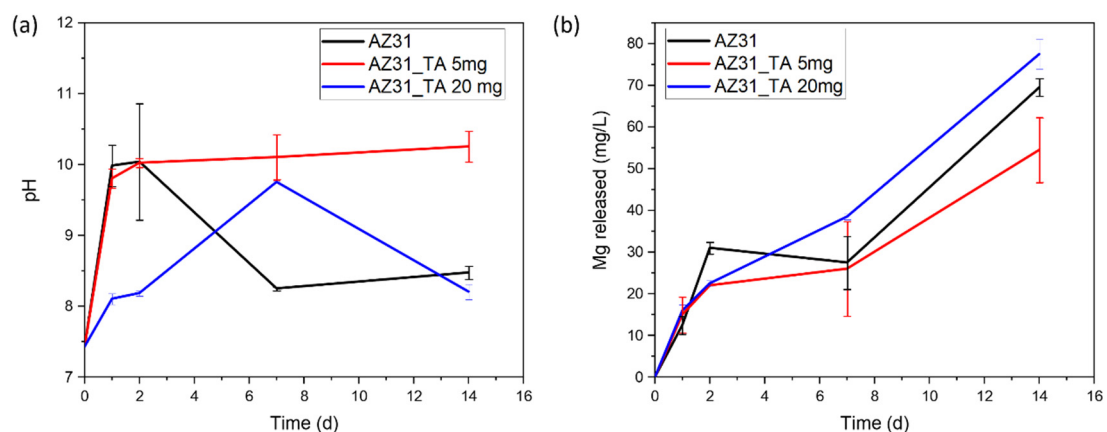
Figure 4. Degradation test in PBS, (a) pH trend versus soaking time, (b) Mg release vs. soaking time.

Figure 4 reports pH and magnesium ions release in PBS during sample soaking for up to 14 days. A rapid pH increase, up to 10, can be observed after 1 d for both AZ31 and AZ31TA_5, while AZ31TA_20 can maintain solution pH close to 8 up to 2 d. A pH decrease of around 8 after 7 or 14 days can be recorded for AZ31 and AZ31TA_20, respectively, while AZ31TA_5 induces persistent basification up to 14 d. The differences, mainly visible at 7 days of soaking, can be correlated with the dissolution and deposition of degradation products. No significant differences can be denoted among samples considering Mg release.

Looking at these results, AZ31TA_20 seems more promising than AZ31TA_5. Degradation behavior is in accordance with SEM observations; in fact, AZ31_TA 20 mg presents smaller scales and cracks, suggesting better coverage and protection. However, it seems that the ability of the tannic acid coating to protect Mg substrates from degradation in PBS is higher on AZ91 substrates [20] than on AZ31. This behavior can be attributed both to a lower reactivity of AZ91 substrates, as reported in [19], and to a better coverage (fewer cracks) of the obtained TA coating.

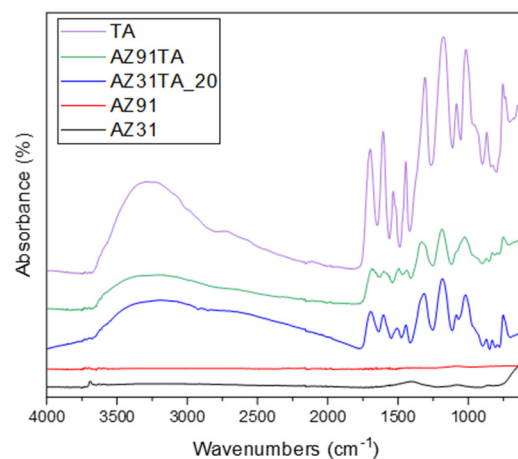
Figure 5. FTIR spectra of bare AZ31 and AZ91, of Mg samples after coating with tannic acid (AZ31_TA 20 mg/mL and AZ91_TA), and of tannic acid (TA).

The FTIR spectra are reported in Figure 5. As expected, the untreated metal surfaces have almost no absorption in the IR region, but a weak band around 1400 cm^{-1} was detected on AZ31, which can be related to some carbonates on the surface of the alloy [31]. After the coating formation, the typical fingerprint of tannic acid can be observed in the spectra, with the bands rising from the vibrational mode of phenolic OH (the halo at 3300 cm^{-1}), C=O (at 1700 cm^{-1}), aromatic rings ($1700\text{--}1400\text{ cm}^{-1}$), COOH ($1400\text{--}1200\text{ cm}^{-1}$), and C-O ($1200\text{--}1000\text{ cm}^{-1}$) [32–34]. The higher intensity of the organic peaks on the AZ31TA_20 with respect to the AZ91TA is related to more intimate contact between the sample and the ATR crystal, due to the lower roughness of the AZ31 samples, which results in better signal detection. FTIR spectra are a further confirmation of the successful integration of tannic acid within the coating on the different alloys.
