Material migration and fuel retention studies during the JET carbon divertor campaigns

ABSTRACT

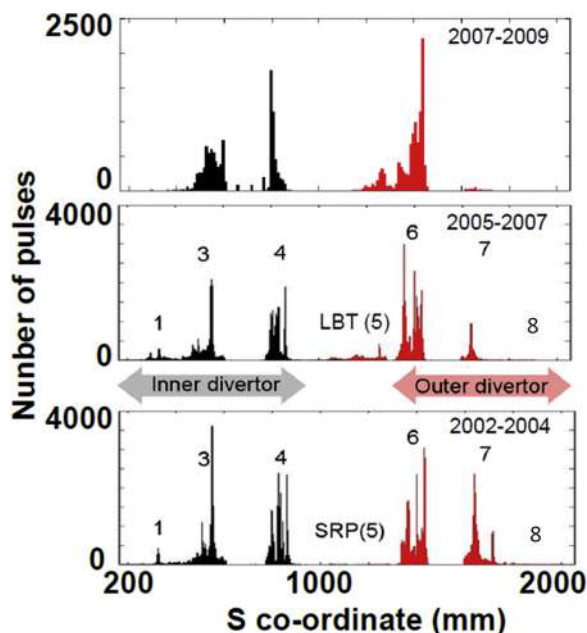
Fig. 16. Histogram showing the distribution of strike point positions in the divertor during the MkII-HD operations 2005–7 and 2007–9, and comparison with the MkII-SRP operations 2001–4. The X-axis is the s co-ordinate: the changes from Tiles 1-3-4-5-6-7-8 occur at approximately 0.43, 0.7, 0.95, 1.32, 1.55 and 1.81 m.

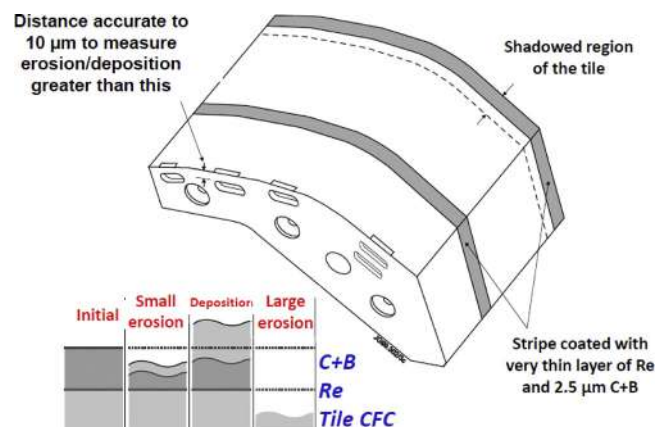
Fig. 20. Schematic view of a marker tile, and a diagram showing how the possible erosion/deposition scenarios would affect the markers.

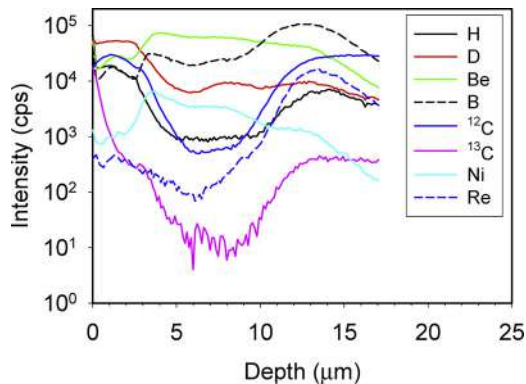
Fig. 22. SIMS spectra from a core cut from the bottom of Tile 1 exposed 1998–2001.

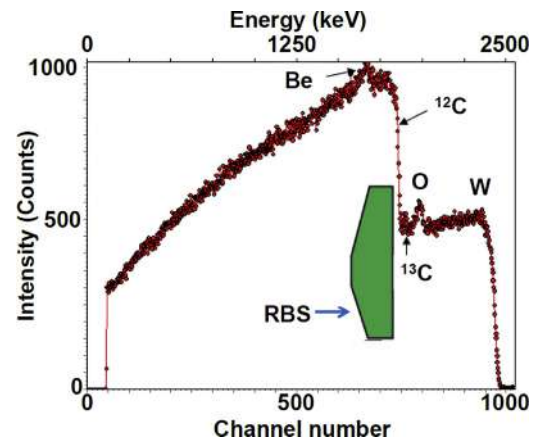
Fig. 27. An RBS spectrum from the W stripe about one-third the way up the Tile 7 surface as shown in the sketch, after exposure in JET 2001–4. Edges labelled W and ¹²C are the high energy edge of the feature characteristic of that element. Small amounts of Be, ¹³C and O are also present at the surface.

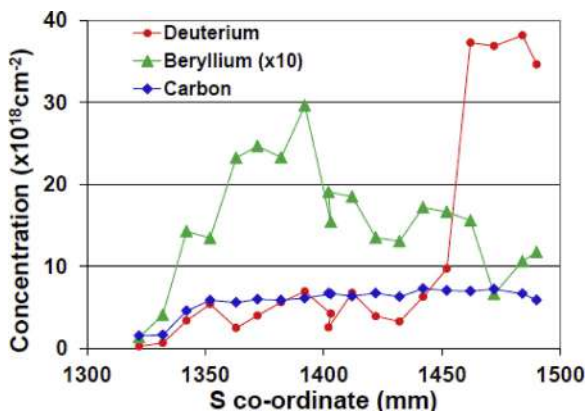
Fig. 37. C, Be and D concentrations across Tile 14BN G6B (Tile 6), plotted inboard to outboard.

At first glance the C, D and Be concentrations on Tile 6 seen from the NRA data plotted in Fig. 37 appear as a mirror image of those for Tile 4 in Fig. 35. There was a film of high D/C ratio on the section of the tile nearest the outer louvres shadowed by Tile 7. The D/C ratio was similar to that on the shadowed region on Tile 4, and the film thickness at the points analysed was greater than the analysis depth (~7 μm). However, coloured fringes in the shadowed region suggest the film probably thinned closer to the louvres, and was unlikely to be as thick as the 50–100 μm typically found on Tile 4 (e.g. as seen in Fig. 36) – SIMS profiling confirmed this impression.

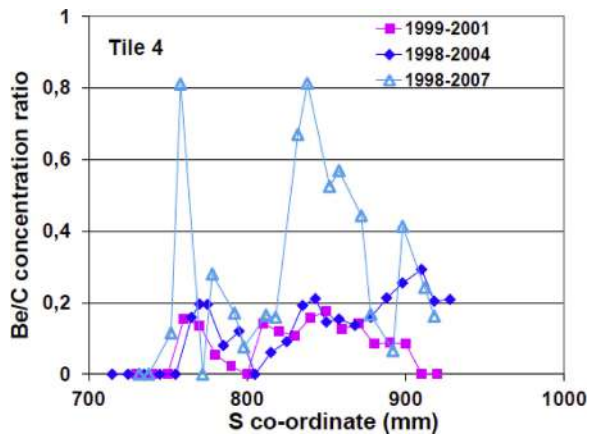
Fig. 48. Comparison of Be/C ratios on Tile 4 for tiles removed after the last three JET campaigns (1999–2001 – Mk II Gas Box, 2001–4 – MkII SRP, 2005–7 – MkII HD divertors).

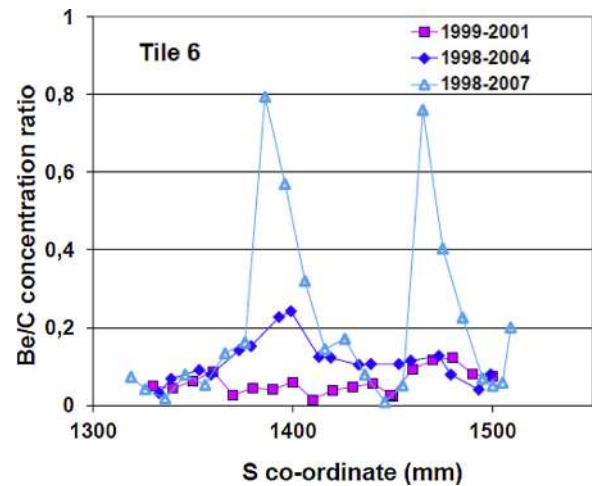
Fig. 49. Comparison of Be/C ratios on Tile 6 for tiles removed after the last three JET campaigns (1999–2001 – Mk II Gas Box, 2001–4 – MkII SRP, 2005–7 – MkII HD divertors).

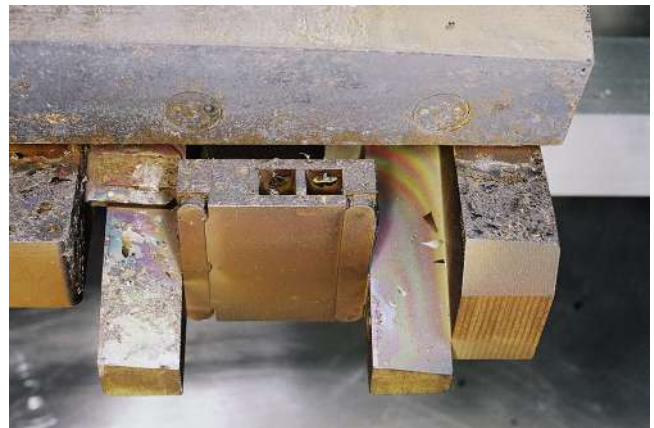
Fig. 50. Photograph of the inner carrier 2IN after removal in 2007. The bottom of Tile 3 is at the top of the picture. Surfaces are covered with a thick deposit, which is showing signs of spalling in certain places. The front face of the mirror test unit is so thickly coated that it is not possible to see where the third channel (with a sample flush to the face) is.

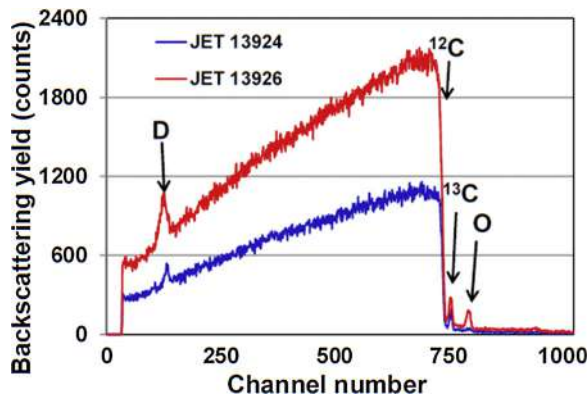
Fig. 52. Rutherford Backscattering spectra from a divertor Tile 7 (2ON G7A, exposed 2005–7). The spectra were recorded from samples 10 mm below (spectrum 13,926) and 10 mm above (spectrum 13924, recorded for only half the beam fluence of 13,926 for clarity) the middle of the tile. The ^{12}C arrow indicates the high energy edge of the carbon feature – the D, ^{13}C and O are present at the surface.

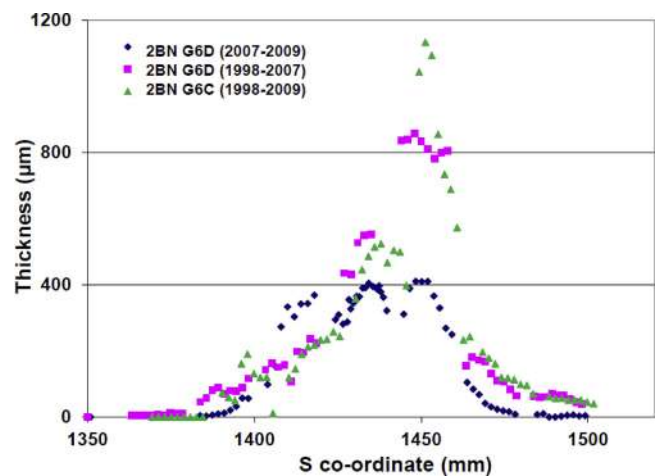
Fig. 62. Film thicknesses from optical microscopy of sections for Tiles 6 removed from Module 2 after operational periods 1998–2007, 1998–2009 and 2007–9.
