Material migration and fuel retention studies during the JET carbon divertor campaigns

J.P. Coad^{a,*}, M. Rubel^b, J. Likonen^c, N. Bekris^d, S. Brezinsek^e, G.F. Matthews^a, M. Mayer^f,
A.M. Widdowson^a, JET contributors¹

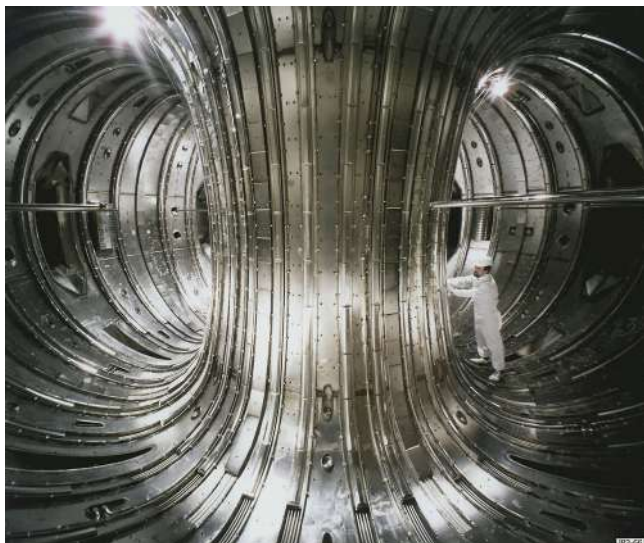
Fig. 2. Interior of the JET vessel in the 1983–84 campaign.

Construction of JET was completed in 1983, and the first operational campaign was from 1983 to 1984. At that time the interior of the Inconel vacuum vessel was very plain – bare metal walls with discrete limiters at the outer mid-plane for controlling the minor radius of the plasma as shown in Fig. 2. JET was designed to have nickel (Ni) limiters, and two can be seen at the outer mid-plane in Fig. 2, but during

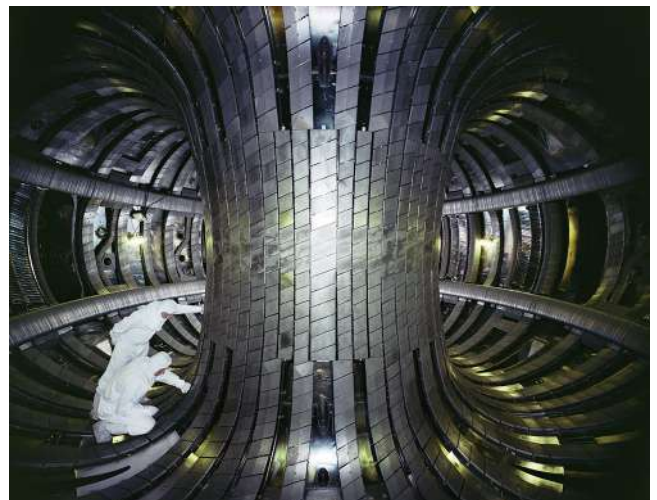
Fig. 3. Interior of the JET vessel in 1987.

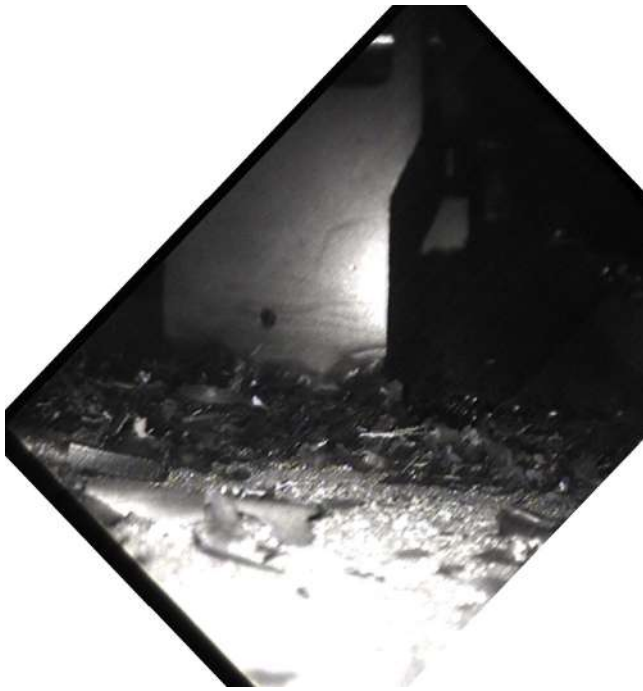
Fig. 19. Flakes piled behind a divertor support leg, observed using an endoscope in 1999.

There was a significant accumulation of flakes and dust on the divertor floor next to the inner louvres, much of which appeared to have resulted from spalling of deposits from the louvres themselves; there were no flakes observed on or near the outer louvres. All the flakes from the inner divertor corner were collected after the tile carriers were removed (all round the torus) using a vacuum cleaner, weighed and a sample analysed at AEA, Winfrith. The analysis showed that the flakes were carbon with a very high D and T content: based on the sample analysed, the 152 g collected contained 0.52 g tritium, giving a specific activity of 1.3 T Bq g^{-1} for the flakes [30]. This reduced the missing T to $\sim 3 \text{ g}$. The way the louvres are angled, most material spalling from their blades would fall into the void under the divertor. If it is assumed that all the missing T is in flakes that have fallen below the divertor, there would need to be $\sim 1 \text{ kg}$ of flakes similar to those collected at the inner divertor corner [31]. In the next intervention (in 1999) an endoscope was fed through the louvres to see if there were indeed flakes in the sub-divertor volume. As the endoscope was being fed through the gap between the divertor structure and the inner divertor coil housing flakes could be seen balanced on each bolt head and ledge, and on the floor of the vessel (which under the inner divertor is sloping towards the lowest point which is approximately beneath the outer divertor) there were piles of flakes behind every obstacle, for example divertor

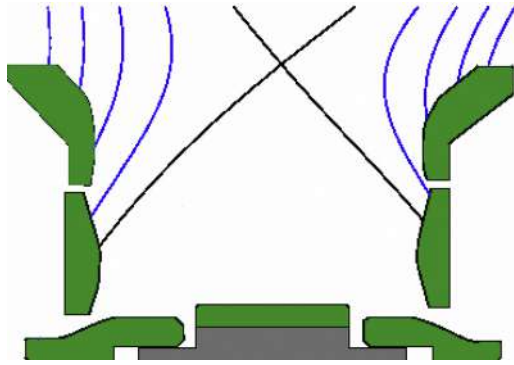
Fig. 29. The strike points and field lines for the series of discharges into which the ^{13}C was puffed in 2004.

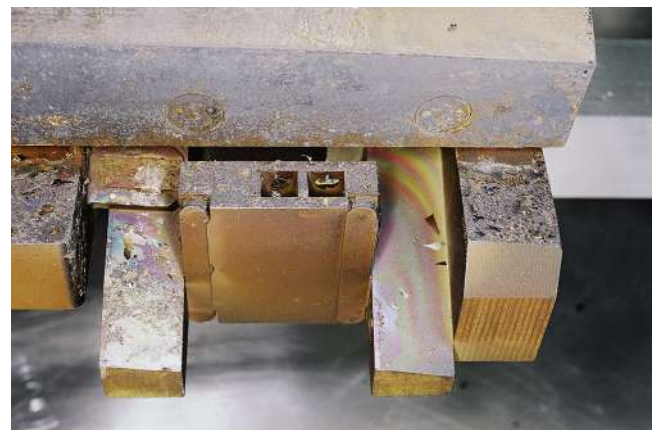
Fig. 50. Photograph of the inner carrier 2IN after removal in 2007. The bottom of Tile 3 is at the top of the picture. Surfaces are covered with a thick deposit, which is showing signs of spalling in certain places. The front face of the mirror test unit is so thickly coated that it is not possible to see where the third channel (with a sample flush to the face) is.
