Effect of Textile Architecture on the Durability of Flax Textile-Reinforced Mortars

Effect of Textile Architecture on the Durability of Flax Textile-Reinforced Mortars / Trochoutsou, N.; Baldassari, M.; Monaco, A.; Cornetti, P.; Guadagnini, M.. - In: PROCEDIA STRUCTURAL INTEGRITY. - ISSN 2452-3216. - ELETTRONICO. - 64:(2024), pp. 1873-1879. (Intervento presentato al convegno SMAR 2024 – 7th International Conference on Smart Monitoring, Assessment and Rehabilitation of Civil Structures tenutosi a Salerno (Italy) nel 4-6 September 2024) [10.1016/j.prostr.2024.09.244].

SMAR 2024 – 7th International Conference on Smart Monitoring, Assessment and Rehabilitation of Civil Structures

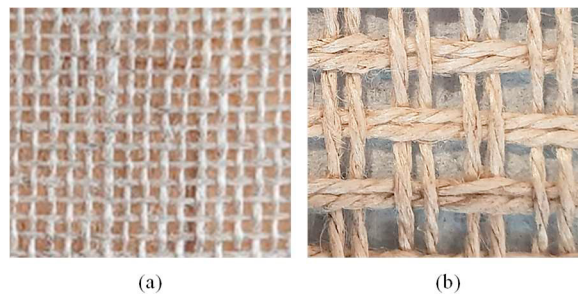
Fig. 1. Flax textile reinforcements adopted in the present study: (a) “K” and (b) “F” textiles.

Two types of flax textiles were used as structural reinforcement, including: 1) a flax textile comprising single twist yarns (denoted as “K”) arranged in a 1.5-mm mesh with linear density equal to 100 TEX; 2) a flax textile comprising two-ply twist yarns arranged in pairs across a 4-mm mesh (denoted as “F”) with linear density equal to 324 TEX (Fig. 1). Both textiles were woven (i.e. warp and weft yarns are interlaced at 90° to each other), balanced bi-directional, with a bulk density equal to 1.5 g/cm<sup>3</sup>. The yarn’s cross-sectional area was found equal to 0.07 mm<sup>2</sup> and 0.22 mm<sup>2</sup> for K and F textiles, respectively. It should be noted that the origin of the two types of flax fibres used in the textile production, and whether it was common to both textiles or not, is unknown.

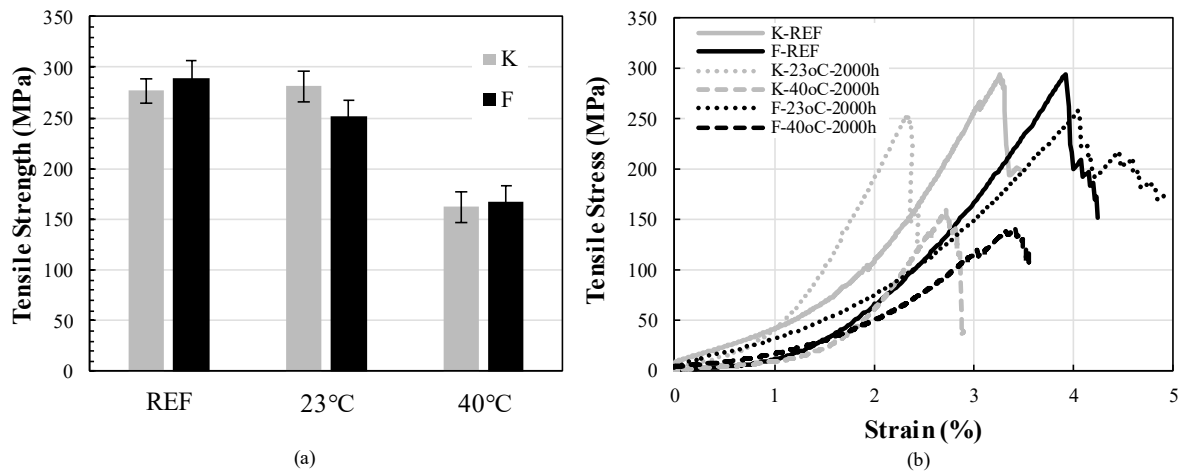
Fig. 2. (a) Tensile strength; (b) stress-strain curves of typical K and F bare textiles before and after exposure for 2000h.

Table 1 summarises the average mechanical properties of the bare “K” and “F” textiles before and after exposure to accelerated ageing. Fig. 2a illustrates the effect of the conditioning protocol on the tensile strength, while Fig. 2b presents the tensile stress–strain curves obtained from representative textiles from each conditioning protocol.

An initial inelastic behaviour followed by a linear elastic response up to the peak stress was consistently observed for both types of flax textiles. In all cases, failure occurred due to the progressive rupture of the individual yarns. Both types of unconditioned flax textiles attained similar values of strength (277 – 289 MPa) and ultimate strain (3.5-3.8%), in good agreement with those reported in previous studies (Ferrara et al., 2019).

Although exposure to 23°C for 2000h did not result in a significant change in the mechanical properties, given the observed variability, a decrease in tensile strength of up to 42% was recorded after exposure to 40°C, which accelerated the chemical reactions and the resulting degradation of the flax fibres.

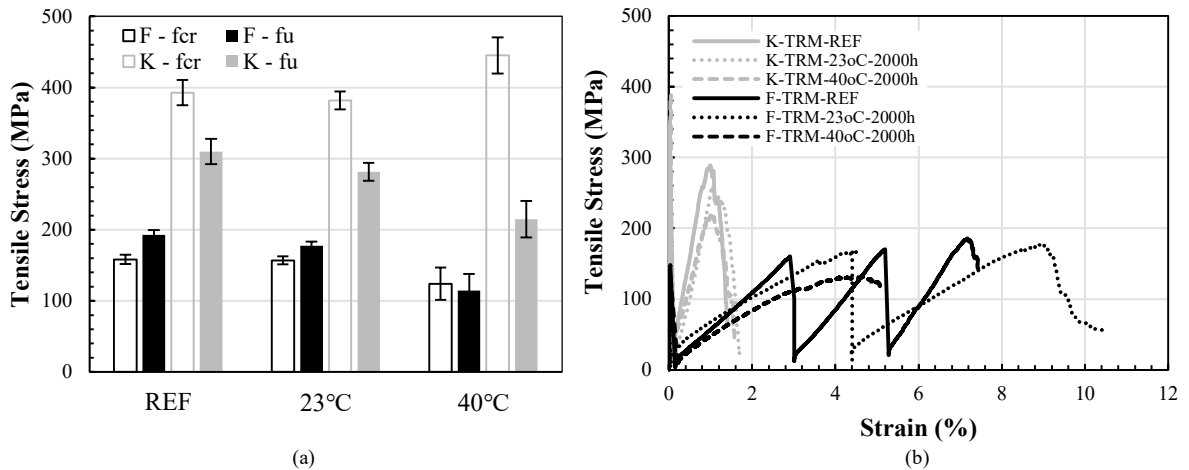
Fig. 3. (a) Cracking/ultimate strength; (b) stress-strain curves of typical K and F TRM composites textiles before and after exposure for 2000h.

Fig. 3a compares the average value of the tensile strength of TRM composites reinforced with two layers of “K” and “F” textiles, while Fig. 3b shows the tensile stress-strain response of representative TRM specimens from each system and ageing protocol. A summary of the average mechanical properties, their CoV, as well as the strength retention rate, calculated as the ratio of the ultimate strength of the TRM after exposure to that of the unconditioned TRM, are reported in Table 2.

The different ultimate strength attained by the two TRM systems can be explained upon the analysis of the associated stress-strain response (Fig. 3b). All “K”-TRM composites achieved a cracking load value higher than that of the maximum load attained during the cracked stage, with no strain hardening behaviour, exhibiting only one single crack during the test. This behaviour was observed in both unconditioned and aged composites, indicating that the reinforcement ratio in “K”-TRM composites (0,8%) was insufficient to enable stress redistribution. Failure occurred due to slippage of the yarns within the mortar in the proximity of the crack, followed by yarn rupture. For unconditioned coupons, the ultimate strength was similar to that attained by the corresponding bare “K” textiles. On the contrary, reference and conditioned “F”-TRM specimens at ambient temperature for 2000h presented the typical stages generally observed in TRM systems: i) stage I, where the stress increases linearly with the first crack formation, ii) stage II, crack development attributed to the degree of bond at the textile/mortar interface, iii) stage III, crack saturation and linear increase in stress until the peak load. The ultimate strength was immediately followed by the progressive failure of individual yarns, with unconditioned specimens showing typically more cracks than specimens conditioned at 20°C for 2000h. Stages II and III were not always distinguishable, with crack formation being accompanied by large energy release. This resulted in the limited contribution of the “F” reinforcement to the overall composite performance, and a lower exploitation of the textile strength (~67-70%) for both unconditioned and

conditioned “F”-TRM, indicating that the reinforcement ratio (1,7%) was still relatively low. This was also reported by Trochoutsou et al. (2021a) when examining flax-TRM composites of similar architecture and reinforcement ratios.
