Non-destructive testing on aramid fibres for the long-term assessment of interventions on heritage structures

2015 J. Phys.: Conf. Ser. 628 012102

Non-destructive testing on aramid fibres for the long-term assessment of interventions on heritage structures.

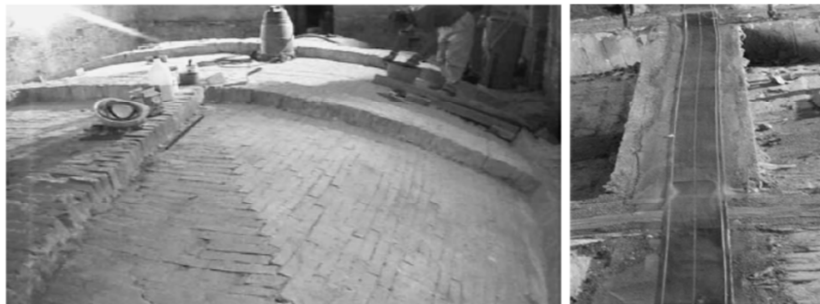
Figure 1. (a) The masonry vault and reinforcement arches dated 1600 during surface preparation for CFRP application. (b) Smart CFRP sheet placed on vault [3].

Interesting applications of FRP materials are typically found in the cultural heritage field, where invasiveness of interventions is a major issue. Carbon fibre reinforced polymers (FRPs) are commonly employed for the strengthening and seismic retrofitting of vaults and other masonry elements of heritage buildings (Figure 1). In any case, experimental studies are still required to better understand the durability and compatibility of interventions in polymeric materials and, in general, in other non-traditional materials. For instance, uncertainties about the long term behaviour of aramid fibres made often designers reluctant to their use in the structural engineering fields.

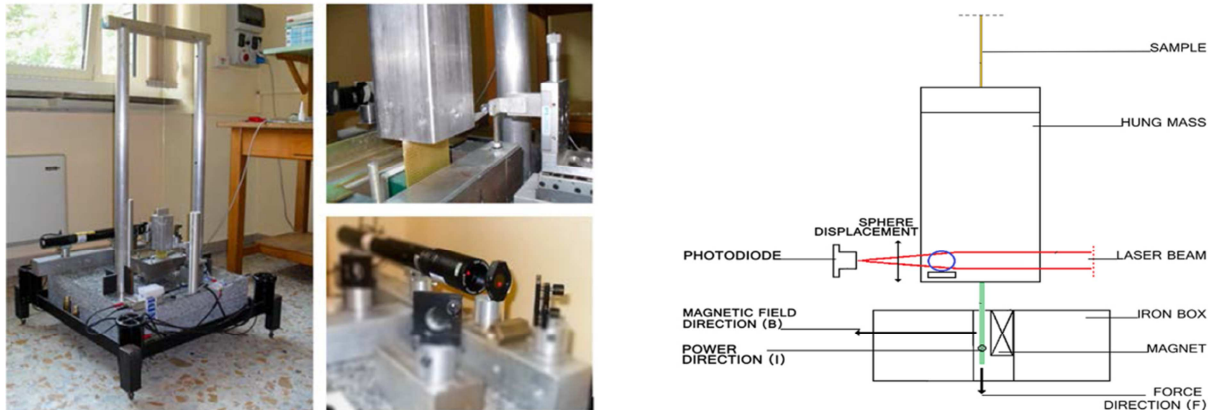
Figure 2. (a) The testing setup. (b) Micrometer slides, magnet for forced oscillation testing and hung mass. (c) He-Ne laser beam generator, attenuator and mirrors. (d) Schematic representation.

The testing machine frame (Figure 2.a) is composed of a rectangular crossbeam ($L=45$ cm, cross section: 4×4 cm) made of aluminium, transversely bounded at two cylindrical aluminium holed columns ($h=95.4$ cm; diameter: 5 cm, thickness: 0.5 cm) on a massive square basement (60×60 cm) made of marble with a thickness of 14.5 cm. An isolation steel table supports the marble mass, this allowing to neutralize most of environment vibrations. The materials used for the testing system were selected in order to minimise the effect of the temperature excursion in the laboratory.

The specimen, consisting of parallel fibres, were mounted vertically, with the top fixed at the horizontal crossbeam and at an aluminium block at the lower part; a special device was inserted at the bottom in order to measure the specimen displacement during the test (Figure 2.b).

A helium-neon generator was used for the experiment (Figure 2.c) in order to produce the laser beam. The device is able to emit a coherent, monochromatic and concentrated light beam in a highly collimated beam straight, through the process of stimulated emission. The laser generator is mounted on a suitable support, so that the laser beam was emitted in the horizontal direction with respect to the anti-vibration table.

An attenuator is an electronic device that reduces the power of a signal without appreciably distorting its waveform. The attenuator was used to prevent saturation of the photodiode, attenuating the beam light (Figure 2.c).

Metal mirrors were used to adjust the direction of the laser beam. They were mounted on supports in order to be adjusted for different inclinations. The combined movement of rotation about the horizontal and vertical axes of the two mirrors allows to determine completely the direction of the light beam (Figure 2.c).

A photodiode, which converts an optical signal to an electric signal, was mounted on three precision micrometre slides. Two of these were assembled together in reference to the X-direction (parallel axis to the plane formed by the optical bench and orthogonal to the laser beam) and Z-direction (orthogonal axis to the plane formed by the optical bench and orthogonal to the laser beam direction). The third slide is positioned in a parallel direction to the bench and the laser beam (Figure 2.b).

In Figure 2.b it is also possible to notice the hung mass of 1.375 kg which was used to form a 1-DoF system with the specimen acting as spring. A copper wire coil was placed inside a magnet and aligned so that an electromagnetic force in the vertical direction could be produced and applied to the hung mass and, consequently, to the fibres (Figure 2.b).

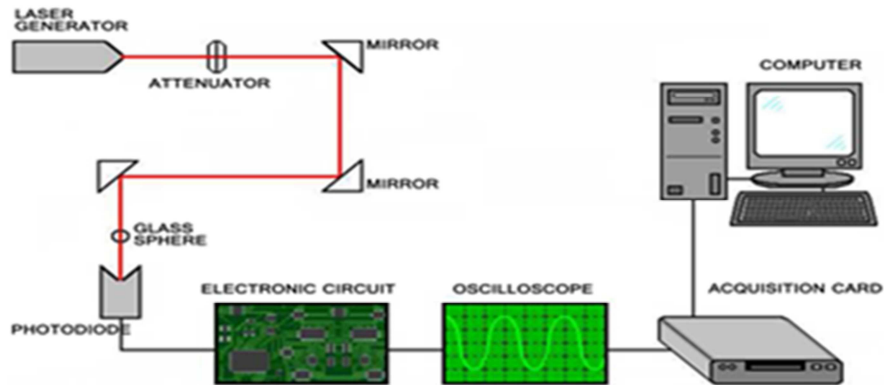
Figure 3. Principle of operation - schematic representation.

The principle of operation of the instrumental apparatus used in the tests (Figure 3) can be summarized in the following stages. The light source produced by the laser generator was forced to follow a predetermined path by means of a prism and two lenses. These lenses, if properly set, deflected the laser beam causing it to converge towards the instrument test, where the sample was allocated. In order to allow the photodiode to read the optical signal and, consequently, the possible displacement of the fiber, a glass sphere (connected to the hung mass) with a diameter of 8 mm was used, which, working as a convex lens, focuses the beam to a very precise point of the marker located inside the photodiode (Figure 2.b). The marker was divided into four sectors, generally square. The sensor read the movement of the glass sphere and indirectly the elongation of the fiber, in relation to the quadrant where the laser beam was focused. Therefore, it was important to make a correct positioning of the

photodiode using the micrometer slides. Indeed, for the system in a quiescent state, the read signal was set equal to zero. An electronic circuit was used to link the photodiode to an oscilloscope. An acquisition card and a Lab View application were used to record the collected data on csv files.

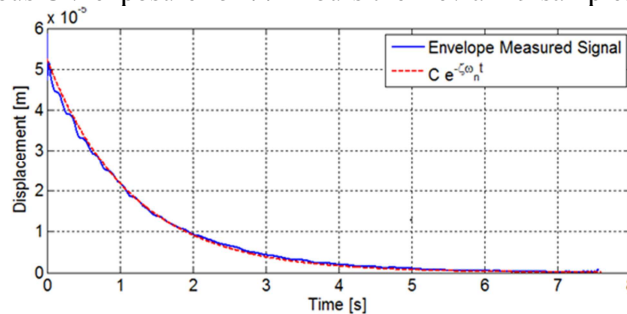
Figure 4. Kevlar-29 pristine sample: fitting of the envelope of the acquired signal.

In order to characterise the dynamic behaviour of the fibres, free-decay tests were performed. The tests allowed for the identification of natural frequencies and damping ratios of both specimens. The system identification was achieved with time domain fitting techniques applied to the Hilbert transform envelopes of the acquired signals (Figures 4 and Figure 5). Results were also validated by using standard ERA techniques [8].

The application of curve fitting techniques over free-decay signals sampled at 2500 Hz gave for the Kevlar-29 pristine samples, a resonance frequency of (20.30 ± 0.03) Hz and an experimental damping ratio of $(0.7 \pm 0.1) \%$; whilst for the Kevlar-29 damaged samples, a value for natural frequency of (19.80 ± 0.02) Hz and experimental damping ratio equal to $(0.6 \pm 0.1) \%$ were evaluated. The spread of the results was computed using 7 free-decay measurements for both samples. The high sensitivity of the measurement device allows to quantify low damping ratio and frequencies with a high level of accuracy. These damping ratios can be directly linked to the intrinsic material dissipation factor, because all other dissipation phenomena can be actually neglected. The mean value of the natural frequency was used to estimate the elastic dynamic modulus of the fibres.

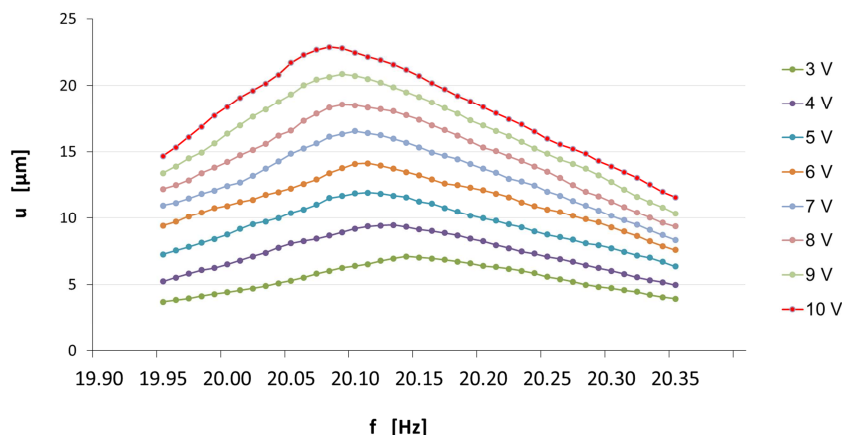
Figure 6. Response spectra for increasing values of the input force – pristine sample.

Once the input voltage interval has been defined, changing the frequency of the driving force (via the function generator) it is possible to record the values of the output voltage, from which the displacement can be determined by using a conversion factor established during the photodiode calibration. The results are reported in Figure 6 and Figure 7.

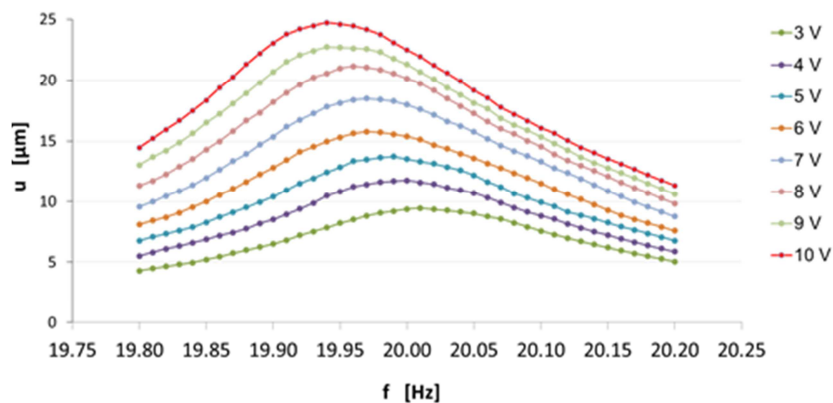
Figure 7. Response spectra for increasing values of the input force – damaged sample

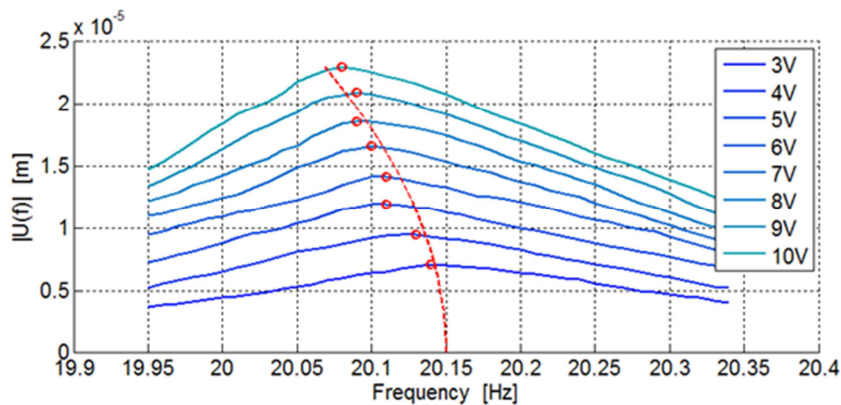
Figure 8. Back-bone nonlinear curve identification - undamaged Kevlar-29 sample.

Equation (1) was used to identify the so-called back-bone non-linear curve of the response, as it is highlighted by a red line in Figure 8 and Figure 9.

For the first Kevlar-29 (not damaged sample) the non-linear stiffness χ was identified at $-3.23 \cdot 10^{11}$ N/m³, whilst for the second Kevlar-29 sample (after damage) it was ca $-3.04 \cdot 10^{11}$ N/m³.

From Figures 8 and 9, where the backbone non-linear curves were represented, no significant differences can be appreciated between the pristine and damaged samples, as regards the inclination of the back-bone curve and the value of the index of non-linearity.

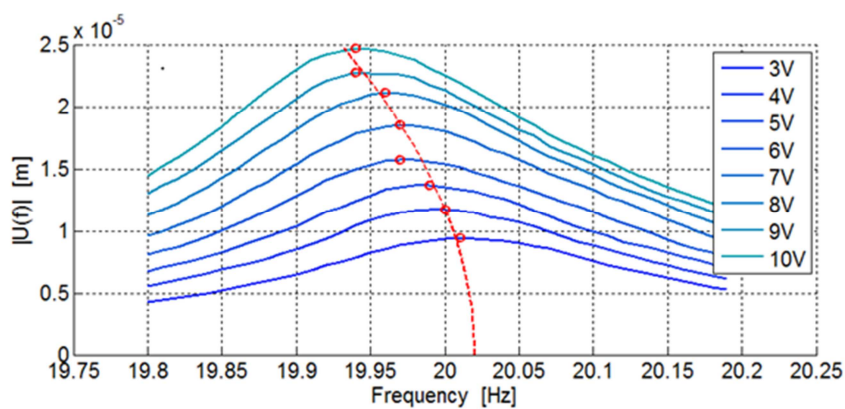
Figure 9. Back-bone nonlinear curve identification - damaged Kevlar-29 sample.
