Fretting damage parameters in splined couplings

V. Cuffaro, F. Curà, A. Mura

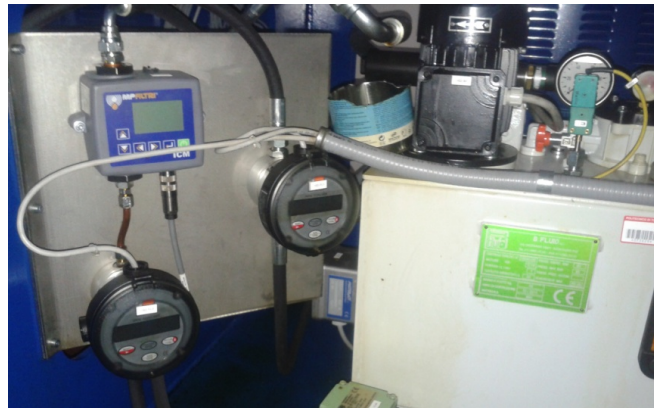
Figure 1: Inline contamination monitor connected to the lubrication system of the splined couplings test rig.

During the tests it is possible to monitor a lot of experimental data (debris present in the oil, temperature and strain of the specimen, speed rotation, torque, etc.), in particular the debris monitoring has been done by means of the inline contamination monitor (ICM) that measures and quantifies the numbers of solid contaminants in hydraulic, lubrication and transmission applications [13]. The instrument uses a light extinction principle whereby a specially collimated precision LED light source shines through the fluid and lands on a photodiode. When a particle passes through the beam it reduces the amount of light received by the diode, and from this change in condition, the size of the particle can be deduced.

The ICM is designed to be an accurate instrument for permanently installed applications utilizing mineral oil as the operating fluid. The unit can operate using any of the international standard formats ISO 4406:1999, NAS 1638, AS 4059E and ISO 11218 [12].

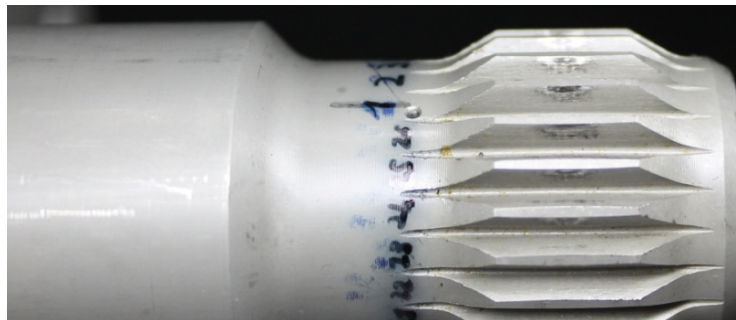
Figure 2: Specimen MB2 after test.

Fig. 1, 2 and 3 show teeth after wear test of respectively specimen MB1, specimen MB2 and specimen MB3

It is possible to point out that after test MB1 (performed without misalignment) the teeth surface doesn't show any evident trace of wear damage. Considering tests MB2 and MB3 it is possible to observe that the wear damage appear on teeth surface and the damage in test MB3 is bigger than in test MB2, that is reasonable because test MB3 has been performed with higher misalignment angle (10°) respect to test MB2 (5°).

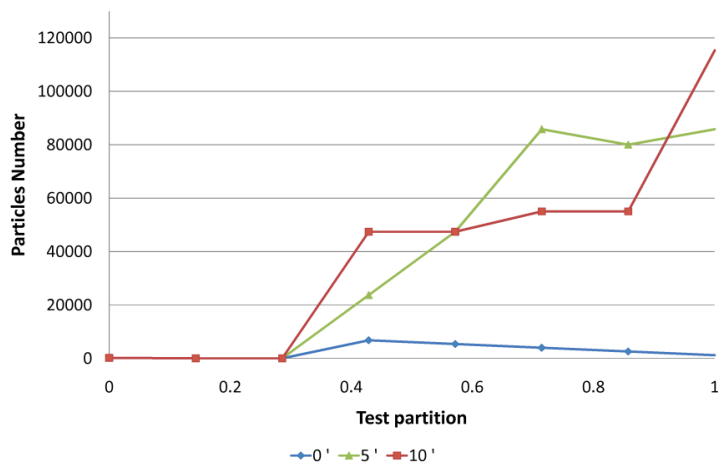
Figure 5: Trend of $6\ \mu\text{m}$ particles during the test.

In Fig. 5 is shown the trend of the particles with a dimension of $6\ \mu\text{m}$; as it can be observed, the trend is similar to that of Fig. 4, the only difference, compared to the previous ones, is the number of the particles; in fact it is less for all tests.
