DIAMOND WIRE – STONE INTERACTION DURING CUTTING PROCESS: MECHANICAL, PHYSICAL AND CHEMICAL INVESTIGATIONS

S. Spriano¹, S. Ferraris¹, R. Bellopede², P. Marini², L. Zichella², A. Tori³

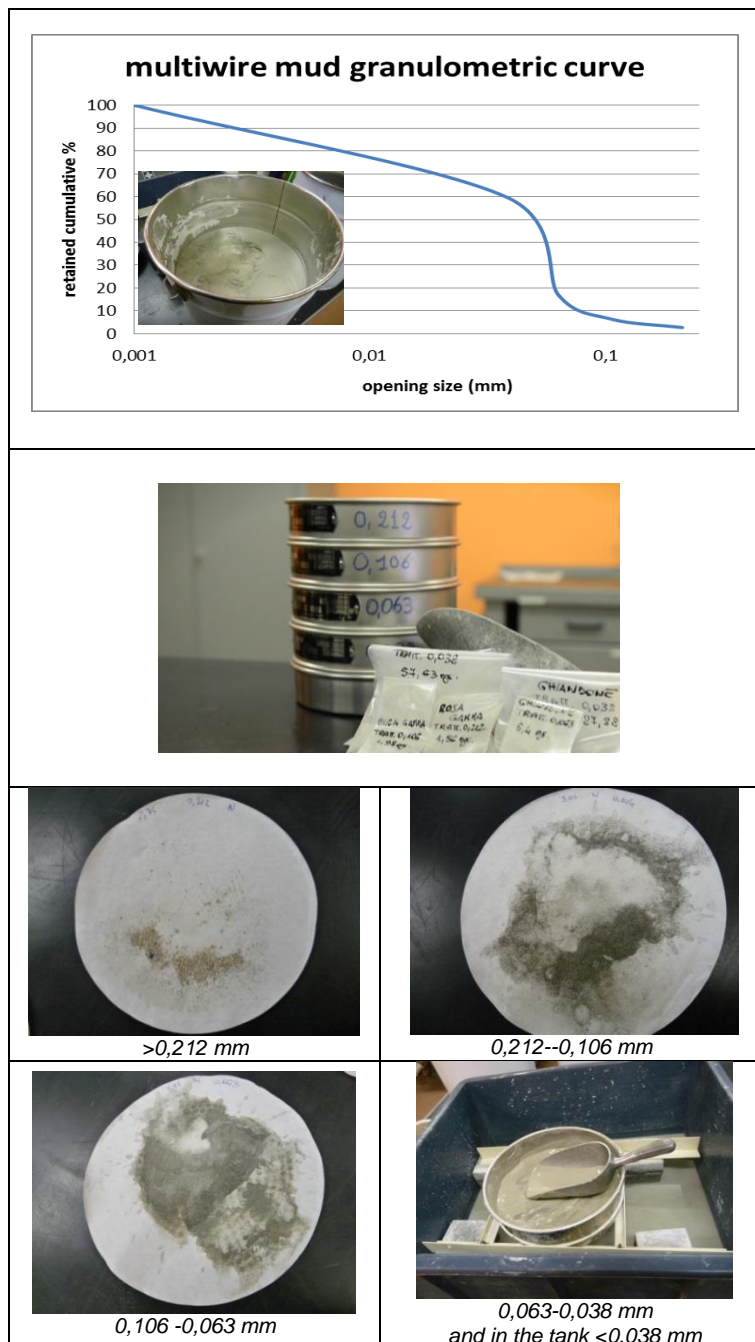
The granulometric curve of multiwire muds is shown in Figure 2; it is characterized by a high percentage (40.2%) of particles minor than 0,038mm.

Figure 2: size distribution process and characterization of multiwire muds

Each one of the classes obtained through the granulometric separation has been processed with a wet magnetic separation (Co-Al – Ni magnet). On the size classes minor than 0,063mm a further analysis by means of X – Ray Diffraction (XRD) have been performed.
