PAPER REF: 2602

## AGEING CHARACTERIZATION OF EXHAUST FLEXIBLE COUPLINGS

Francesca Curà<sup>(\*)</sup>, Andrea Mura, Raffaella Sesana

Department of Mechanics, Politecnico di Torino, Torino, Italy

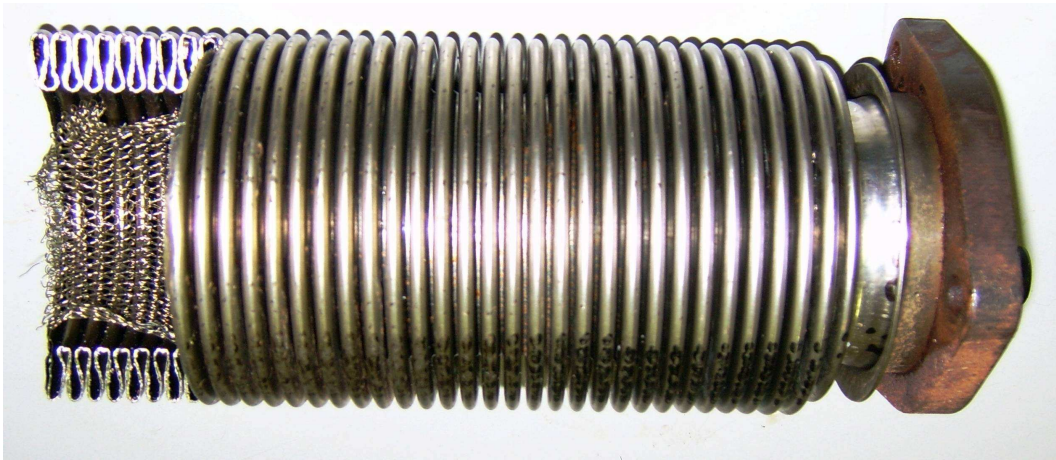
The flexible exhaust coupling, represented in Figure 1, is composed of two metal layers. All components tested in this work have the same shape geometry and dimensions, but they are made using different materials: three stainless steels (AISI 309, AISI 321, AISI 316 Ti) and a nickel alloy (Incoloy 825). In this work five kinds of flexible exhaust couplings have been tested, four made of a single material, respectively AISI 309, AISI 321, AISI 316 Ti and Incoloy 825, and one made of two materials Incoloy 825 and AISI 321.

Fig.1 Flexible exhaust coupling

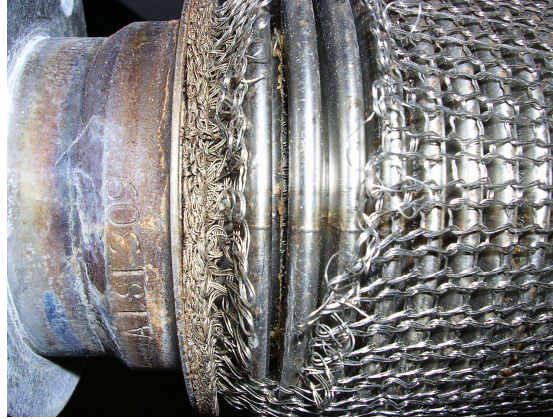
In this work totally 39 components have been tested. During the aging tests many mechanical failures occurred on the components, as an example Figure 2 shows a fatigue crack occurred on an AISI 309 component.

Fig.2 Fatigue crack on a AISI 309 component

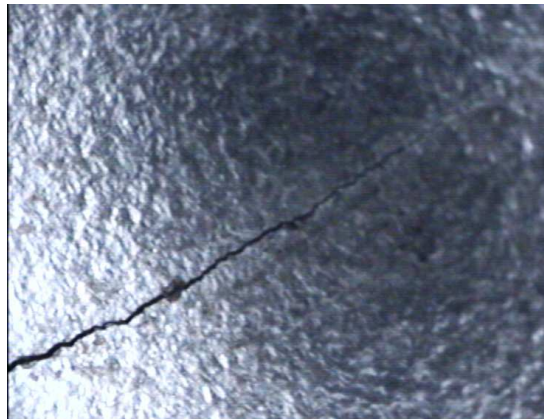
Figure 3 shows a detail (400X magnification) of a crack growth of an AISI321 component.

Fig.3 Fatigue crack propagation on a AISI 321 component (400X magnification)

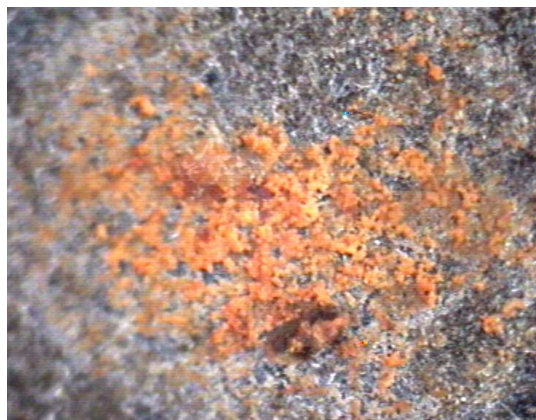
As an example, Figure 4 shows a particular of general corrosion on an AISI 309 component, and Figure 5 shows pitting corrosion phenomena on AISI 321 component.

Fig.4 General corrosion on a AISI 309 component (800X magnification)

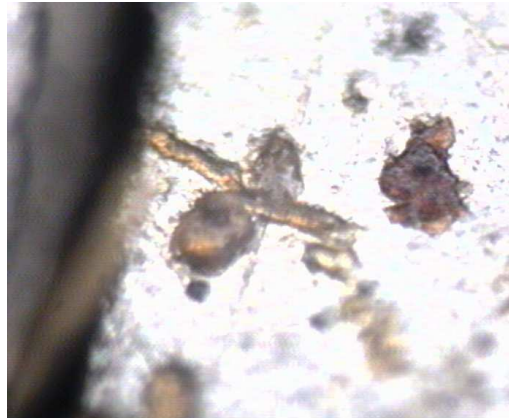
Fig.5 Pitting on a AISI 316Ti component (800X magnification)

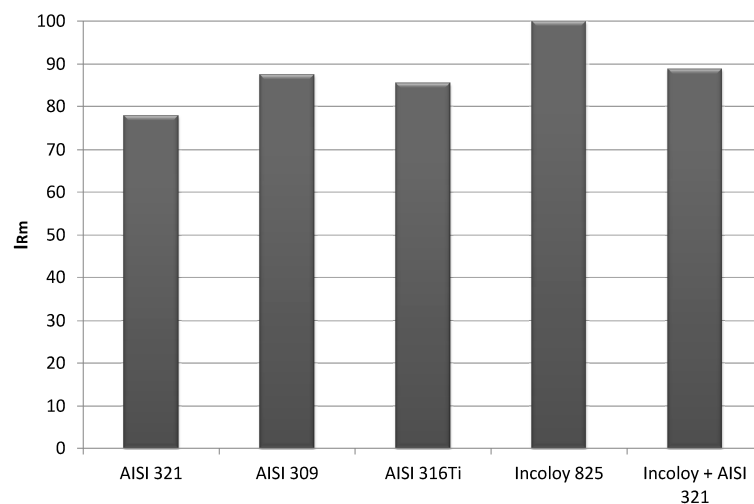
Figures 6 to 10 show respectively the tensile strength, the yield strength, low cycle fatigue, corrosion, and cost normalised indexes.

Fig.6 Tensile strength index  $I_{Rm}$

$$I_{Rm} = (R_{mTe} - \sigma_{ref}) + (R_{m500} - \sigma_{ref}) \quad (1)$$

where:  $R_{mTe}$  is the ultimate tensile stress of the material at room temperature,  $R_{m500}$  is the ultimate tensile stress at 500°C temperature, and  $\sigma_{ref}$  is the stress applied at the component during the ageing procedure.

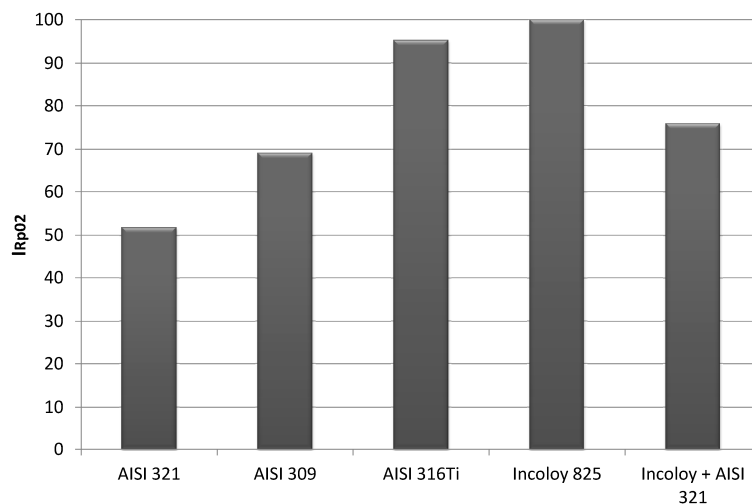
Fig.7 Yield strength index  $I_{Rp02}$

$$I_{Rp02} = \frac{R_{p02Te} + 2 \cdot R_{p02500}}{3} \quad (2)$$

where:  $R_{p02Te}$  is the yield strength of the material at room temperature,  $R_{p02500}$  is the yield strength at 500°C temperature.

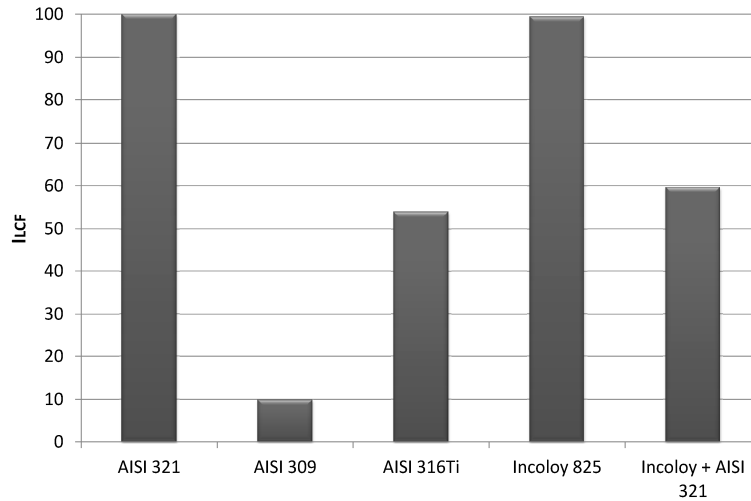
Fig.8 Low cycle fatigue index  $I_{LCF}$

$$I_{LCF} = 3.5 \left( \frac{R_{mTe}}{E} \right) N^{-0.12} + \Delta Z \cdot N^{-0.6} \quad (3)$$

where E is the young's modulus of the material,  $\Delta Z$  is the necking deformation of the material and N is the number of cycle when the component presents any mechanical failure.

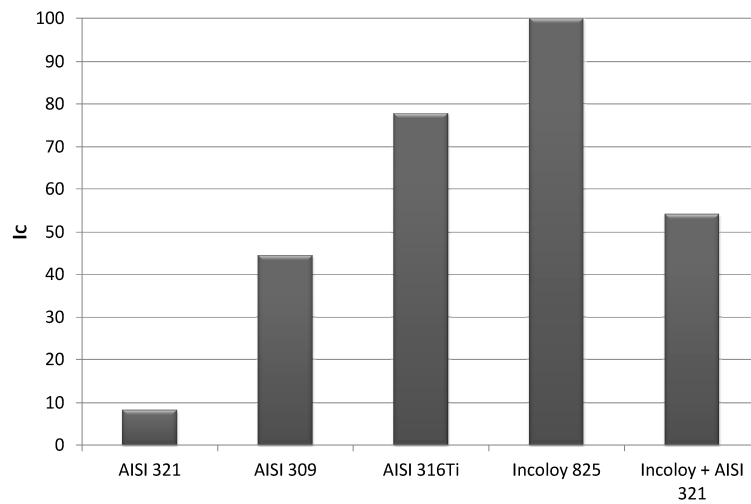
Fig.9 Corrosion index  $I_C$

The corrosion index  $I_C$  has been obtained considering four kinds of corrosion phenomena: general corrosion, intergranular corrosion, pitting corrosion and hot salt corrosion. For each corrosion phenomena, two penalties have been assigned: one representing the level of danger related to the corrosion and the other concerning the entity of the corrosion attack, according to Table 2.

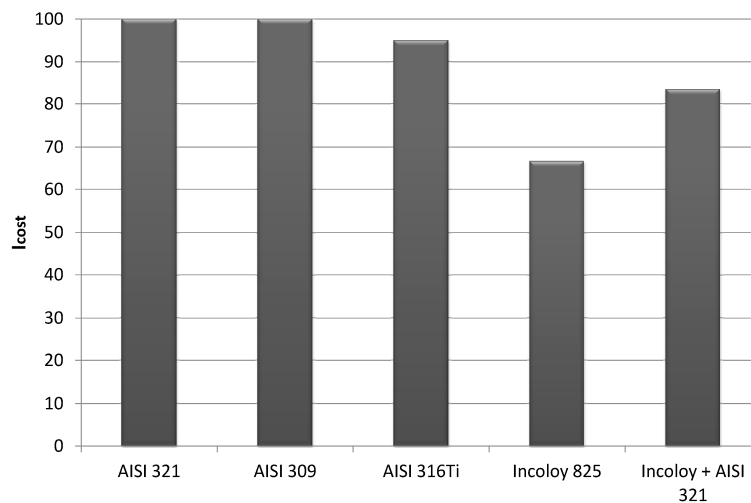
Fig.10 Cost index  $I_{cost}$

The cost index  $I_{cost}$  has been obtained considering the material costs and normalising by the maximum cost value.

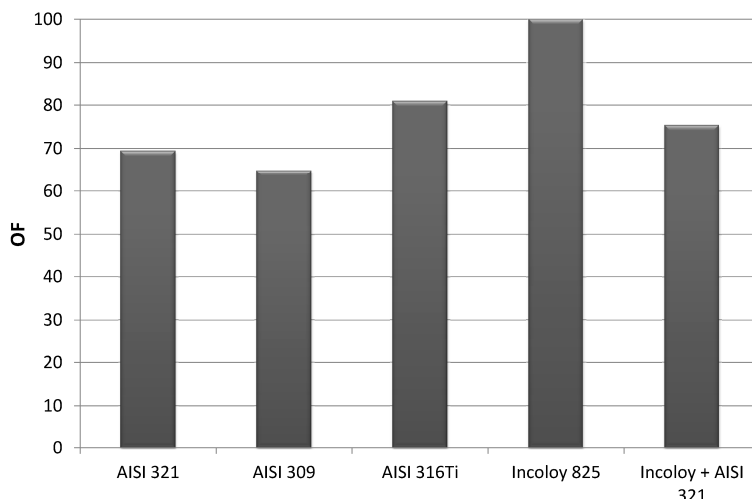
Figure 11 shows the final ranking of the analysed components. Components made of Incoloy 825 have the best scores given by CTQs analysis.

Fig.11 Final ranking of analyzed components

The ranking of analysed materials is obtained by means of the target function OF. The OF function is calculated by multiplying the normalized values of the indexes  $CTQs_i$  with the associated weight  $C_i$ :

$$OF = \sum_i C_i \cdot CTQs_i \quad (4)$$

Weights considered in this work are:  $C_{Rp02} = 1$ ;  $C_{Rm} = 1$ ;  $C_{LCF} = 2$ ;  $C_C = 3$ ;  $C_{cost} = 3$ .
