2011 International Conference on Green Buildings and Sustainable Cities

## Auditoria and public halls. The preserved architectonic heritage, in the perspective of sustainability.

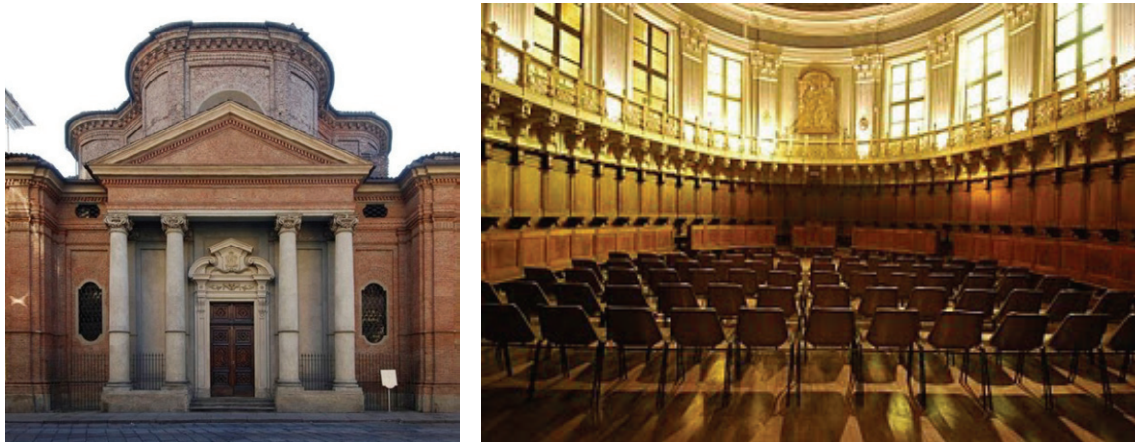
Fig. 2. (a,b) Church and Choir of Santa Pelagia, Torino. Choir detail. [Pictures © Bruna Biamino]

The hall is now used for concerts, drama, debates and conferences open to the general public. Its dimensional characteristics (choir surface: 140sqm for a height of about 15 meters) allow to host 98 seated spectators accommodated in the internal hall space and the wooden stalls. Excellent acoustic diffusion performances are very rarely improved by use of sound amplifying equipment. The wooden balcony over the stalls is supported by wooden corbels. The balcony cannot be accessed by the public but only and exclusively by operators and technicians for maintenance purpose.

During musical or theatre performances, usually held in the choir, the church hall is kept separated by heavy velvet curtains. Such device, requested by the Preservation Authority in order not to interfere visually with the order of the sacred place, guarantees only partial resistance to air and heat dispersion towards the worship hall.

Air diffusion varies in the two areas: in the main hall the air supply is performed via jet nozzle diffusers masked by the choir wooden gratings of the mezzanine floor; the return air is instead performed via the grill inlets obtained in some doors leading to ancillary areas under the choir/organ.

In the hall of the large semi-elliptical choir, the supply has been carried out in the floor and the return takes place through gratings masked in the choir itself. Floor diffusers are placed under the choir stalls, along the whole perimeter of the semi-ellipsis.

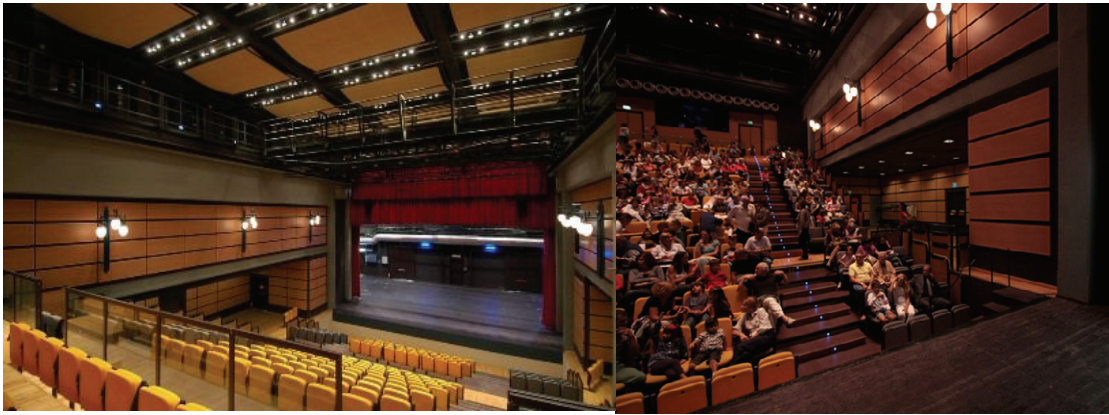
Fig. 3. (a,b), “Casa del teatro Giovani e Ragazzi”, Torino. Hall detail, reverse angle of the hall towards the stage. [Pictures © Bruna Biamino]

- “*Sala grande*” (Large Hall): i.e. a surface of 406sqm. for a total of 298 seats. The stage is 16-meter deep by a 10-meter wide scene. The hall is 11.20-meter high and planned to stage different types of shows by changing its configuration thanks to its telescopic stairs and a mobile platform.
- “*Sala Piccola*” (Small Hall): i.e. a surface of 132sqm., allocating 132 seats. The multi-purpose hall is aimed at hosting small-size shows, exhibitions, meetings, conferences, etc.
- Rehearsal rooms, laboratories, conferences : there are 4 units in the complex, for a total of 350sqm.;
- Areas for the public including *foyer*, ticket office, wardrobe, coffee-shop, bookshop: an overall surface of 700sqm. that, in the summer, integrates with an outdoor arena, with tier of seats, of about 200sqm. hosting about 120 seats.

The main hall is equipped with two independent sections of 21.000m<sup>3</sup>/h, one for the stage area and one for the audience area; they have variable capacity as per occupation level. The foyer area is equipped with an additional section of the same capacity. Air is supplied via slot and jet nozzle diffusers in the halls and the return is made via ceiling gratings.

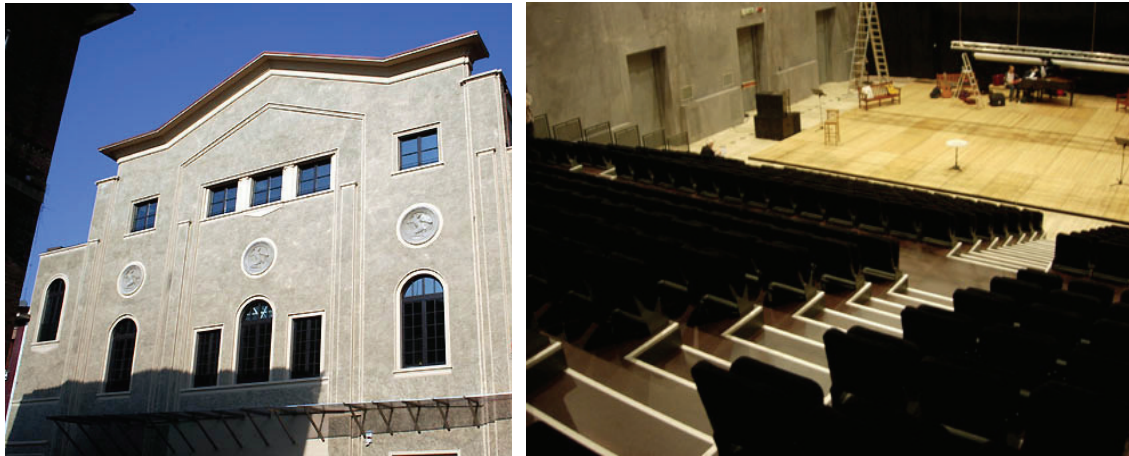
From the thermal perspective, the new intervention is almost completely decoupled from the original structure. That is a responsible choice as the new function would not adapt well with the original envelope. The “technological box”, i.e. the energy decoupling of the original with the new functions, cannot be easily adopted in contexts where the internal decoration represents a valuable element. In such cases, the constraint of the original order prevails.

The planning of show halls obtained as “technological boxes” – i.e. spaces which are architectonically and functionally independent – not interacting directly with outside areas, is a solution that enables to bypass the original thermal function of the building. It is a kind of solution that brings about positive results as far as the interface spaces between the box and the original case/envelope allow for the positioning of the necessary installations on top of the functions which are related to the hall itself.
