A Power and Energy Procedure in Operating Photovoltaic Systems to Quantify the Losses According to the Causes

F. Spertino¹, A. Ciocia¹, P. Di Leo¹, R. Tommasini¹, I. Berardone², M. Corrado², A. Infuso²,
M. Paggi³

Abstract: Recently, after high feed-in tariffs in Italy, retroactive cuts in the energy payments have generated economic concern about several grid-connected photovoltaic (PV) systems with poor performance. In this paper the proposed procedure suggests some rules for determining the sources

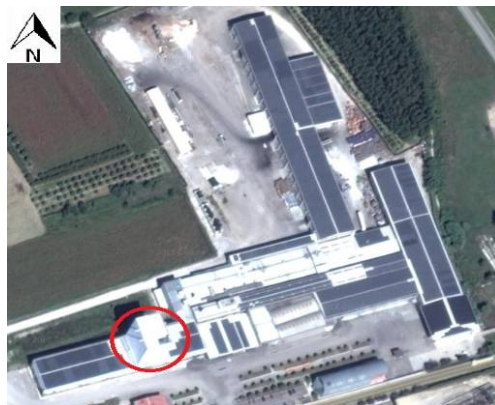
Fig. 2. Satellite image of the 2.5 MWp *BIPV* system.

During the inspection of the *BIPV* plant, it was observed that a remarkable obstacle (Fig. 2 inside the red circle) can put into shade a part of the PV modules. The 3D model of the obstacle (a tower in the factory) in SketchUp with the near roofs, subject to lateral shades of tower, was created to estimate the resulting power losses on the PV modules. In details, the tower is 25-m higher than the roofs, where these PV modules are placed. The tilt of the roof is 6° , whereas the azimuths are -17° (southeastern) and $+163^\circ$ (northwestern). The decrease of productivity is different for each individual string and depends on the position in which it is installed. To carry out daily simulations representative of the yearly behavior, spring, summer and autumn days are chosen: the winter impact is negligible. The Sun-beam evolution is analyzed with respect to the projected shades on the PV modules: 109 strings in different colors in Fig. 3 at right and left sides of the tower. The irradiance profiles, only for 10 strings with SE (left side) and NW (right side) orientations, are shown in Fig. 4, in which the steep increments and decrements represent the end of shadows in the morning and their beginning in the afternoon on the involved strings. PVGIS [12] provides data on global irradiance and diffuse contribution in monthly mean conditions. The diffuse irradiance is considered, if the shadow of the tower covers at least one of the string modules, neglecting the action of the bypass diodes inside the modules with a pessimistic estimation. As main findings of the simulation on a 272-kWp portion of *BIPV* system, the energy losses are $\approx 6\%$ in spring, $\approx 9\%$ in summer and $\approx 3\%$ in autumn (negligible in winter) with respect to the calculation without the shade effect. However, these losses have an impact $< 1\%$ on yearly basis (0.7%, 1.1% and 0.3% in the three seasons, respectively), taking into account the relative weight (12% of 2.3 MWp) of the PV system portion in the energy production. In addition, other obstacles, as e.g. balustrades and chimneys, provide losses concentrated in winter (it accounts for 9% of the yearly production) with noticeable deviations with respect to energy calculated without shades. Even if the shades have an impact month by month, the energy reduction per year can be estimated within 1—2%.
