Icelandic Concrete Surfaces: Guðjón Samúelsson's *Steining* (1930–50)

Sofia Nannini

Politecnico di Torino, Italy

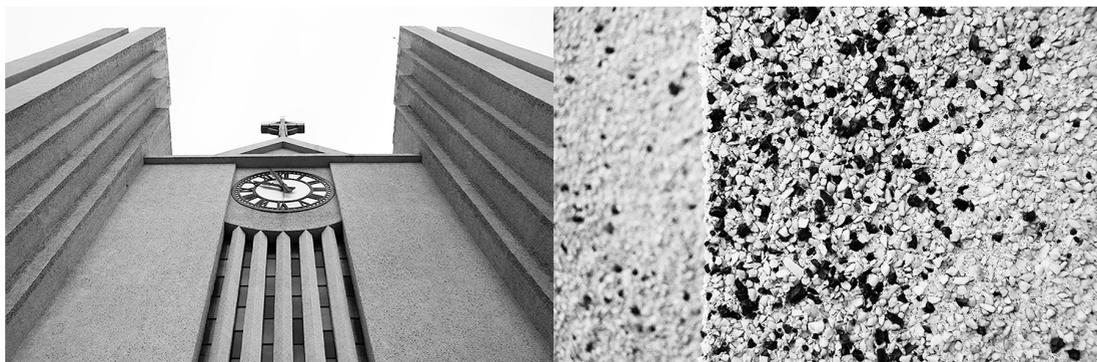
Figure 7. Steining on the church of Akureyri. Detail on the right. Photos by Sofia Nannini.

Quartz (*kvars*) was mined in the Mosfellsbær area, near Reykjavík. Its presence was discovered mostly in the vicinity of some gold mines which had been active since 1909 [31]. An interesting application of both obsidian and quartz can be seen on the façade of the church in Akureyri, northern Iceland, designed and built by Guðjón Samúelsson in 1934–40. Dark obsidian splinters were used to mark the edges of the structure, while pale quartz pieces covered the rest of the surface (Fig.7).

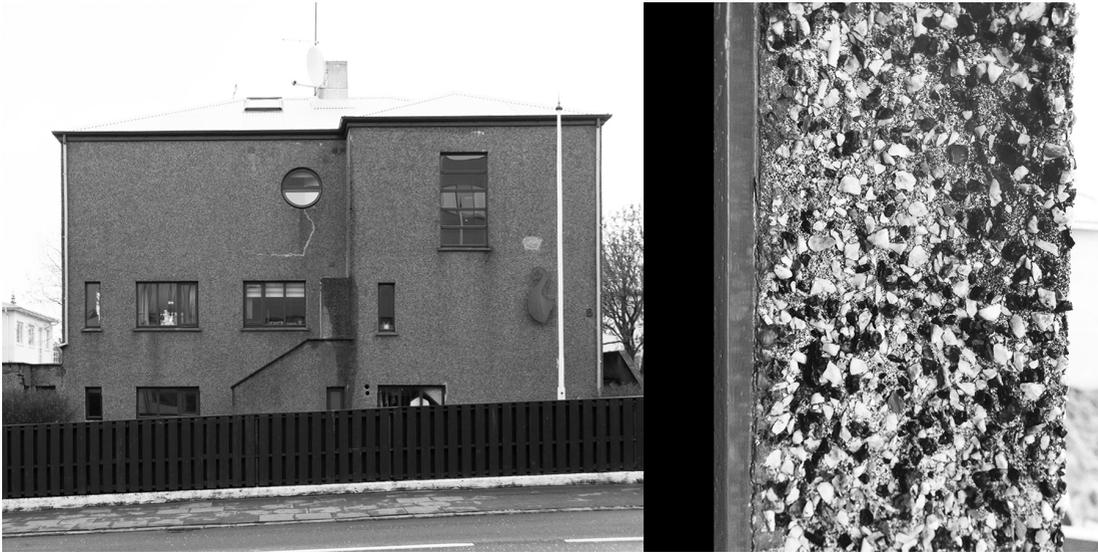
Figure 8. The villa in Eiríksgata 6, Reykjavik, designed by Guttormur Andrússon and commissioned by Trausti Ólafsson. Detail of Steining on the right. Photos by Sofia Nannini.

The most precious material to be found in the *Steining* render is ground Iceland spar (*silfurberg*), also known as Iceland crystal. This particular kind of calcite had been mined in Helgustaðir, eastern Iceland, since the mid-nineteenth century, and it had been pivotal in the development of modern studies on light polarisation [32]. Indeed, only the cheapest and most opaque fragments of Iceland spar were used for building purposes [33]. Today, a few buildings still boast the original *Steining* render and their first pebble mix. One of them is the modern villa commissioned by the chemist Trausti Ólafsson in 1934, whose *Steining*-rendered walls include Iceland spar, obsidian, and other volcanic rocks (Fig.8).
