# Experimental Characterization of Piezoelectric Transducers for Automotive Composite Structural Health Monitoring

Massimiliana Carello, Alessandro Ferraris, Andrea Giancarlo Airale, Alessandro Messina, Lorenzo Sisca,  
Henrique de Carvalho Pinheiro, and Simone Reitano

Politecnico di Torino

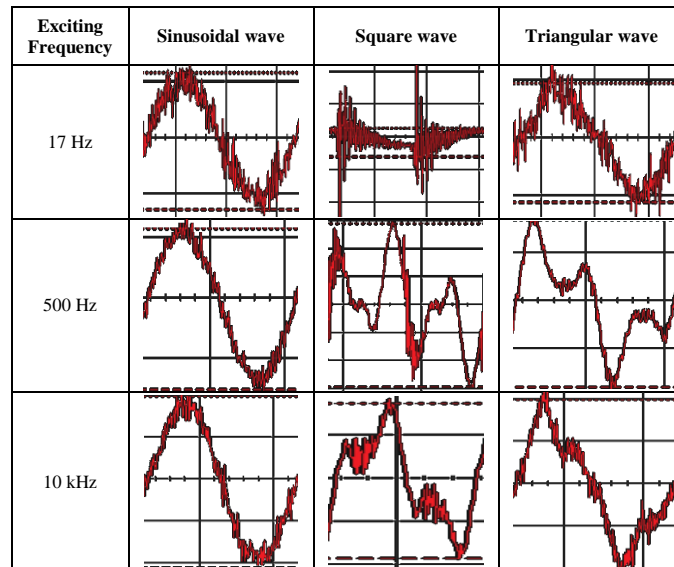
Table 6: Analysis of wave shape transmission from piezo actuator to piezo sensors.

The sinusoidal wave is the only input shape that is perfectly transmitted and received at any frequencies. On the contrary, triangular wave is subjected to distortion at low frequencies and it becomes acceptable just at the higher ones, while the square wave is not received well neither at high nor at low excitation.
