AIAS 2019 International Conference on Stress Analysis

## Monitoring of railway freight vehicles using onboard systems

Nicola Bosso\*, Antonio Gugliotta, Matteo Magelli, Nicolò Zampieri

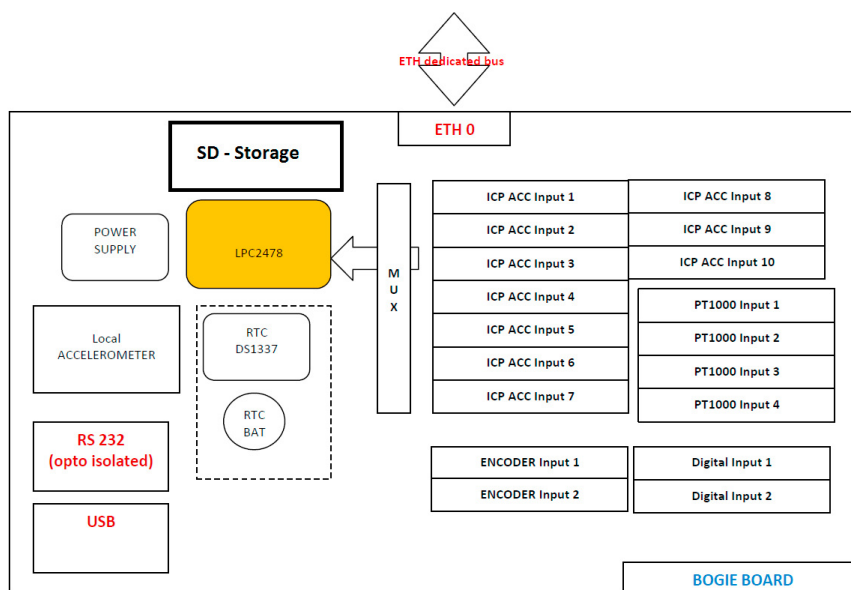
Fig. 2. Layout of the Monitoring Board

The monitoring board is designed to equip a vehicle bogie and, for each of the four axle-boxes of the bogie, includes a vertical accelerometer, a longitudinal accelerometer and a thermal probe. On one of the two axle-box of each axle, a lateral accelerometer is also installed, while on the opposite axle-box, an encoder is installed to detect the angular speed of the wheelset. The channels acquired are therefore the following:

- 10 channels for accelerometers (ICP or capacitive)
- 4 thermal probes (PT1000 or semiconductor sensors)
- 2 incremental 1024 pulse / rev encoders.
- 1 tri-axial capacitive accelerometer integrated in the board and mounted on the vehicle body

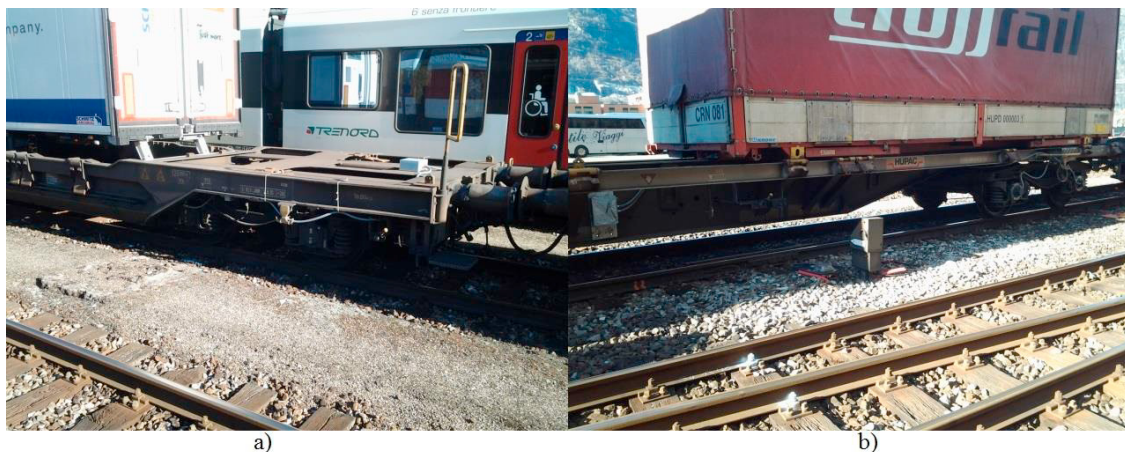
Fig. 6. Instrumented vehicles during the tests: a) Tasca 4.2 Wagon, b) CT-Light Wagon.

The tests shown in the paper have been performed in Switzerland, on the Gotthard Base tunnel between Biasca and Altdorf and on the old line, between Busto Arsizio and Aarau, in order to compare the performances of the two tracks in terms of vehicle accelerations. The tests on the Base tunnel have been performed considering different axle-load and different speed in order to test the new track under different conditions. Fig. 6 shows the equipped vehicles during the tests.

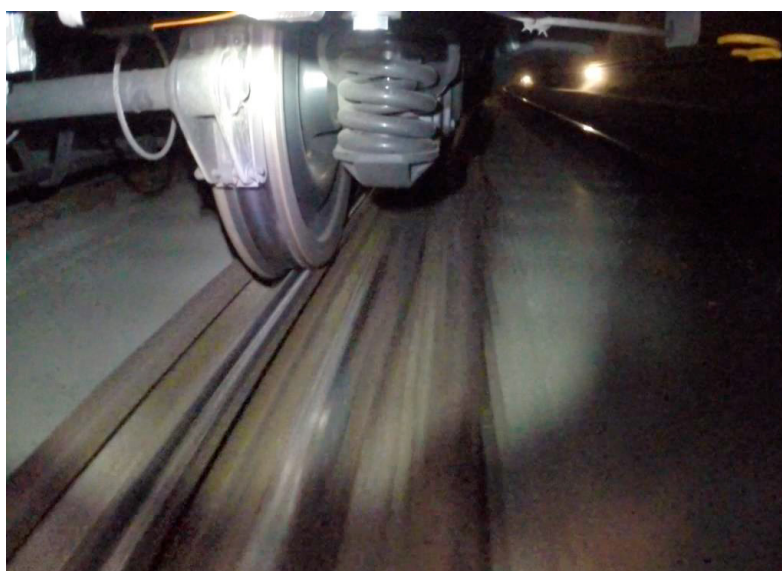
During the test, a camera was fixed on the coach and synchronized with the acquisition system, in order to relate the results with the track defects and singularities. The camera has been oriented to record the track and one wheel of the coach. From the analysis of the video at about the km 37, where the acceleration peak was detected, it is possible to notice the presence of a series of railway switches that is the cause of the acceleration increment. Fig. 11 shows the first railway switch located at the km 37.

Fig. 11. Detail of one vehicle wheel while running on the switch located at km 37 of the Gotthard Base tunnel.
