Structural design criteria for safety by monitoring of the architectural heritage damage: new proposal

# Structural design criteria for safety by monitoring of the architectural heritage damage: new proposal

**Keywords:** masonry bell-tower; seismic vulnerability; architectural heritage; damages; rigid blocks.

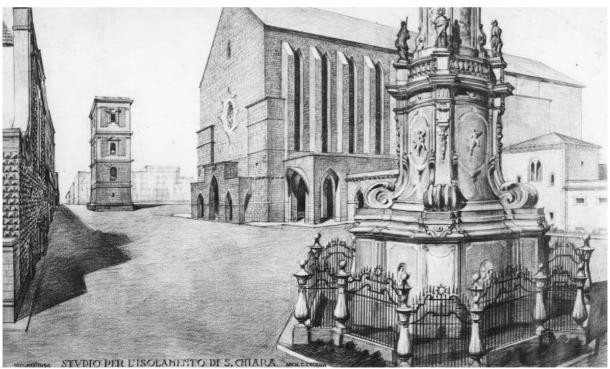
Fig. 1: C. Guerra, Study for the isolation of St. Chiara, June 1954.
